# National Transportation Safety Board Aviation Accident Preliminary Report

| <b>Location:</b> | Half Moon Bay, CA | <b>Accident Number:</b> | WPR19LA238 |
| <b>Date &amp; Time:</b> | August 19, 2019, 17:54 Local | <b>Registration:</b> | N134P |
| <b>Aircraft:</b> | Beech 36 | <b>Injuries:</b> | 2 None |

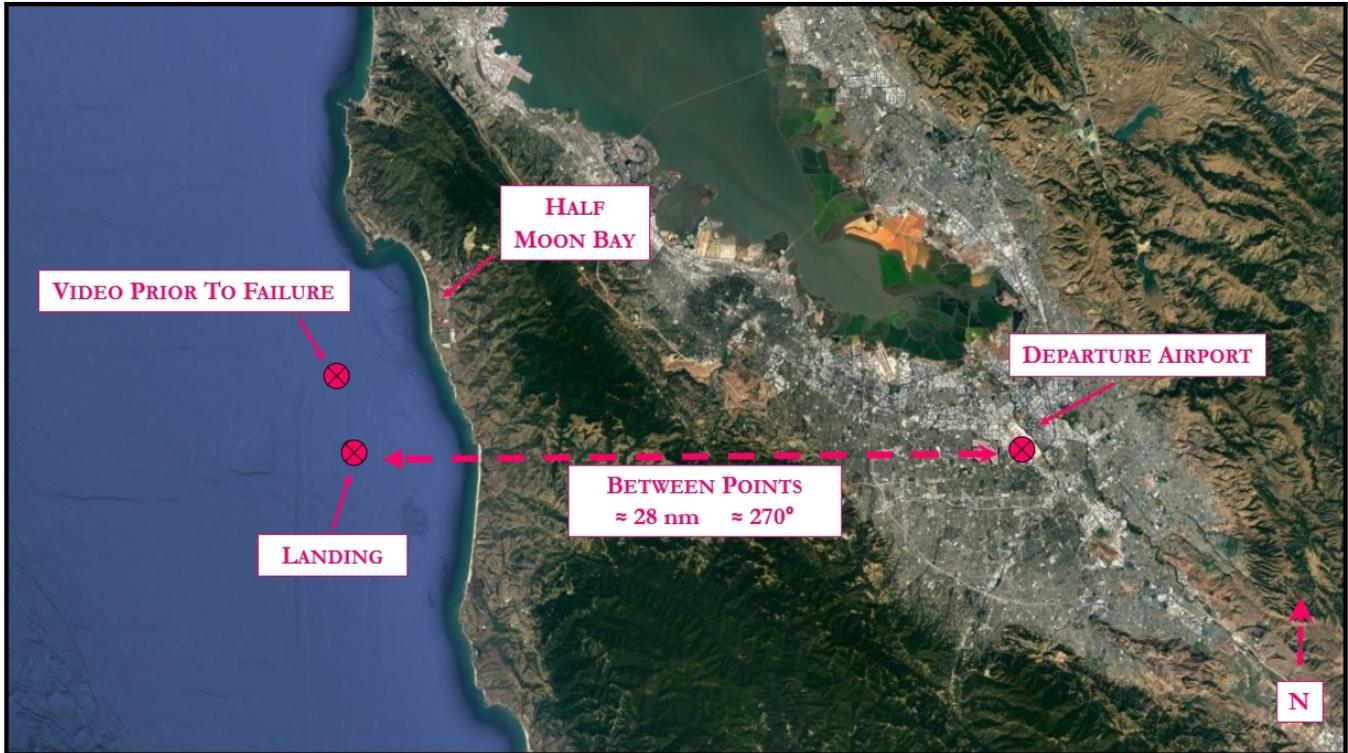
Just prior to the engine anomaly, the passenger took two cell phone videos, both of which were posted to the social media platform Instagram. The last video was started at 1735:26 (at a location 3 nm north of the accident site) and captured 16 seconds showing the pilot making the left turn just prior to the engine losing power (reference picture 01).

Picture 01: Accident Site in Reference to Departure Airport

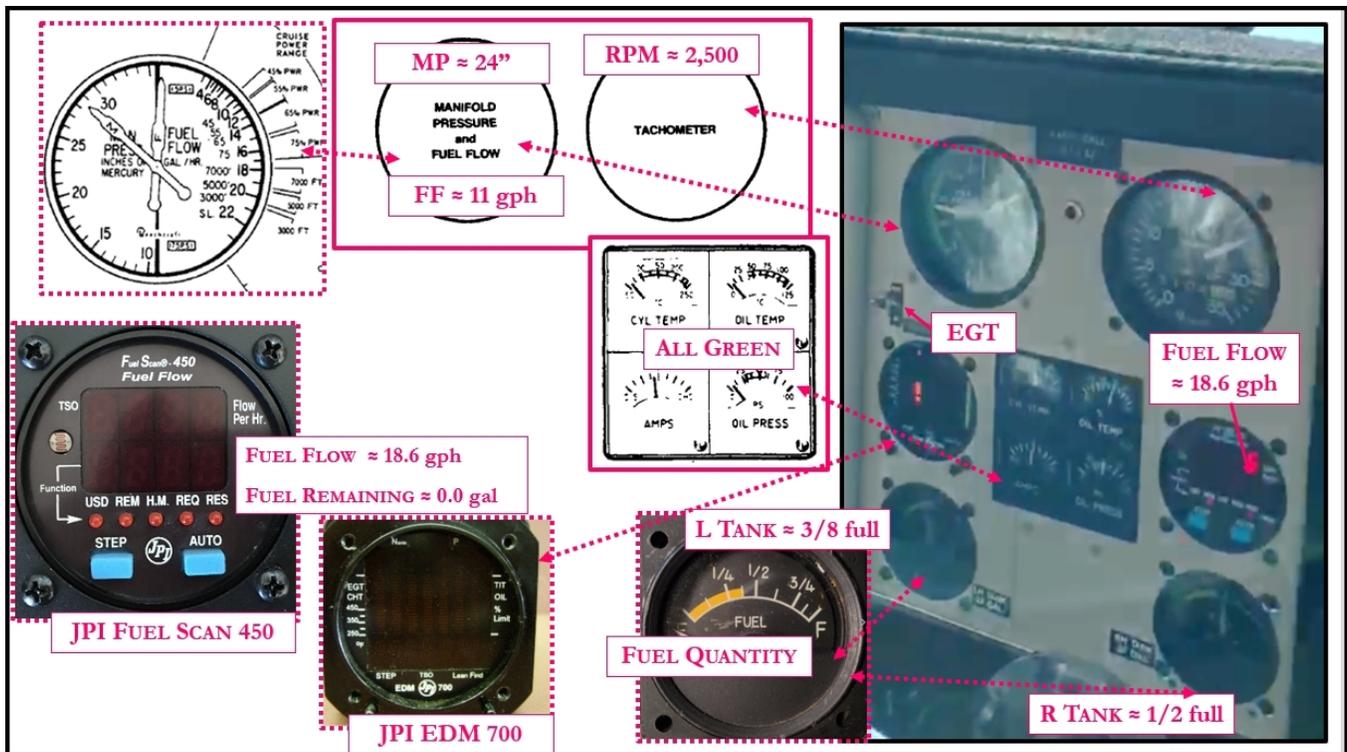
A review of the video disclosed that the JPI Fuel Scan 450 instrument showed a 18.6 gph flow; that the left wing tank contained about 3/8 full fuel; the right tank was 1/2 full, and a manifold pressure of 24 inches (reference to picture 02).

Picture 02: Cockpit Instruments Prior to Engine Failure

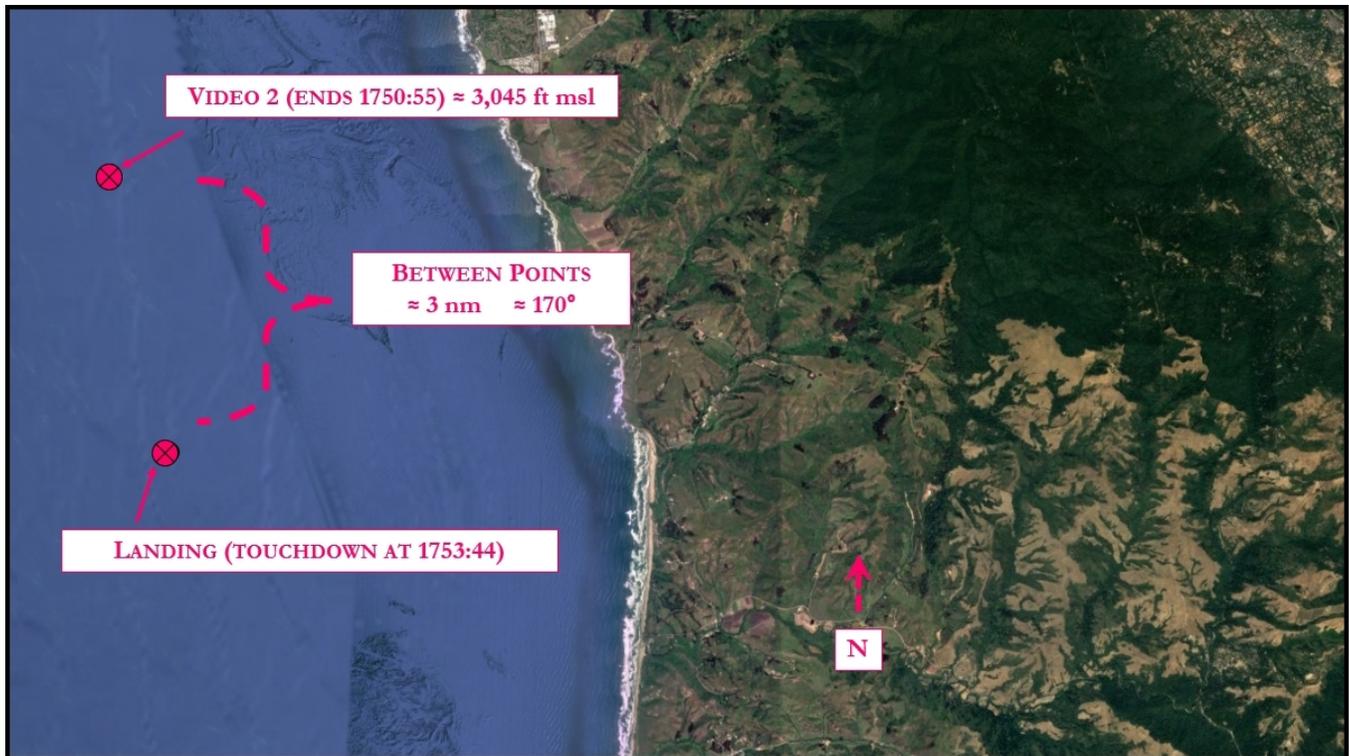
The pilot of the Cessna began taking a video of the accident airplane ditching in the ocean at 1753:44, where the airplane touches down on the surface of the water at 1754:02 and comes to a stop about 1754:15 (reference pictures 03). The pilot began a to take a video of himself and his passenger while they were standing on the wing at 1754:33.

Picture 03: Accident Site in Reference to Last Video
