Pillar Point Harbor

Updated Marina Facility Condition Survey Report

Prepared for:
San Mateo County
Harbor District

May 2021

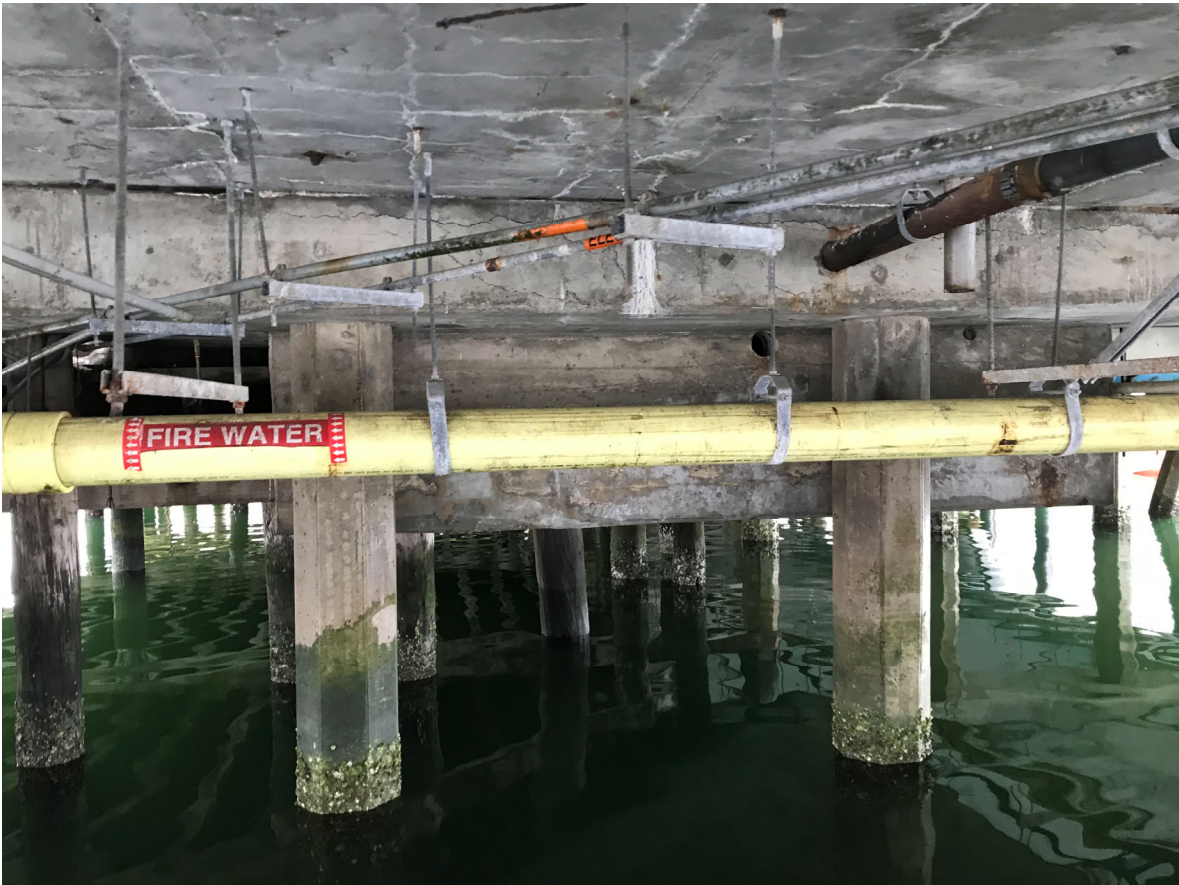
The majority of the below deck areas of the pier visually inspected were found to be in “good” condition with the reinforced concrete pilings, support beams (bents), and deck panels not showing signs of significant cracking, spalling or overstressing. However, at the end of the pier in the vicinity of the Fish Buyer Building, the stacking/storing of fish gondolas (boxes) and the off-loading of fish via forklift onto semi-trucks appears to have caused several of the reinforced concrete deck support beams to show signs of overstressing in our opinion, as previously mentioned, and are in need of repair and structural upgrades to accommodate the loading.

7 – View of overstress cracked beam and utilities under end of pier

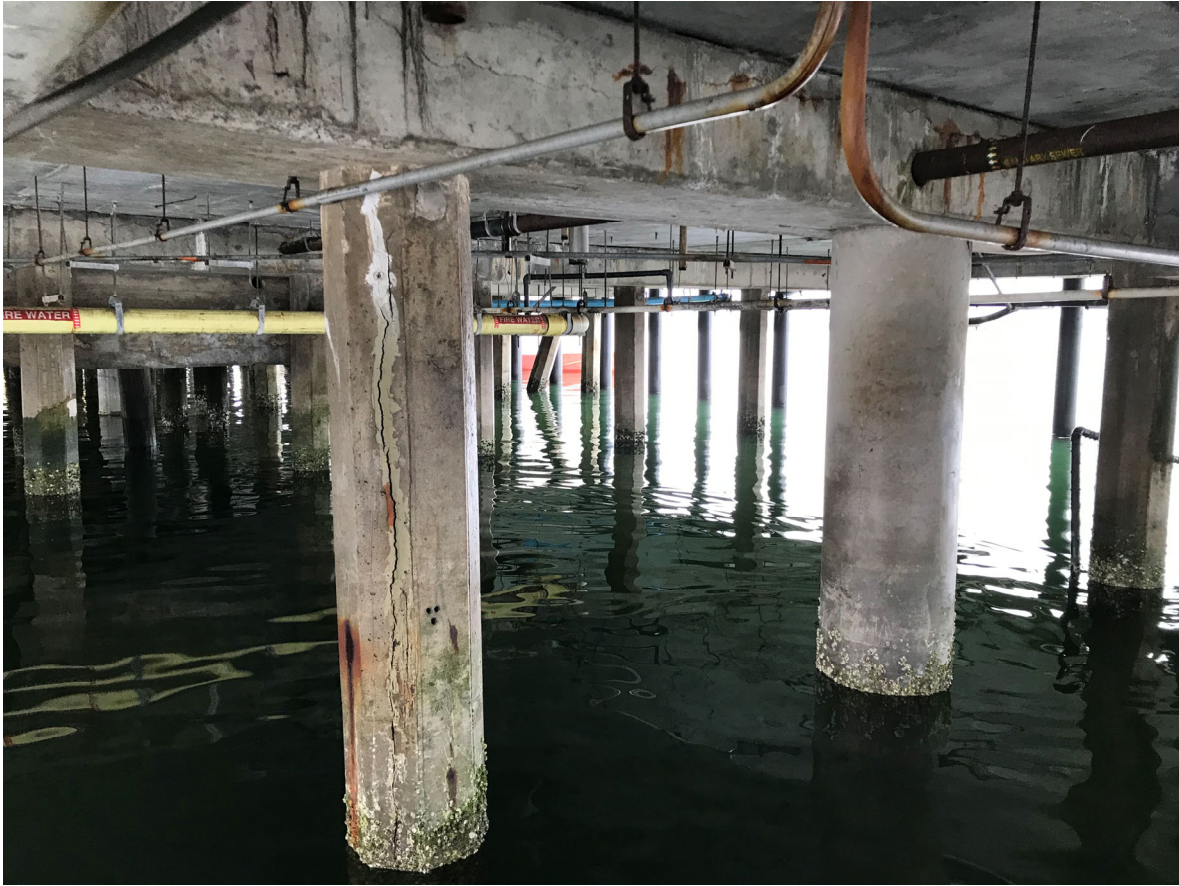
Johnson Pier was built in 1961 and is the backbone and centerpiece of the harbor, and has been well maintained and structurally and mechanically is considered to be in overall “good” condition. In 2013, a comprehensive repair and improvement project was undertaken that focused on various aspects of the pier including deck and bullrail repairs, utility improvements, and upgrades to the perimeter railing and area lighting. With continued maintenance, the remaining useful life for the majority of the structure is anticipated to be 30 to 40 years, while several of the reinforced concrete beams (or bents) supporting portions of the deck at the end of the pier were noted to be in “poor” condition and in need of repair and structural upgrades in the next 5 to 10 years due to overstressing by excessive loading. One reinforced concrete support pile near the end of the pier has also been identified to be overstressed and in “poor” condition and in need of repair (jacketing) in the next 5 to 10 years.

10 – View of overstressed pile and bent at end of pier

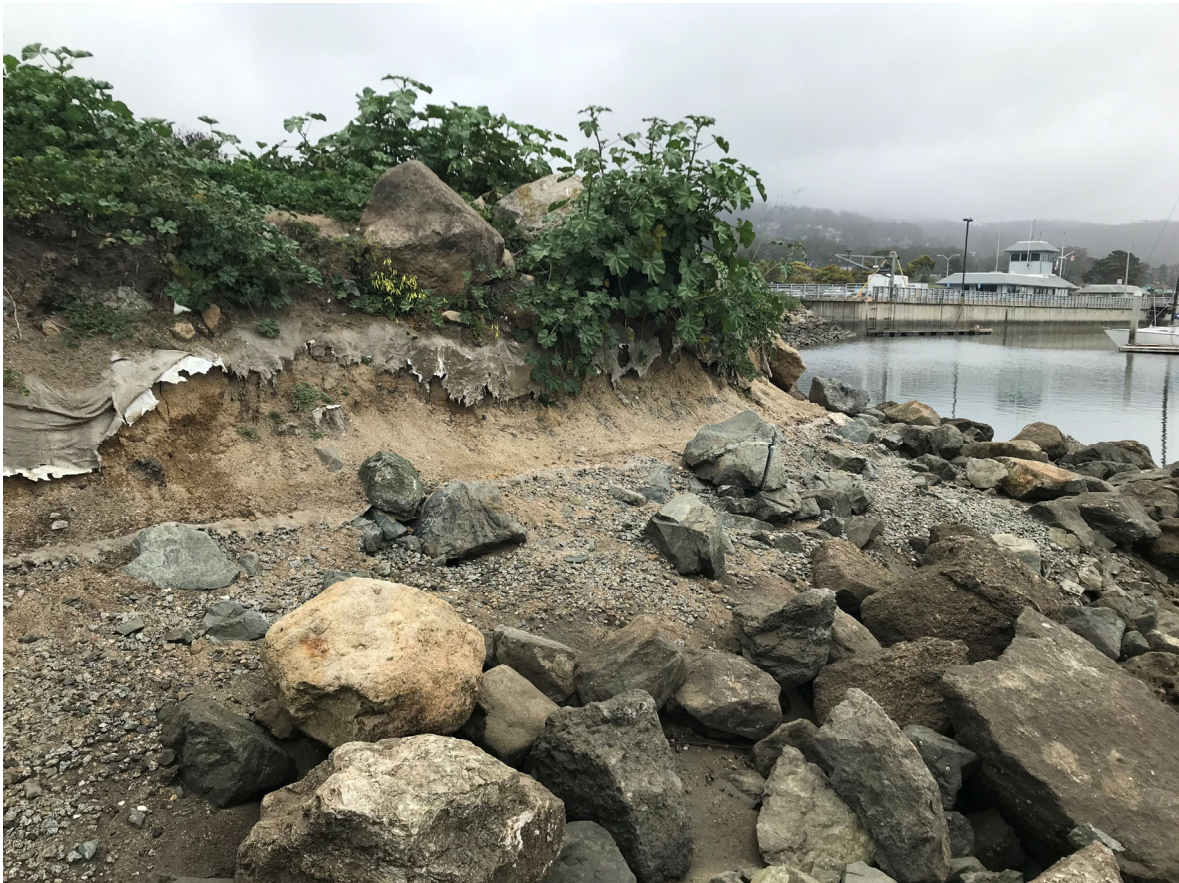
The rock slope protection separating the promenade and parking lot areas from the harbor have failed and are in “critical” condition and in need of immediate repair, with a remaining useful life (RUL) of 0 to 2 years. Sloughing of the slope underneath the rock has created areas where the underlying filter fabric has been ripped and displaced, and bare earth is exposed to the elements allowing the slope to deteriorate and loose soil material to enter the harbor.

23 – View of failed rock slope protection

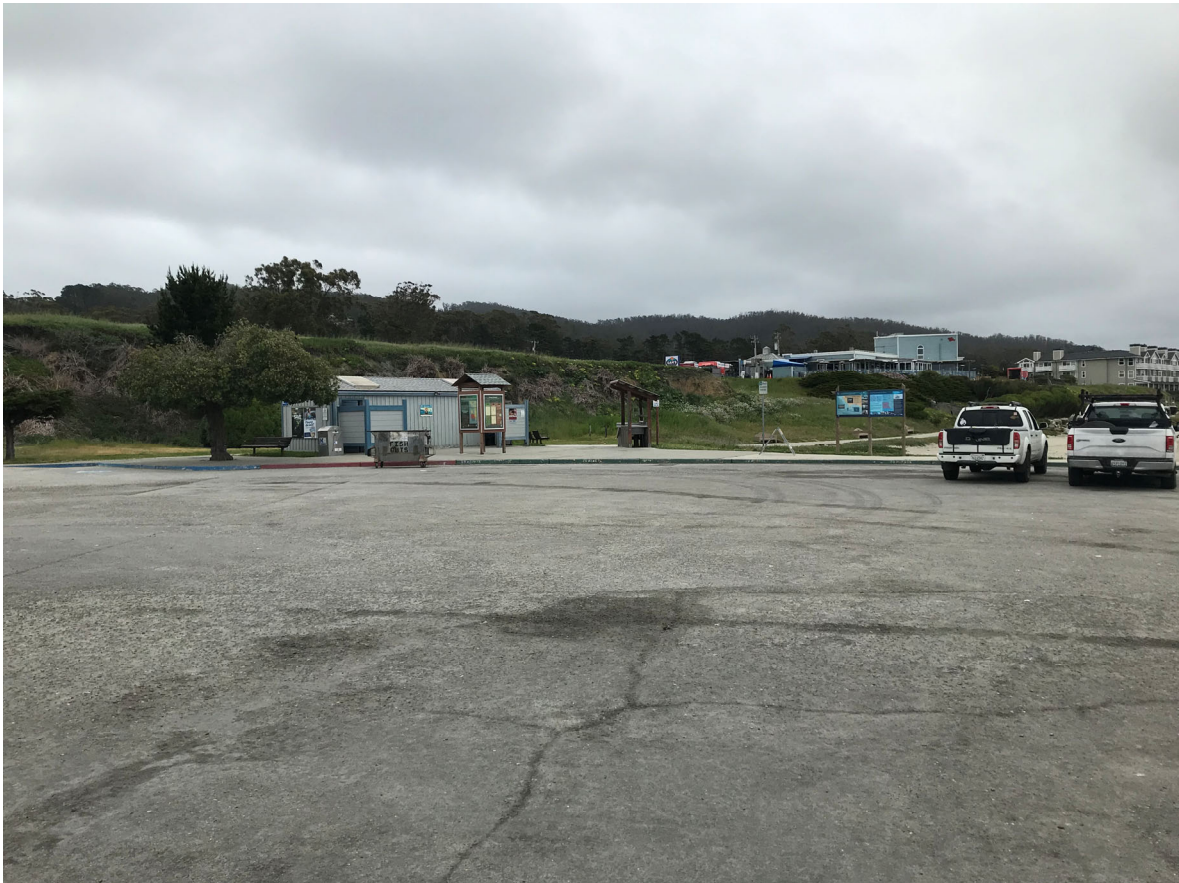
Boat Launch Ramp - Surface and boarding float docks were observed to be in “fair” condition with an anticipated remaining useful life 10 to 20 years, and the concrete pavement at the top of ramp is considered to be in “poor” condition with an anticipated remaining useful life of 5 to 10 years before needing replacement. The asphalt concrete roadway from the launch ramp to the boat trailer parking area is more heavily degraded and considered to be in “serious” condition with an anticipated remaining useful life of 2 to 5 years before needing replacement.

43 – View of worn concrete apron turnaround at top of boat launch ramp

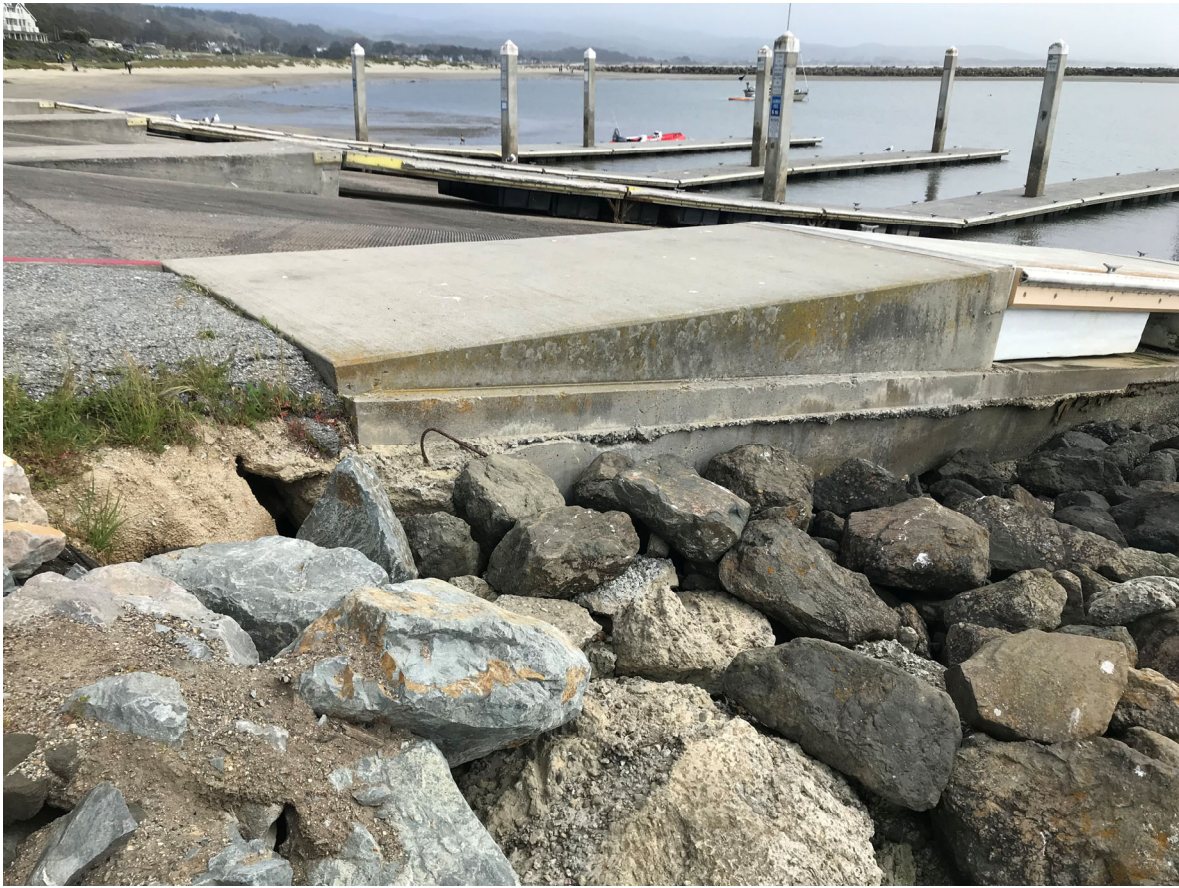
46 – View of boat ramp abutment undermining

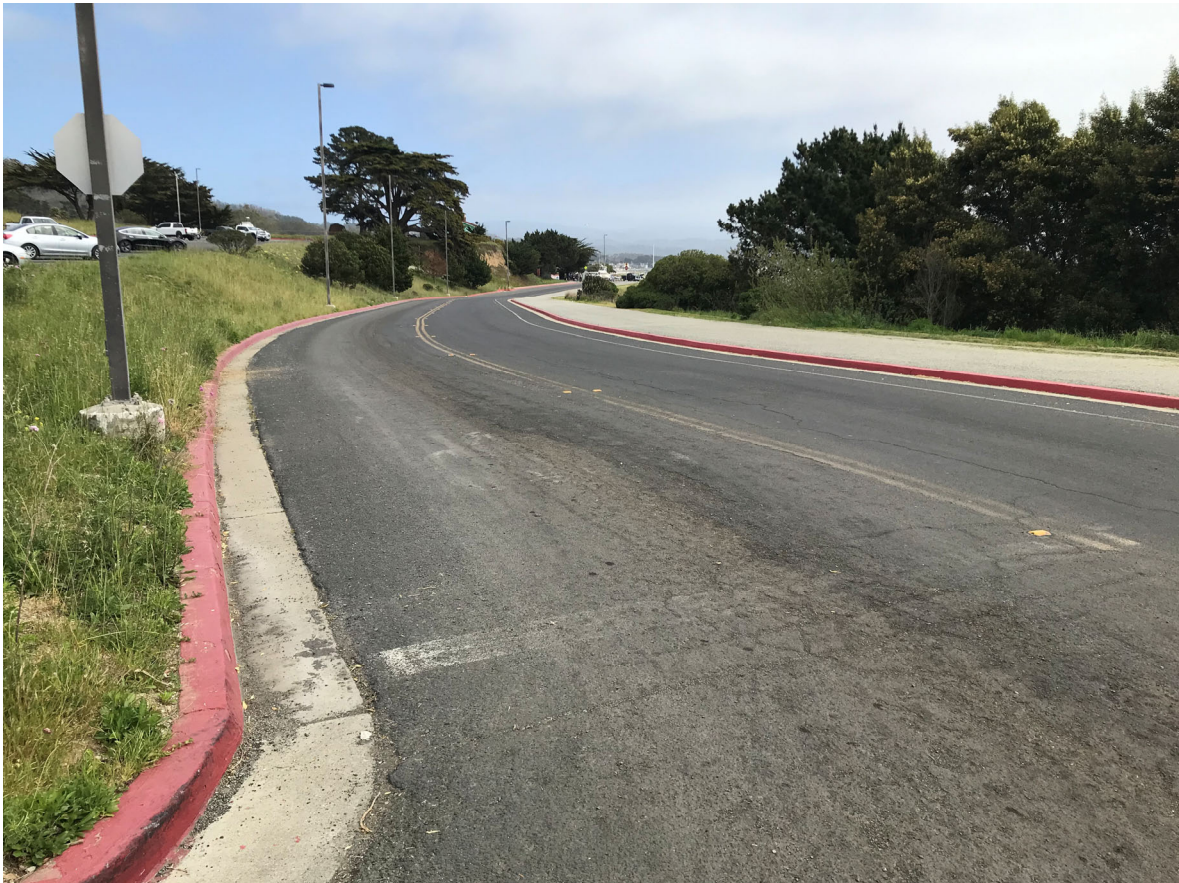
47 – View of worn and failing pavement from boat ramp to trailer parking area

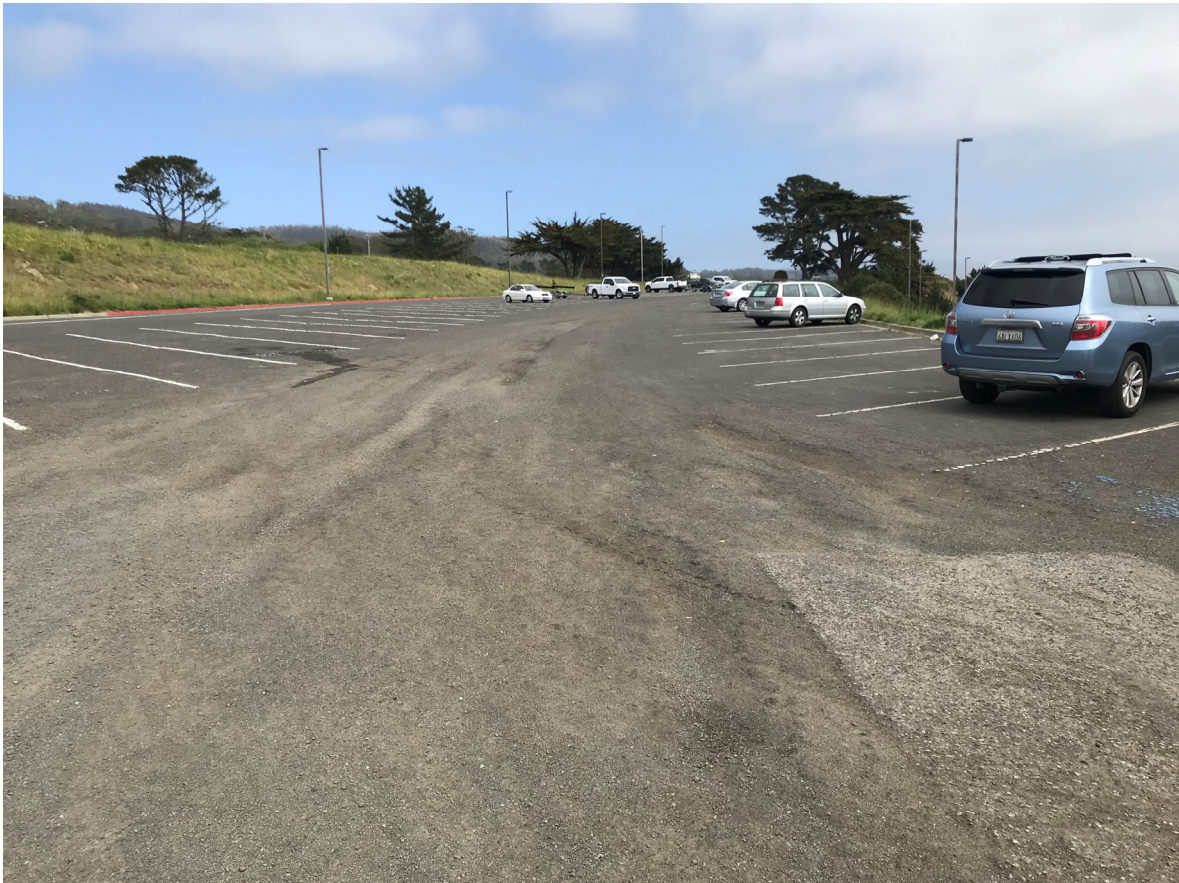
49 – View of worn and failing pavement in boat trailer parking area

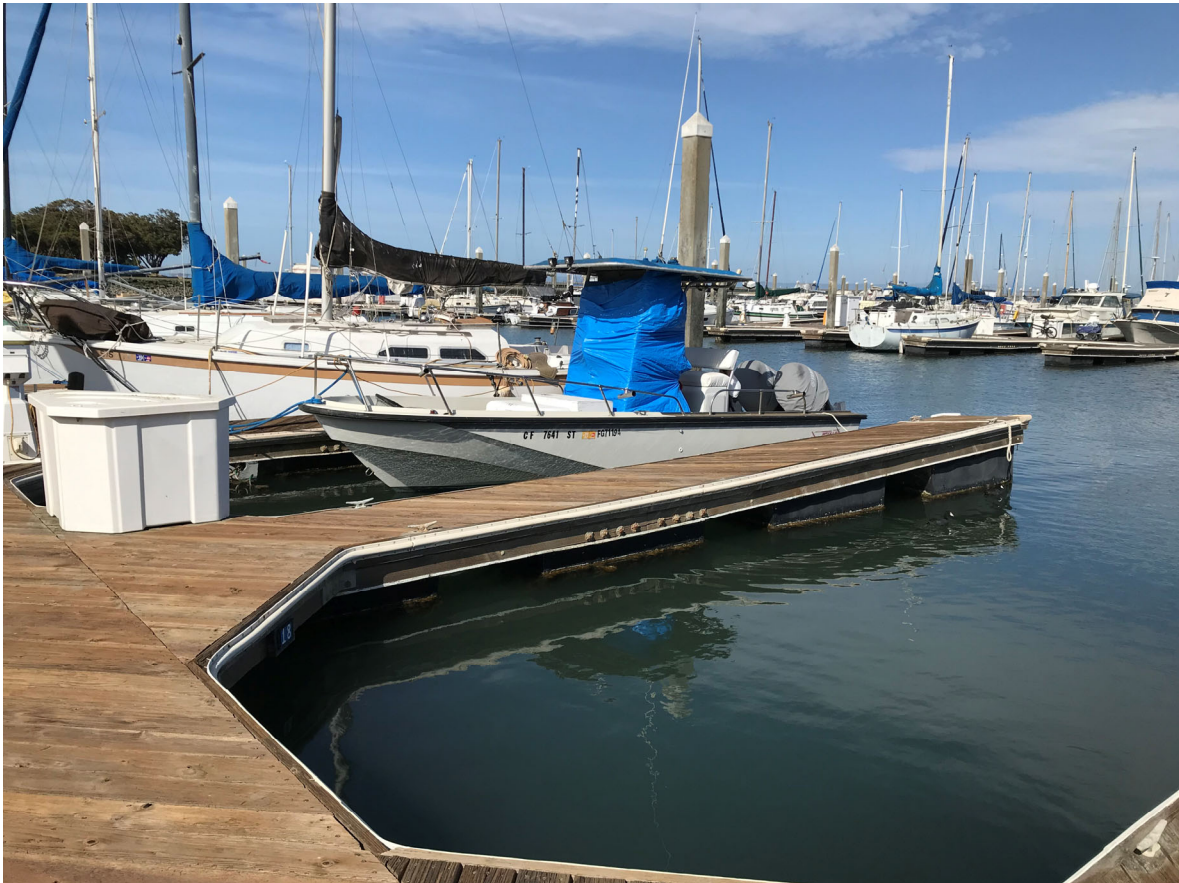
9 – View of uplifting West Basin Dock 2 finger

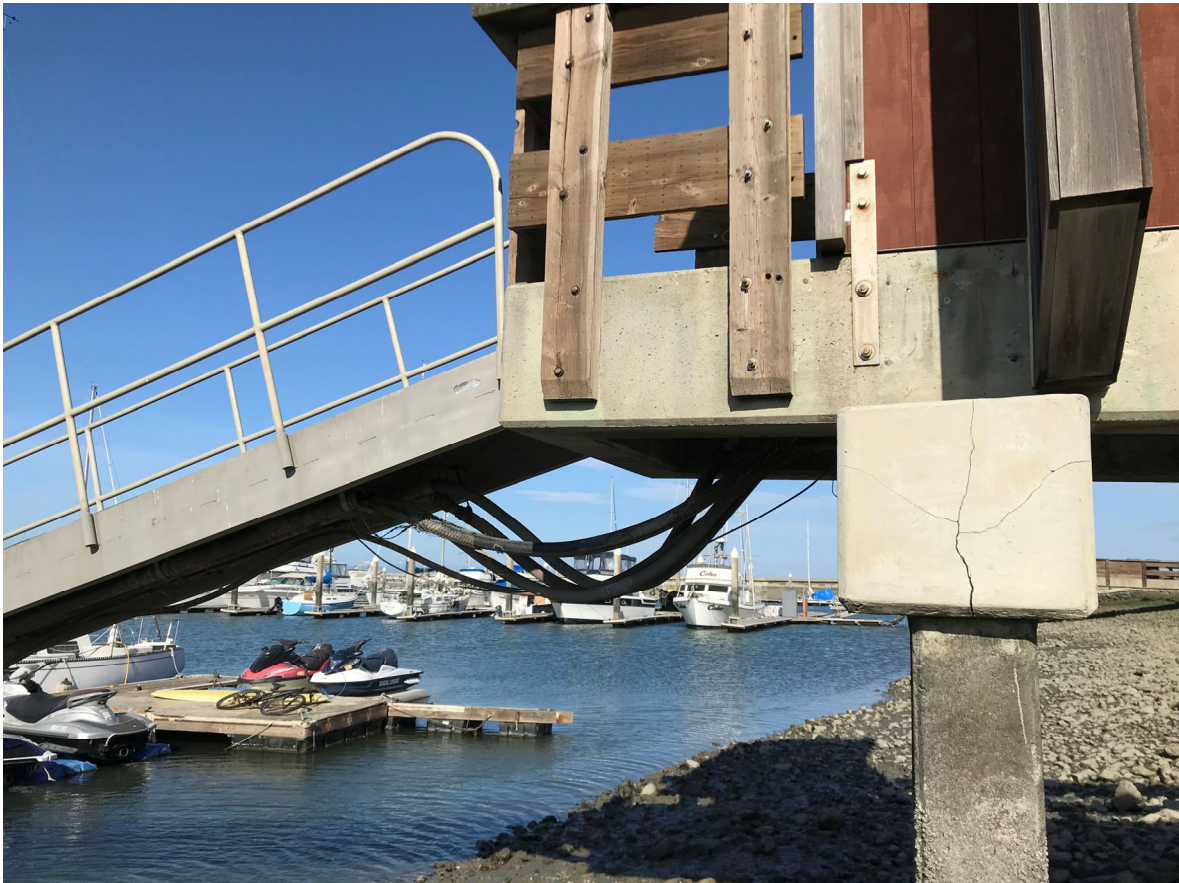
33 – View of Dock 12 gangway platform concrete bent cracks

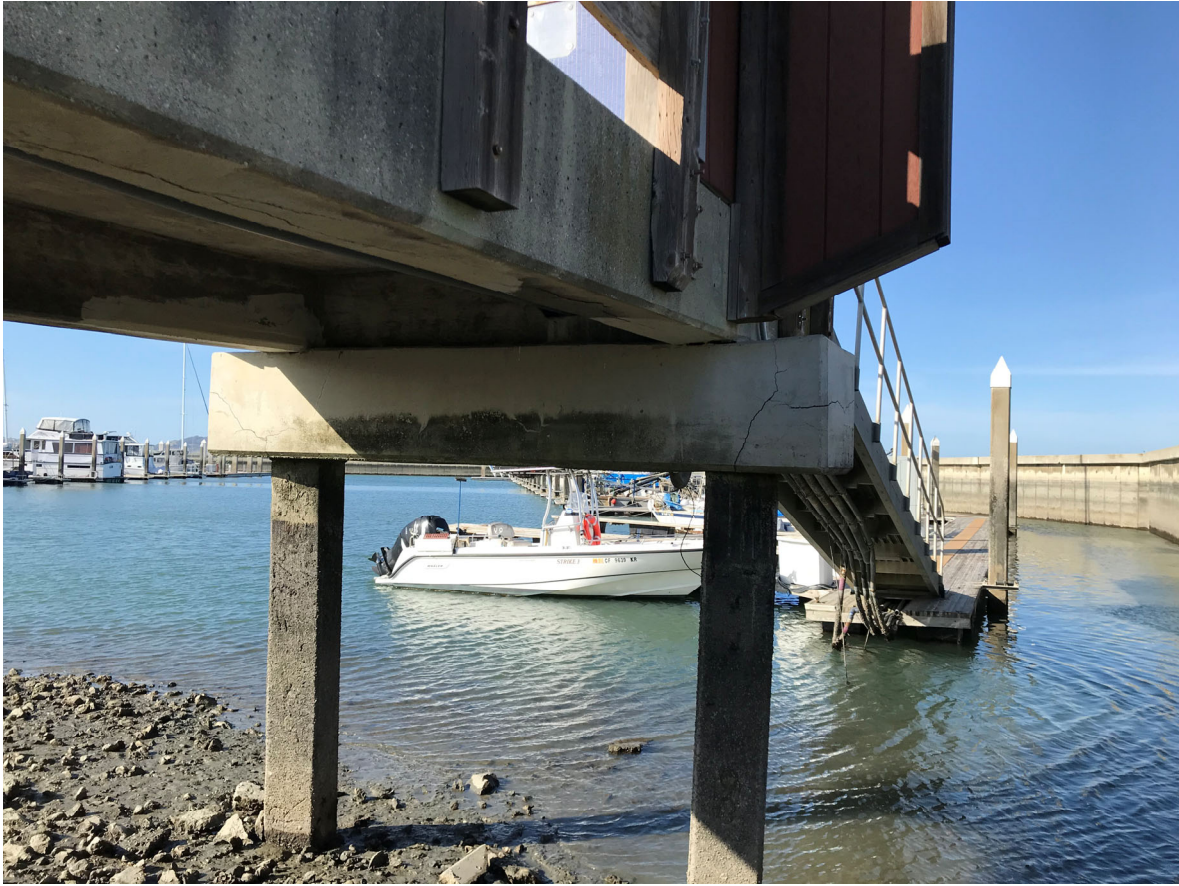
44 – View of East Basin dock 14 gangway platform cracked concrete bent

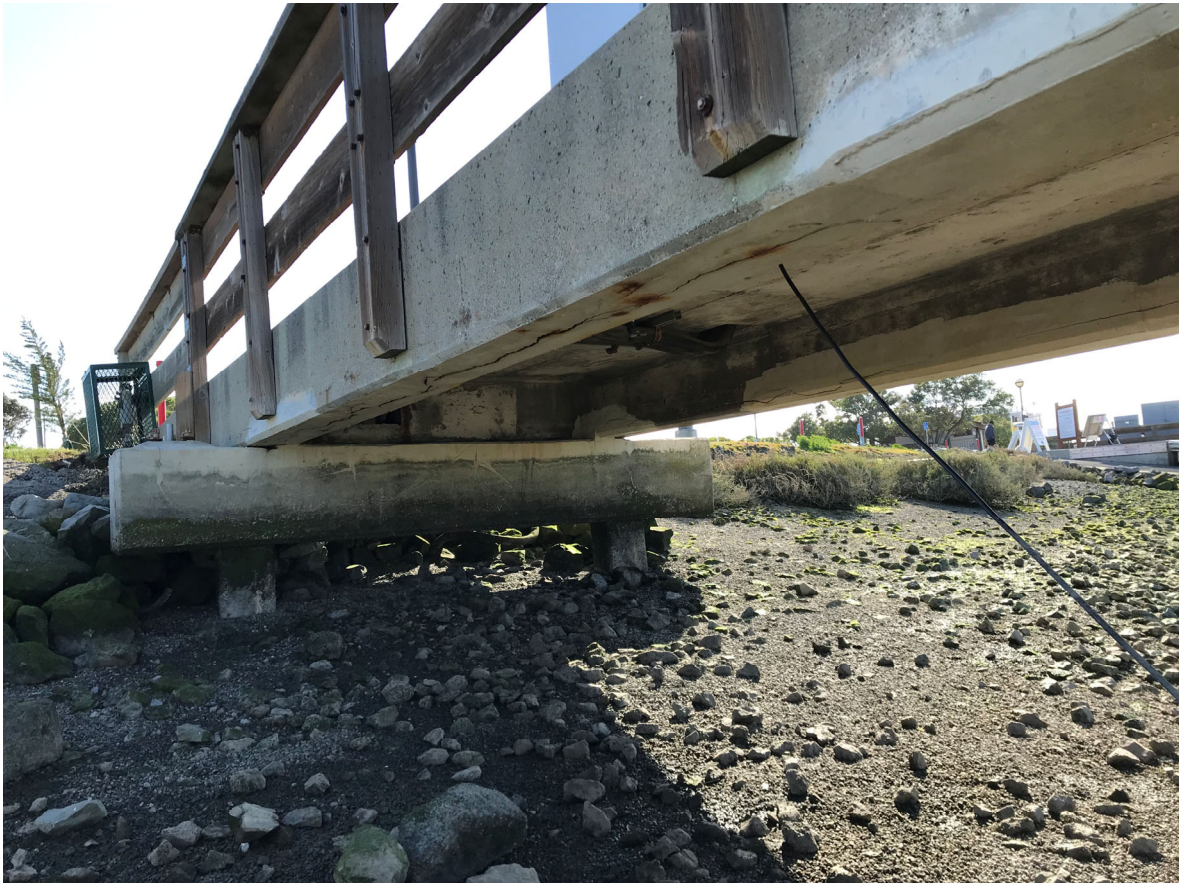
45 – View of East Basin dock 14 gangway platform cracked concrete beams

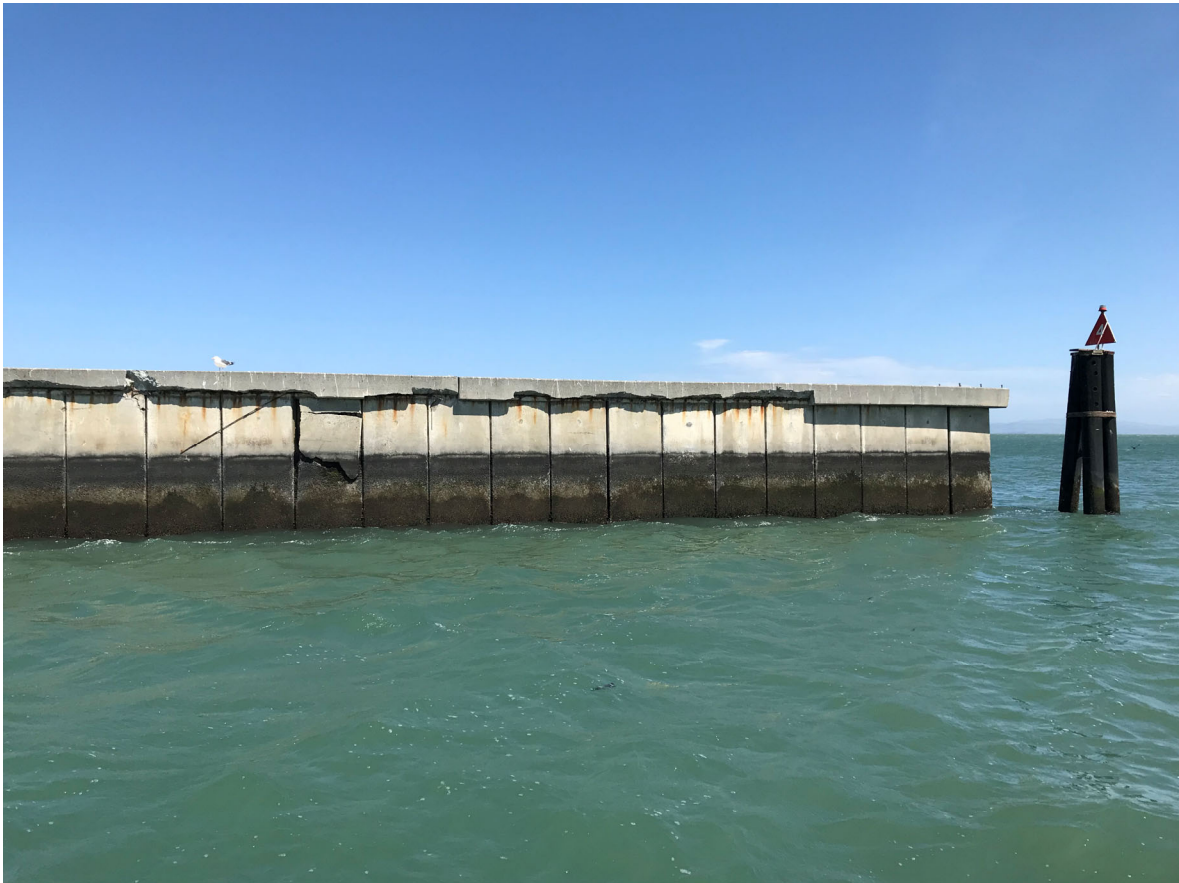
47 – View of damaged seawall cap

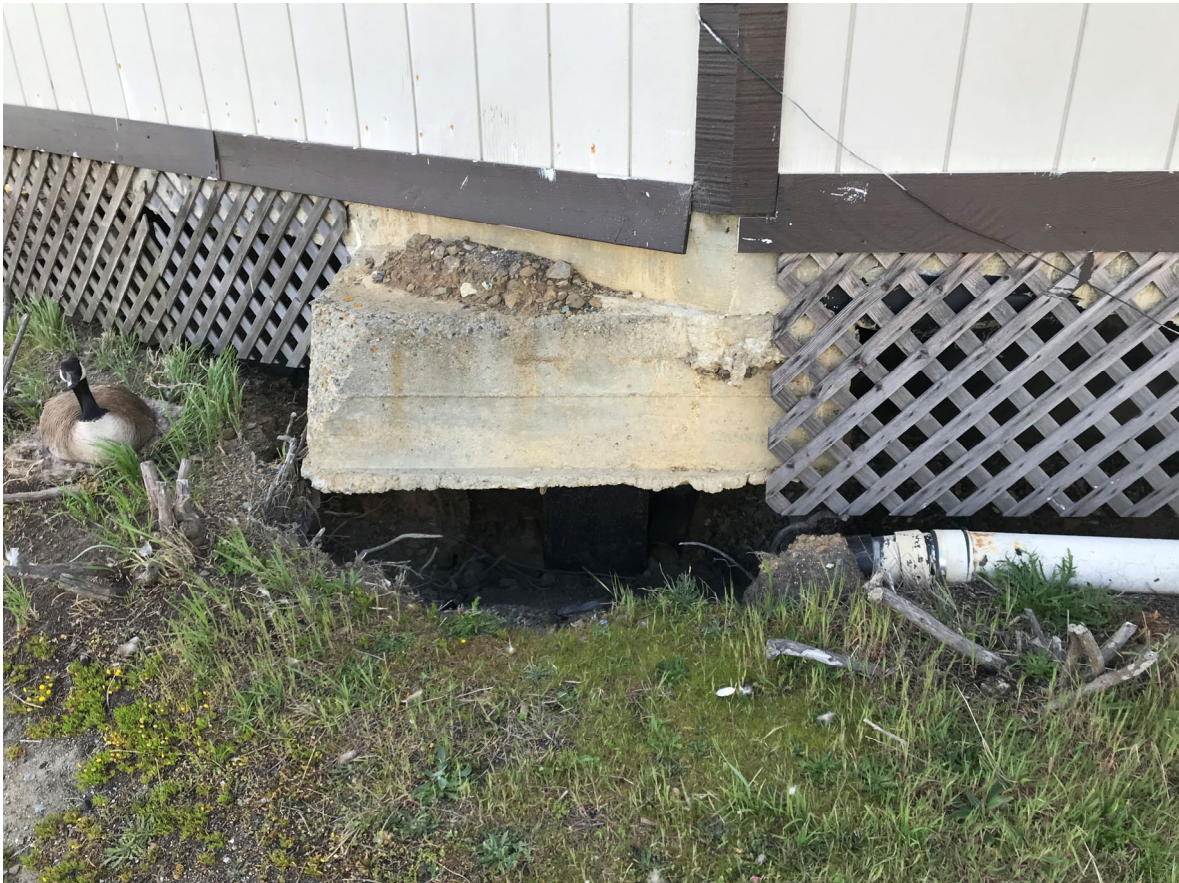
49 – View of undermining of Harbormaster's Office Building foundation

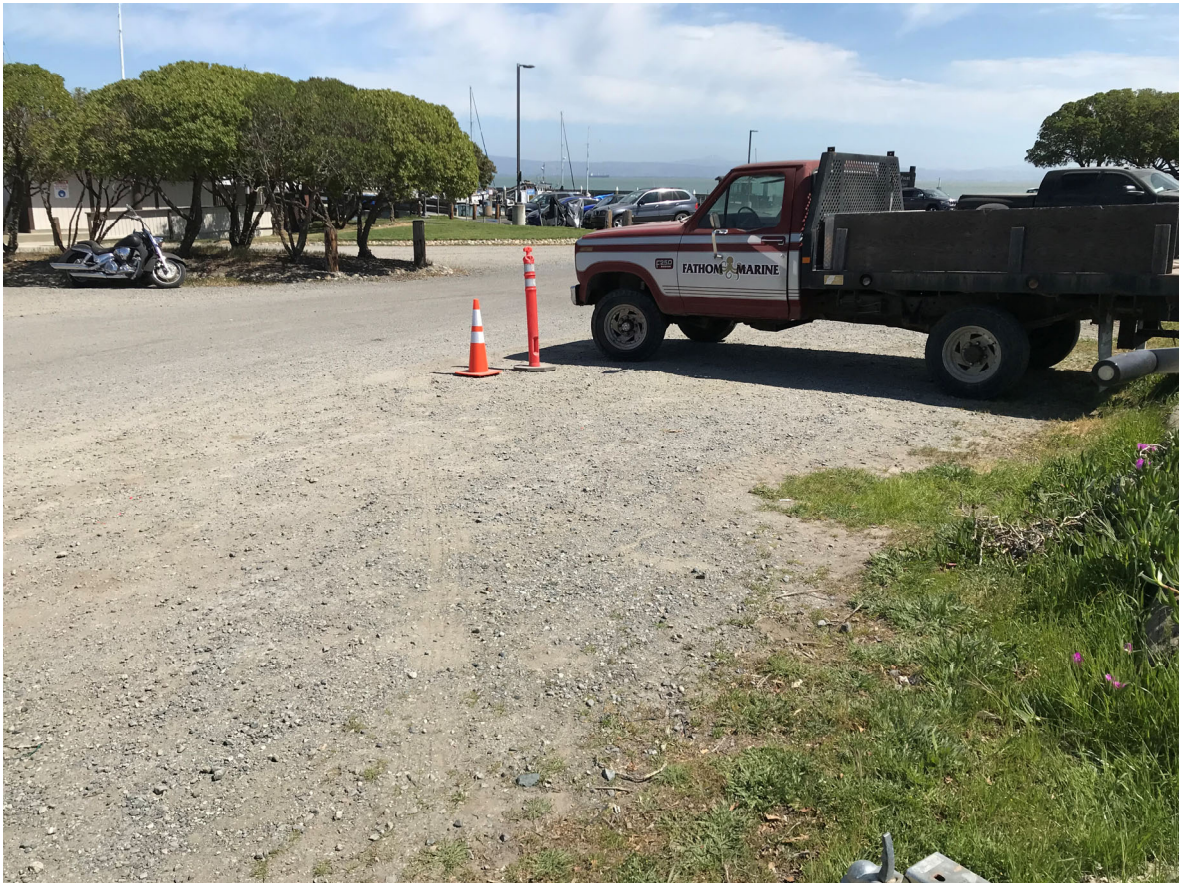
65 – View of Lower Parking lot gravel and degraded asphalt surfaces

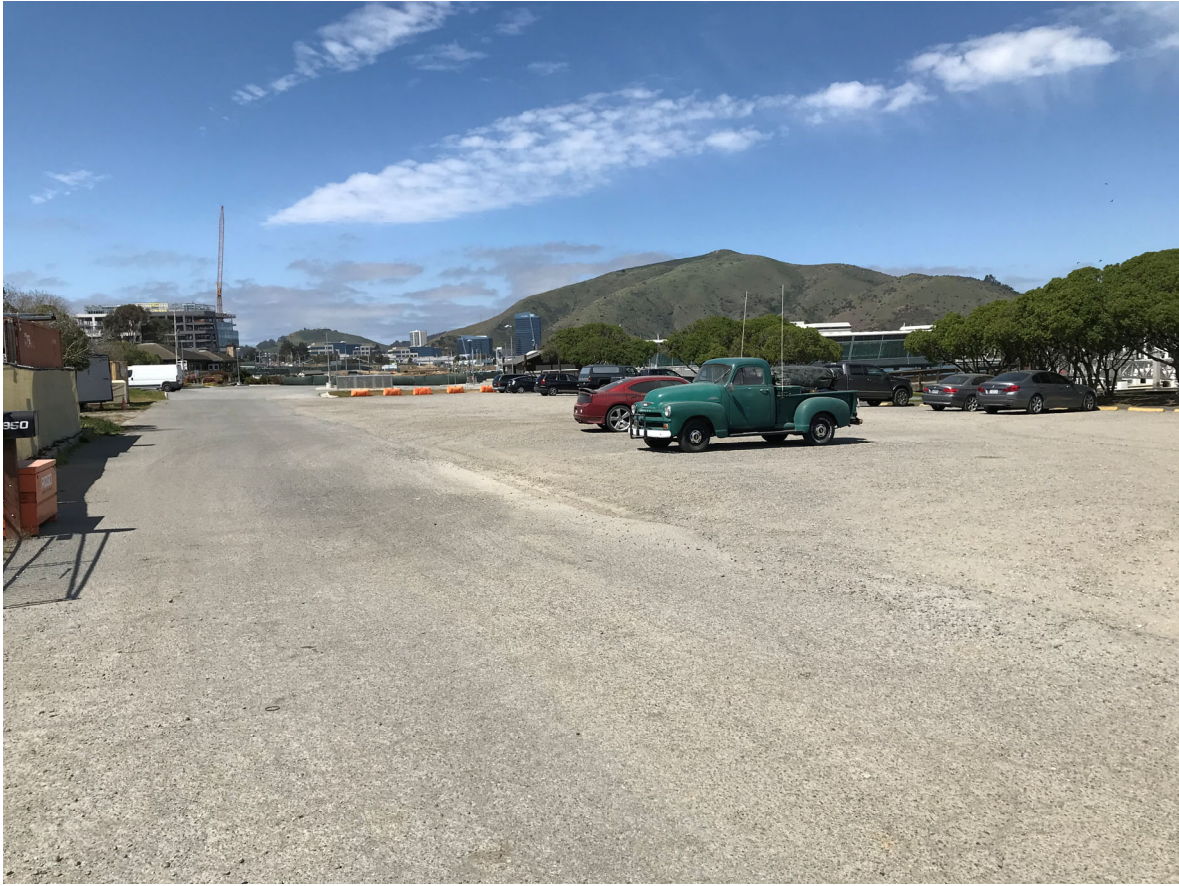
66 – View of Lower Parking lot gravel and degraded asphalt surfaces

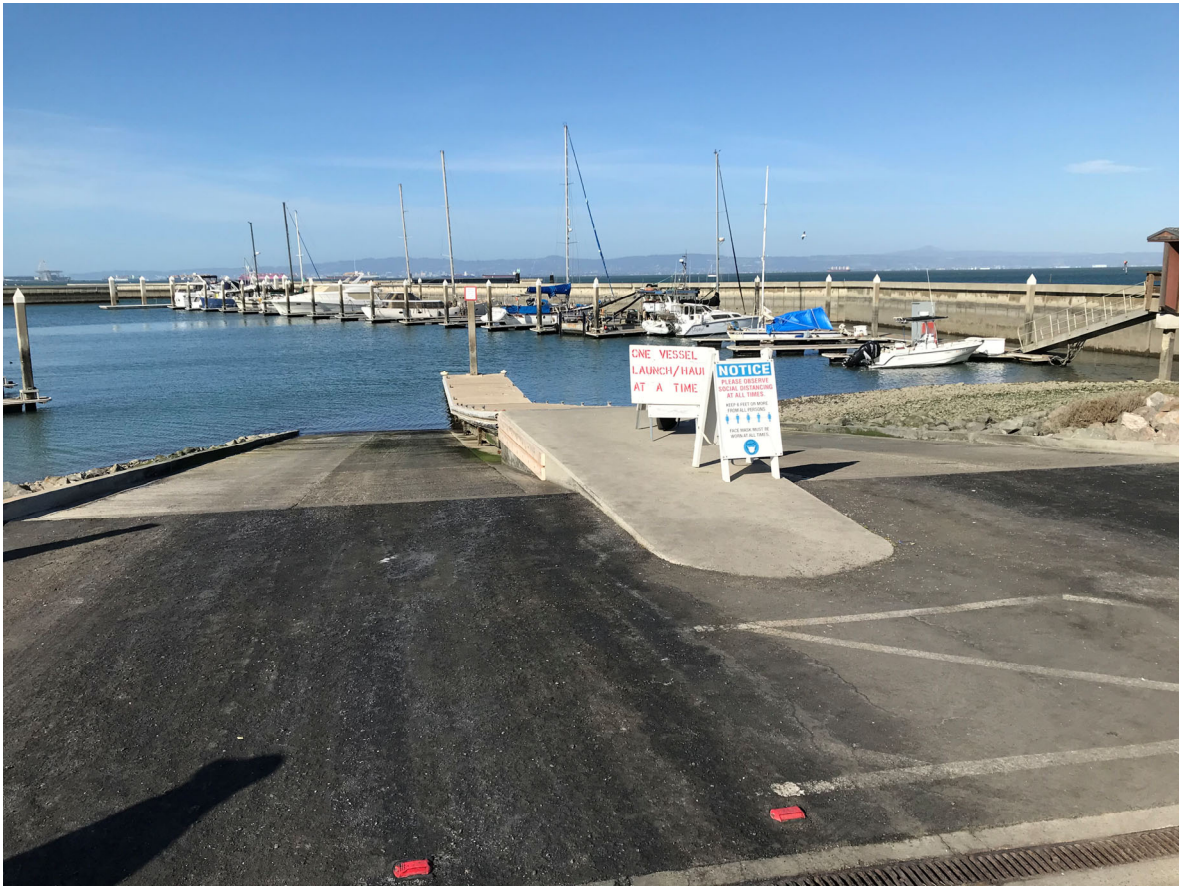
78 – View of Boat Launch Ramp and worn asphalt apron surface

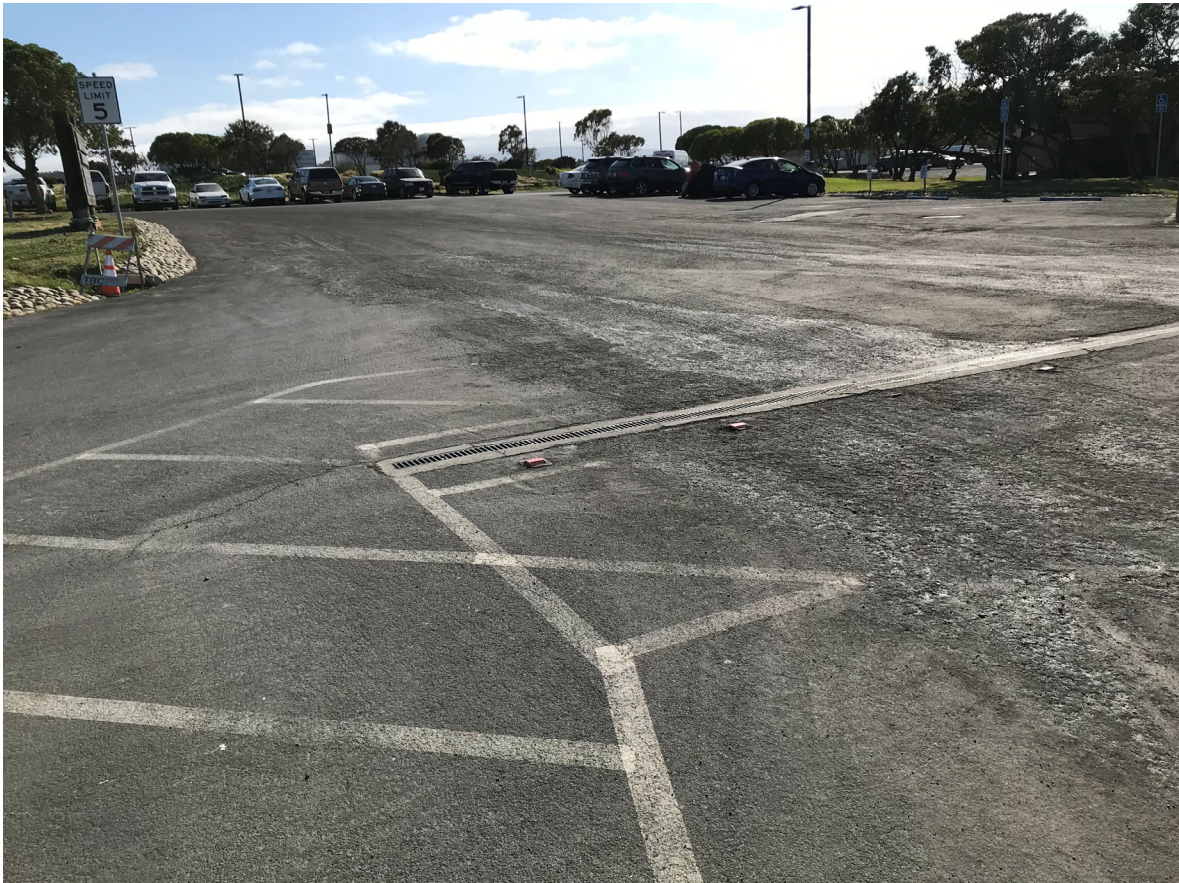
79 – View from top of Boat Launch Ramp of worn asphalt apron and roadway surface to parking area
