Board Presentation

JANUARY 10, 2022

Storm Impacts on SAM WWTP

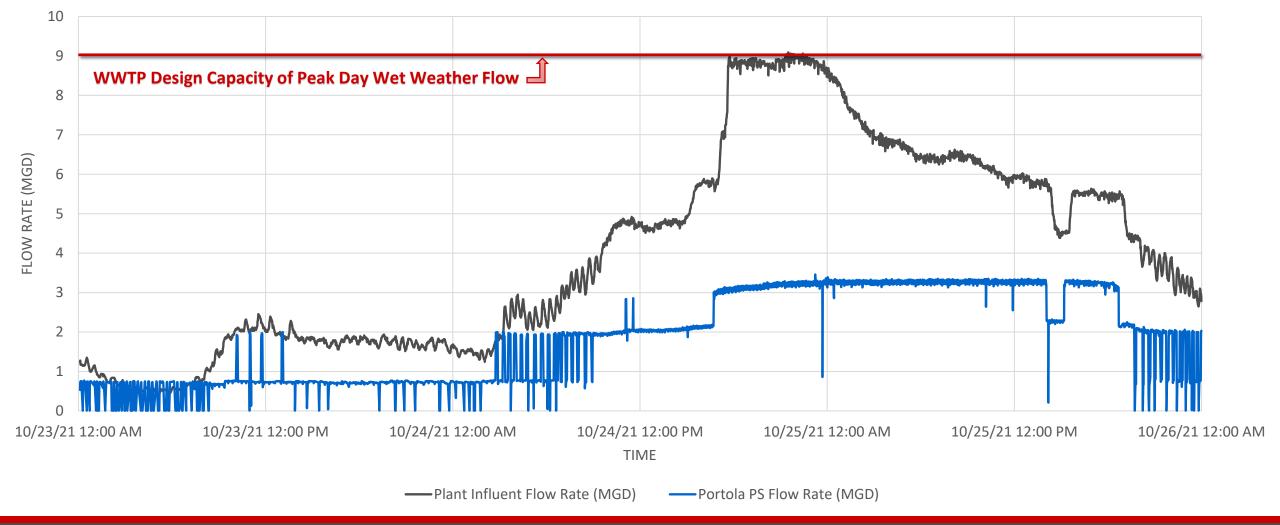
Plant Influent and Portola Pump Station Flow Rate

- Total Rainfall of 11.14" at WWTP
- Maximum rainfall recorded at 4.94" on October 24, 2021
- Maximum influent flow recorded at 9 MGD at 10:16 pm on October 24, 2021
- All 8 influent pumps were in operation
- Portola Pump Station wet well, as well as the Wet Weather Storage Facility, reached a level of 17.9', only 6" away from spill elevation

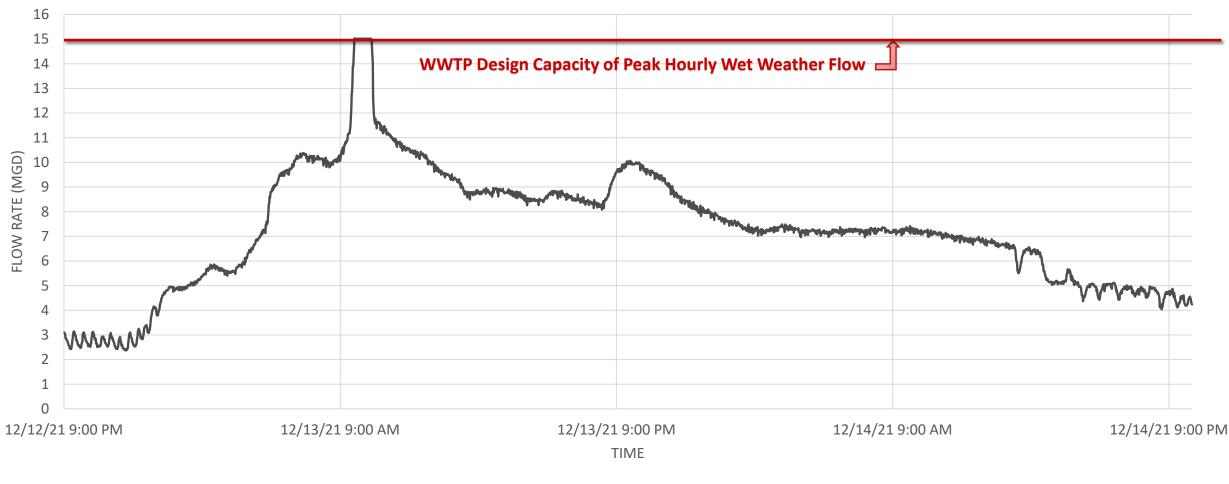
SAM WWTP Influent Flow Rate

- Total rainfall of 6.66" at the Plant
- Maximum rainfall recorded at 4.71" on December 13, 2021
- Maximum influent flow recorded at 15 MGD* for almost 1 hour at 9:37 am on December 13, 2021
- *The influent flow rate was likely to be higher than 15 MGD because the flow sensors are calibrated to measure a maximum of 15 MGD
- Wet Weather Storage Facility reached a level of 17.2 ft. on 11:49 AM on December 13, 2021

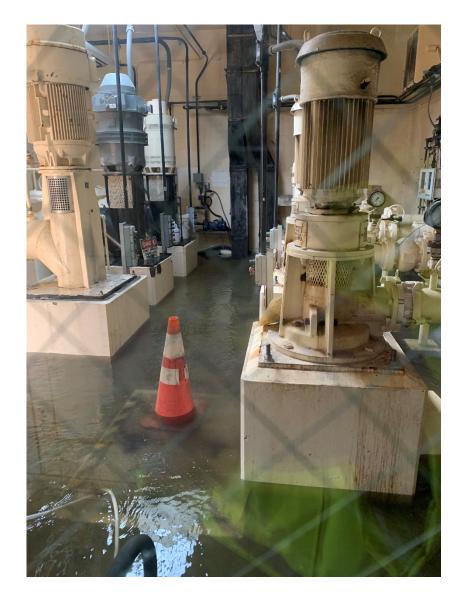
Flooding at Effluent Building

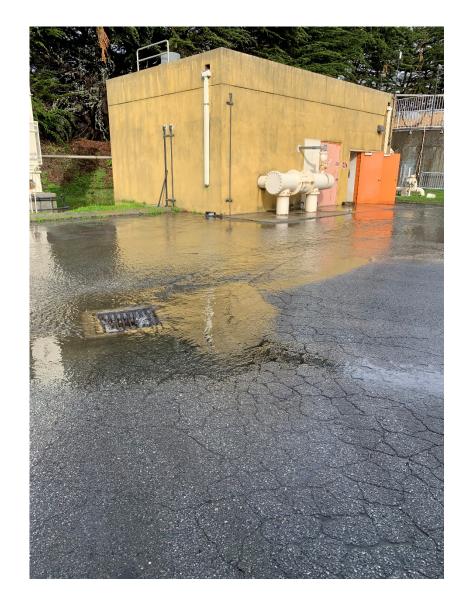
Flooding at manhole outside of Effluent Building

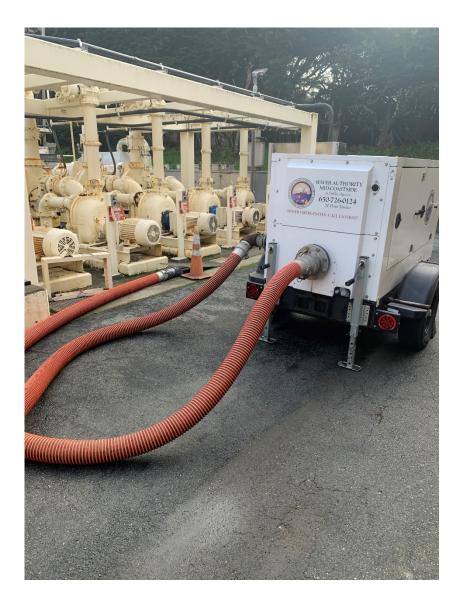
Portable pump used to pump influent into Primary Tanks

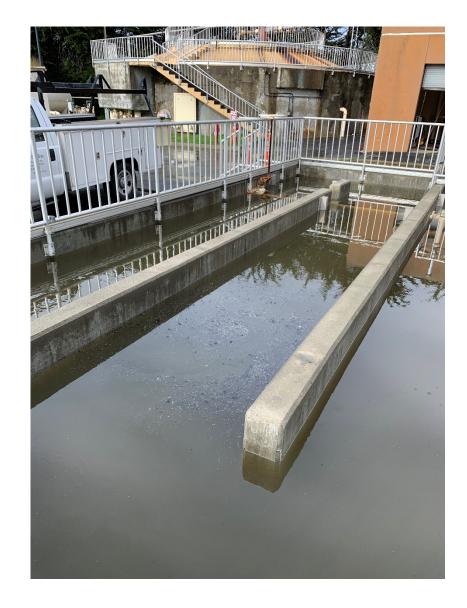
Chlorine contact basin being overwhelmed

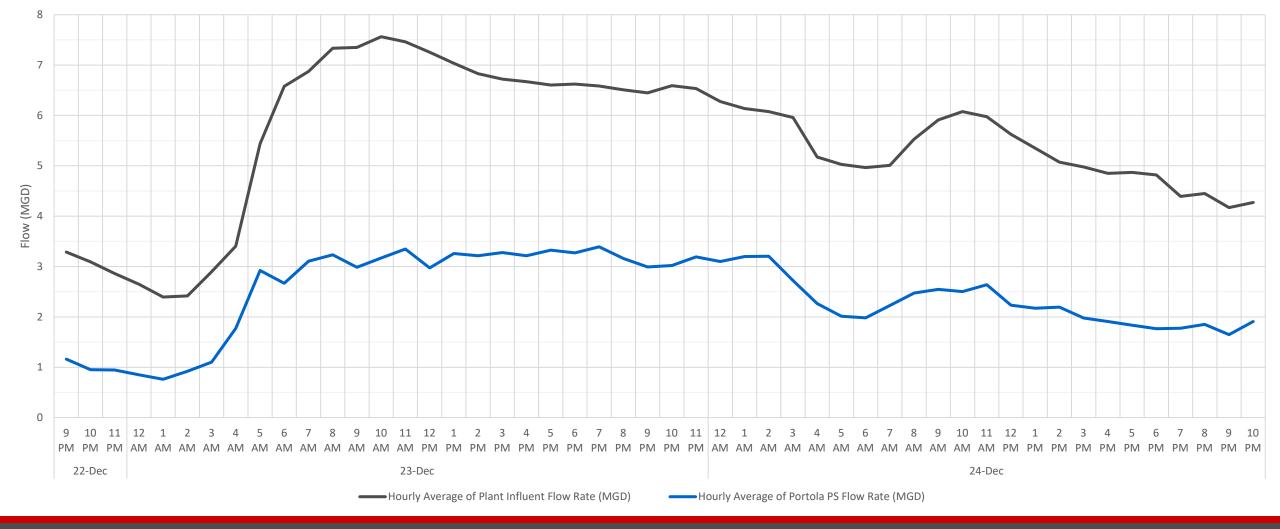
Plant Influent Flow Rate and Portola Flow Rate

- Total rainfall of 3.05" at the Plant
- Maximum rainfall recorded at 1.32" on December 23, 2021
- Maximum influent recorded: 7.7 MGD at 11:00 am on December 23
- The precipitation was more intense in the north side of SAM's service area compared to the south side
- The Walker Tank at Montara Pump Station was close to being overwhelmed
- The level at the manhole outside the Montara Pump Station was 4' away from overflowing

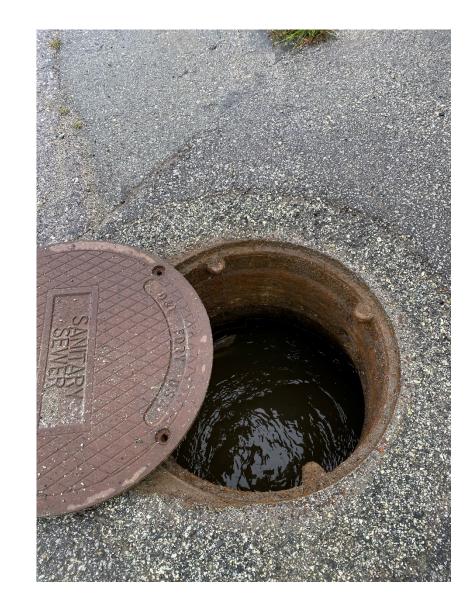
Manhole outside of Montara Pump Station

The water level is only 4 ft. below the manhole rim.

- Reducing Inflow and Infiltration (I&I) in all of the Member Agencies' systems
- Installing wet weather storage facility south of SAM's WWTP
- Expanding the existing wet weather storage facility at Portola Pump Station
- Hiring an engineering firm to recommend changes in SAM's facility to adequately address wet weather related issues
