What is Electro Scan & How Can it Help SAM?

Sewer Authority Mid-Coastside Board Meeting

July 22th, 2019

Electro Scan Demo Report

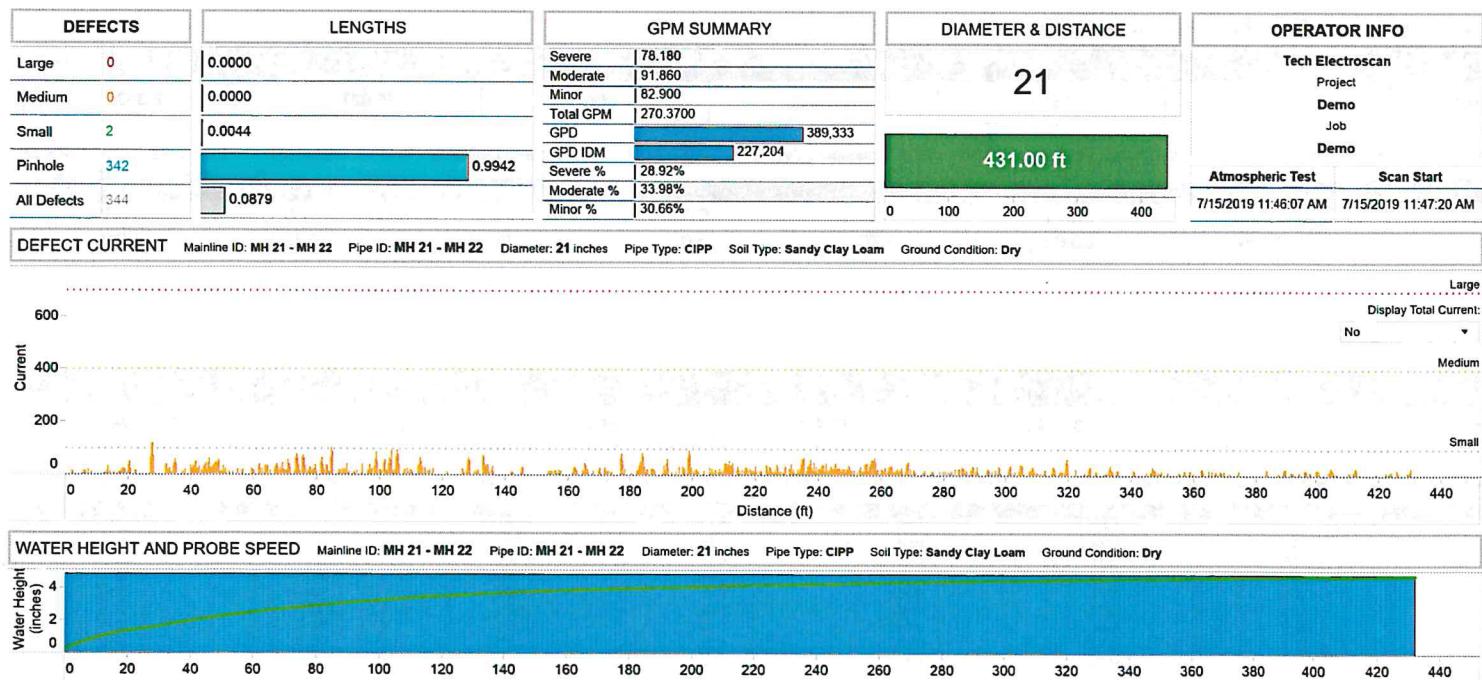
Cured-In-Place Pipe (CIPP)

MH 21 – MH 22 – Defect Current

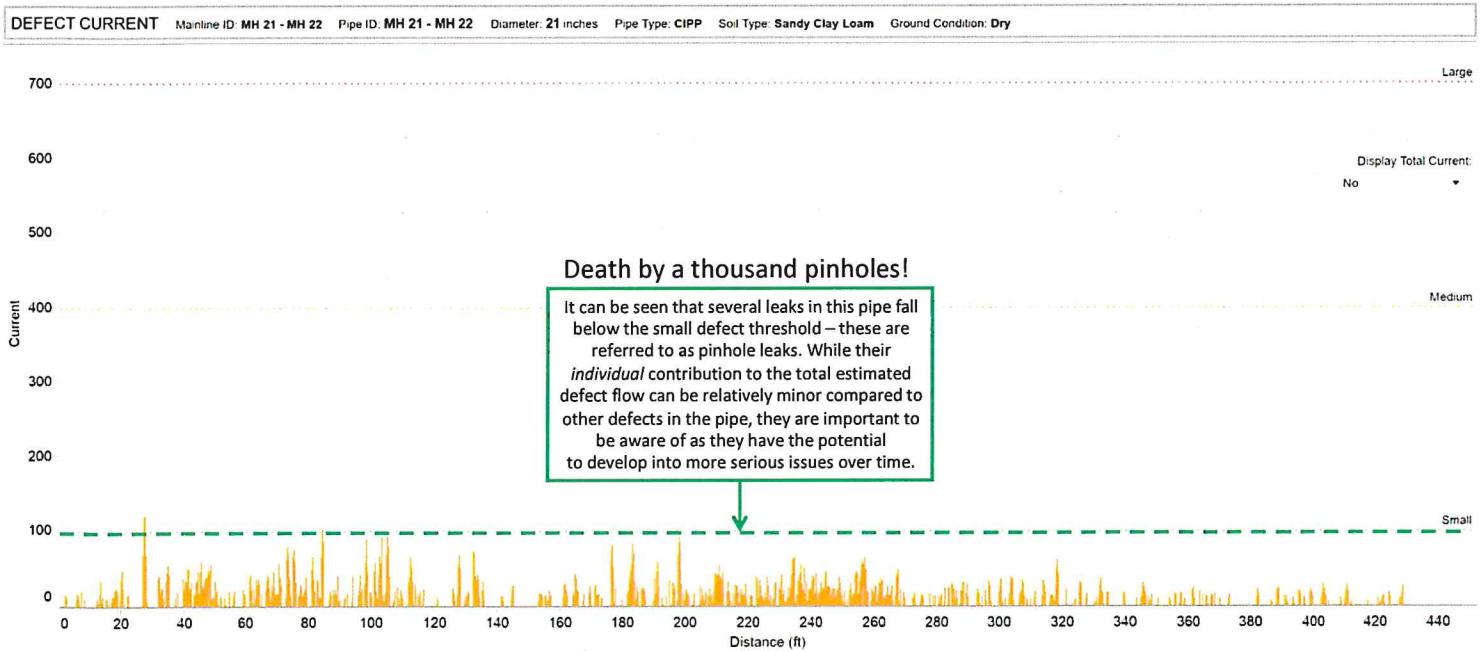
MH 21 – MH 22 – Defect Chart

2 Small Defects = 4% of Estimated Defect Flow

DEFECT BY LOCATION Mainline ID: MH 21 - MH 22 Pipe ID: MH 21 - MH 22 Diameter: 21 inches Pipe Type: CIPP Soil Type: Sandy Clay Loam Ground Condition: Dry Pinholes Not Included							
Defect Grade	Defect Start (ft)	Defect End (ft)	Length of Defects (ft)	GPM	% of GPM	GPD	GPDI/DM
S	27.50	28.71	1.21	6.11	2.26%	8,798	5,135
S	84.34	85.03	0.70	5.02	1.86%	7,229	4,219

Pinholes = 96% of Estimated Defect Flow

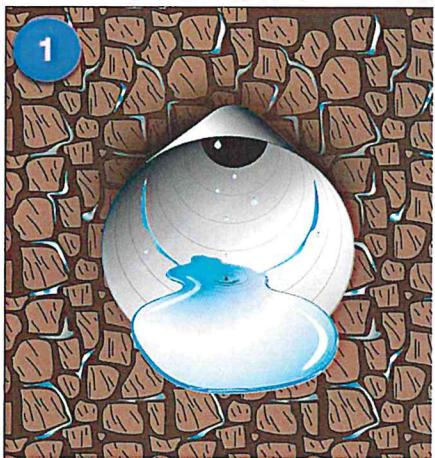
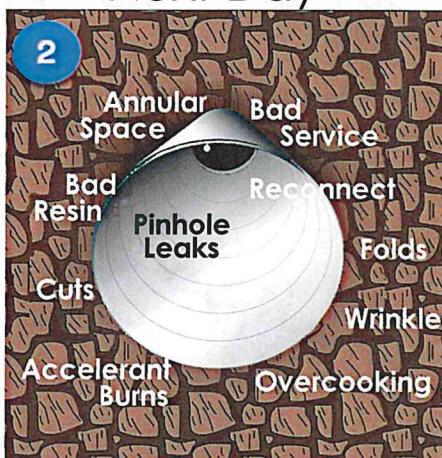
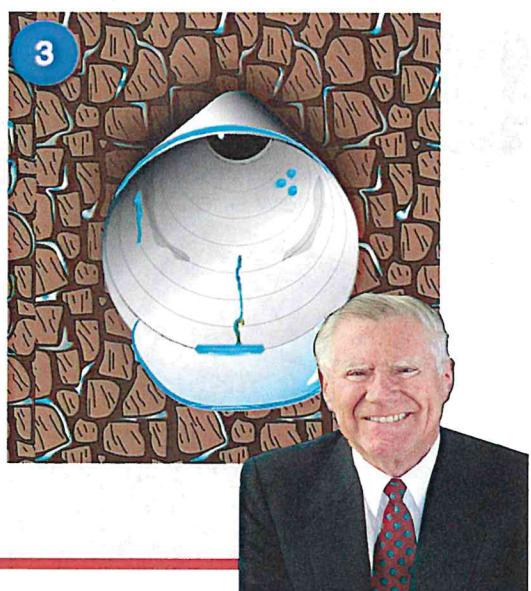
One Year Later

CIPP Leakage After Multiple
Wet Weather Events

643 Days
1 year, 9 months, 3 days
21 months, 3 days

36.4 GPM

20.9 GPM

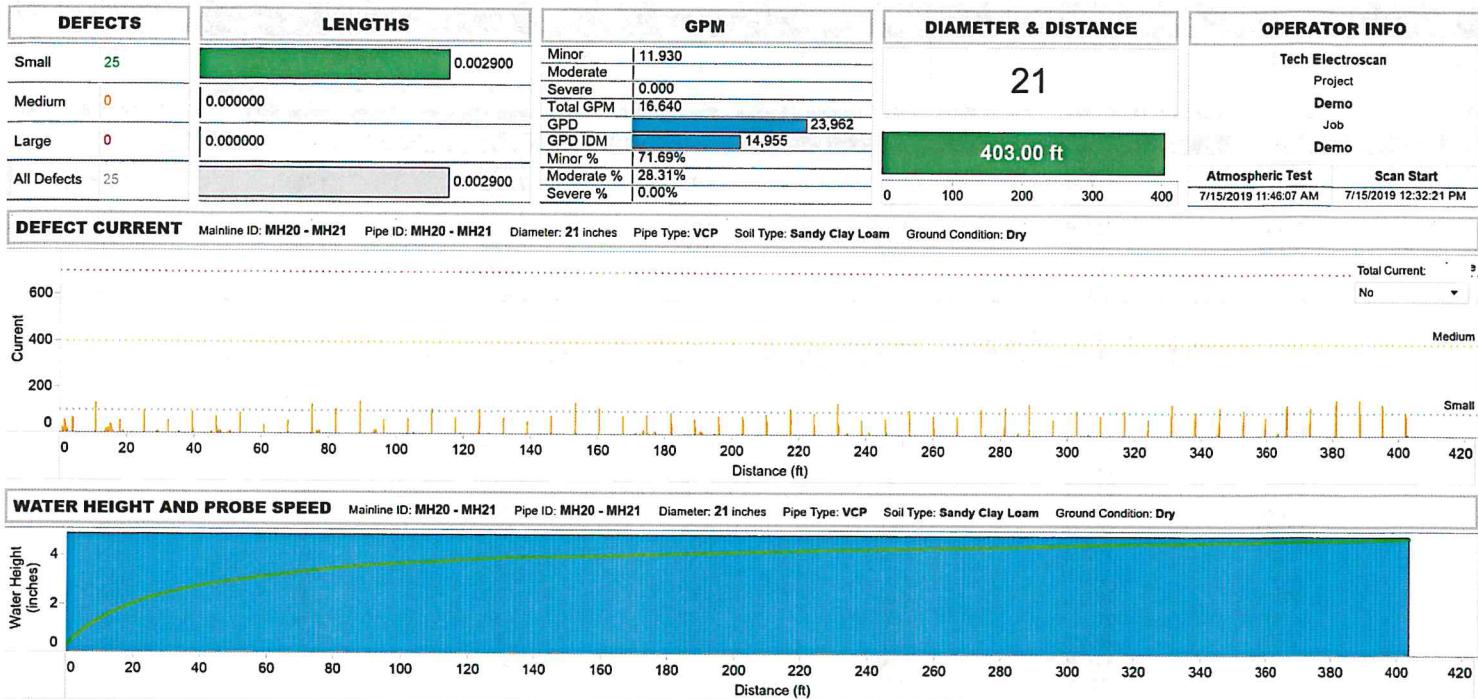
MH 20 – MH 21 Vitrified Clay Pipe (VCP)

MH 20 – MH 21 – Defect Current

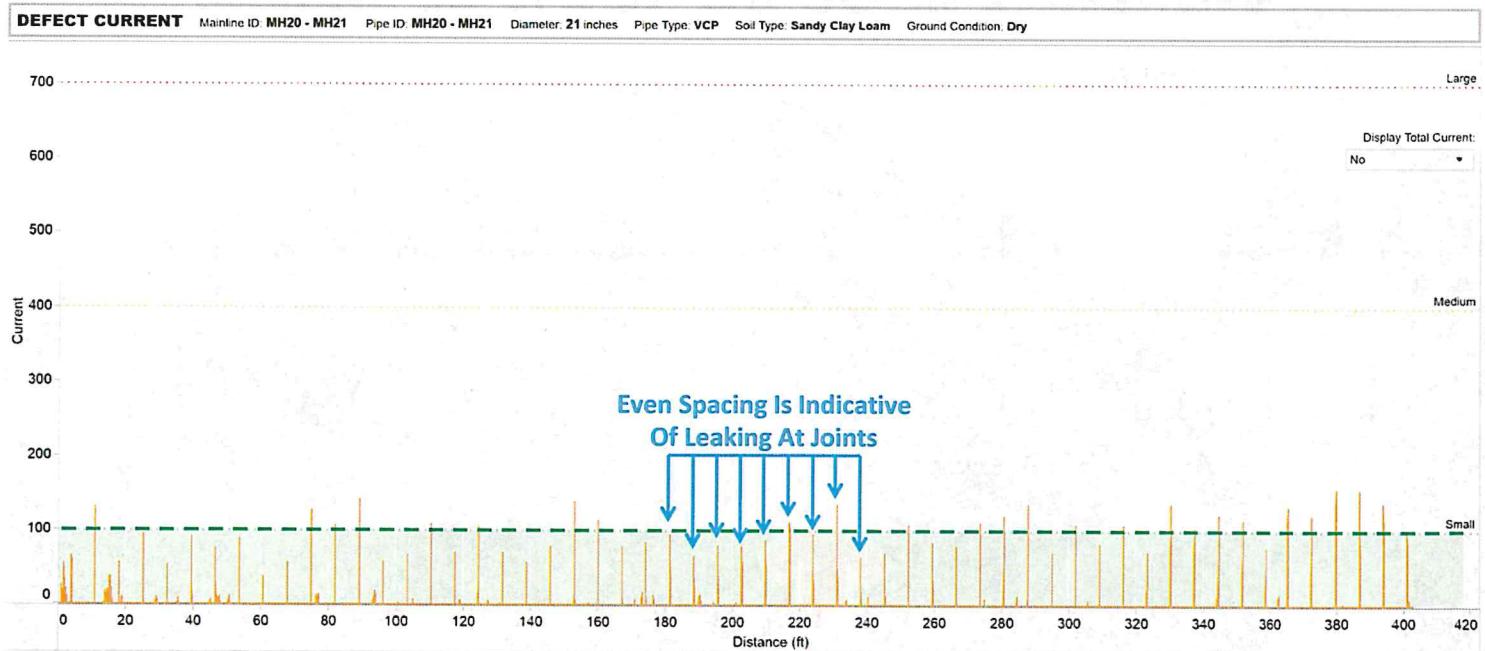
MH 20 – MH 21 – Defect Chart

Defects	Length (ft)	GPM	% of GPM	GPD	GPD/IDM		
Total:	25	1.188	17.080	103%	24,595	15,351		
DEFECT BY LOCATION		Mainline ID: MH20 - MH21	Pipe ID: MH20 - MH21	Diameter: 21 inches	Pipe Type: VCP	Soil Type: Sandy Clay Loam	Ground Condition: None	Ranked By GPM
Defect Grade	Defect Start (ft)	Defect End (ft)	Length (ft)	GPM	% of GPM	GPD	GPD/IDM	
S	379.92	380.02	0.10	1.33	7.99%	1,915	1,195	
S	330.29	330.39	0.10	1.24	7.45%	1,786	1,114	
S	152.90	153.00	0.10	1.10	6.61%	1,584	989	
S	386.97	387.05	0.08	1.04	6.25%	1,498	935	
S	287.74	287.81	0.07	0.96	5.77%	1,382	863	
S	89.09	89.16	0.08	0.91	5.47%	1,310	818	
S	394.10	394.17	0.07	0.90	5.41%	1,296	809	
S	10.99	11.04	0.05	0.73	4.39%	1,051	656	
S	301.97	301.99	0.02	0.46	2.64%	634	413	
S	301.97	301.99	0.03	0.46	2.76%	662	413	
S	110.35	110.38	0.02	0.46	2.76%	662	413	
S	337.37	337.39	0.03	0.45	2.70%	648	404	
S	280.61	280.63	0.03	0.45	2.70%	648	404	
S	273.60	273.63	0.03	0.44	2.64%	634	395
