AGENDA

CITY OF HALF MOON BAY PLANNING COMMISSION MEETING

**TUESDAY, AUGUST 24, 2021
7:00 PM**

CORPORATION YARD
CONCEPTUAL DESIGN

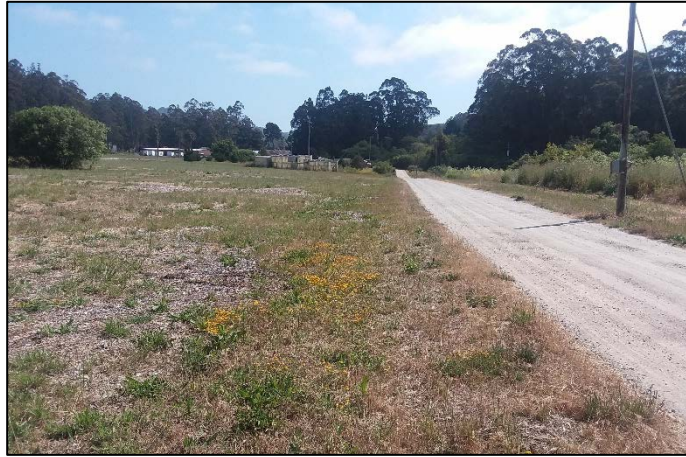
Vegetation. Ruderal (i.e., disturbed) annual grassland habitat occupies most of the BSA (Photo 1). At the time of the reconnaissance survey, this habitat was dominated by non-native grasses and forbs such as wild oat (*Avena* sp.), Italian rye grass (*Festuca perennis*), riggut brome (*Bromus diandrus*), Italian thistle (*Carduus pycnocephalus*), bristly ox-tongue (*Helminthotheca echioides*) and Chile tarweed (*Madia sativa*). Of these, Italian rye-grass and bristly ox-tongue are technically scored as facultative hydrophytes (Lichvar et al. 2016),

Photo 1. Ruderal grassland occurs in most of the BSA.

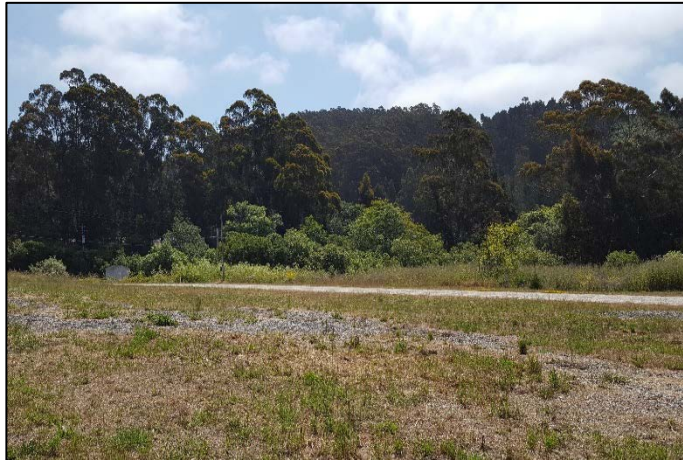
Vegetation. Riparian woodland habitat is found along Pilarcitos Creek and around the perennial freshwater marsh. Trees observed in the riparian woodland habitat along Pilarcitos Creek include arroyo willow, red willow (*Salix laevigata*), red alder, and blue gum (*Euclayptus globulus*). The understory is an impenetrable thicket of Himalayan blackberry (*Rubus armeniacus*), cape ivy (*Delairea odorata*), poison hemlock, common horsetail (*Equisetum arvense*), French broom (*Genista monspessulana*), hoary nettle (*Urtica dioica* ssp. *holosericea*), bristly ox-tongue, pampass grass (*Cortaderia jubata*), and Italian rye grass (Photo 3).

Photo 3. Riparian habitat along Pilarcitos Creek (in the background), which runs along the entire southern edge of the BSA.

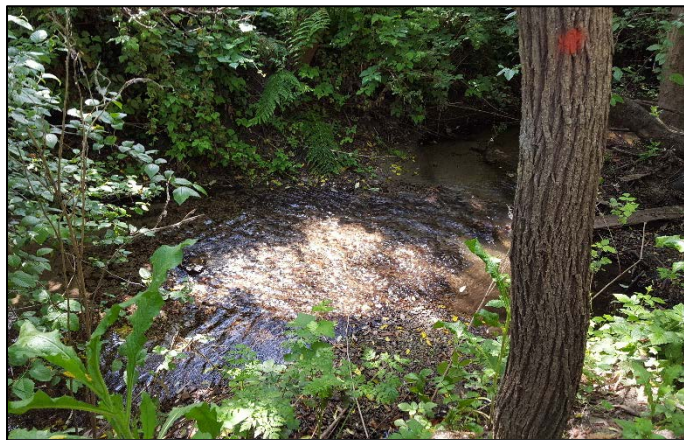
Wildlife. The aquatic habitat within Pilarcitos Creek supports native fish species such as the California roach (*Hesperoleucus symmetricus*), hardhead (*Mylopharodon conocephalus*), and threespine stickleback (*Gasterosteus aculeatus*). In addition, the federally threatened Central California Coast steelhead and California red-legged frog, and federally and state endangered San Francisco garter snake have been documented within Pilarcitos Creek (CDFW 2013, CNDDDB 2021). Pacific chorus frogs, California newts (*Taricha torosa*), western pond turtles (*Actinemys marmorata*), non-native bullfrogs (*Lithobates catesbeianus*) and crayfish (*Pacifastacus leniusculus*) may be present in the creek, and birds such as the green heron (*Butorides virescens*), and belted kingfisher (*Ceryle alcyon*) likely forage in the creek. Bats forage aerially on insects over Pilarcitos Creek. During the reconnaissance survey, two unidentified species of bat were observed foraging amongst the trees along the edge of the channel, just upstream from the BSA.

Photo 5. Pilarcitos Creek, which runs through the BSA along the southern boundary.

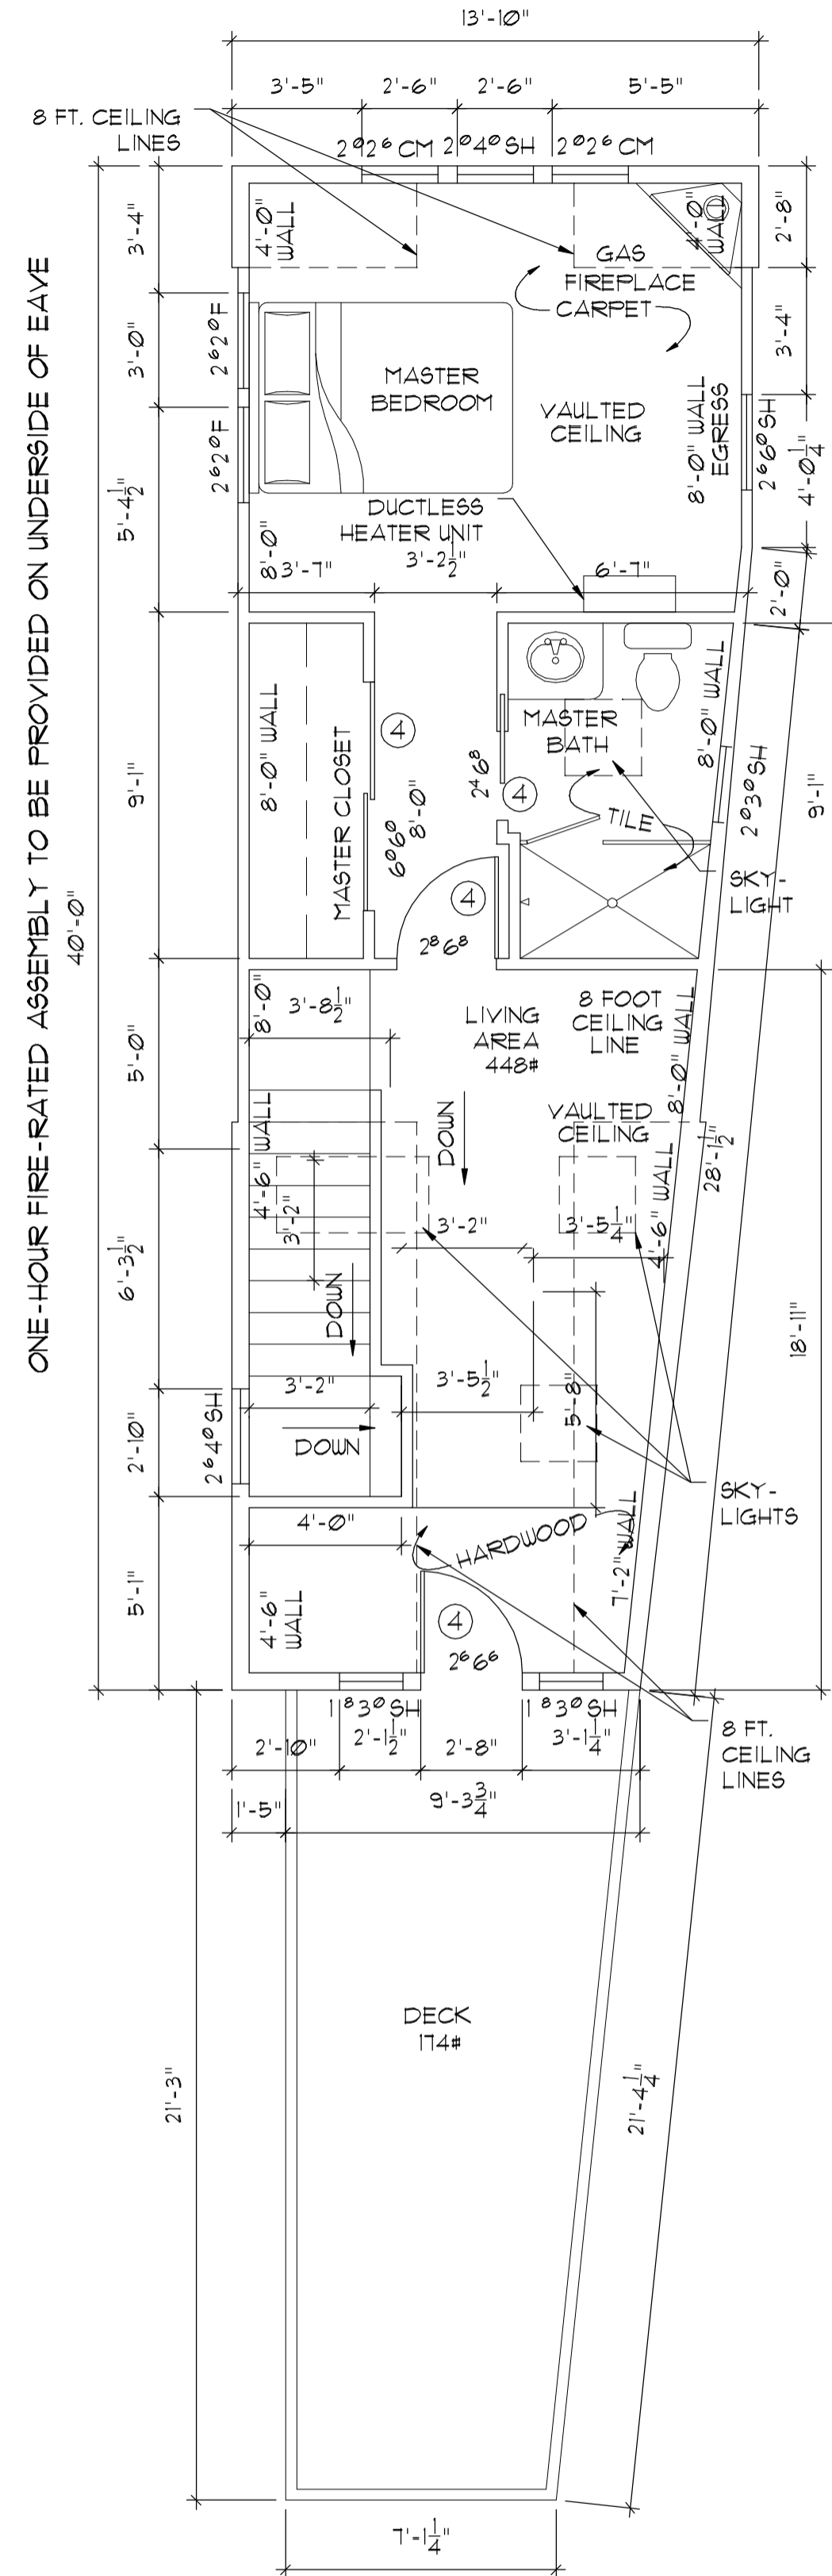
SECOND FLOOR PLAN

ONE-HOUR FIRE-RATED ASSEMBLY TO BE PROVIDED ON UNDERSIDE OF EAVE
