# Progress to Date

# Conceptual Site Model

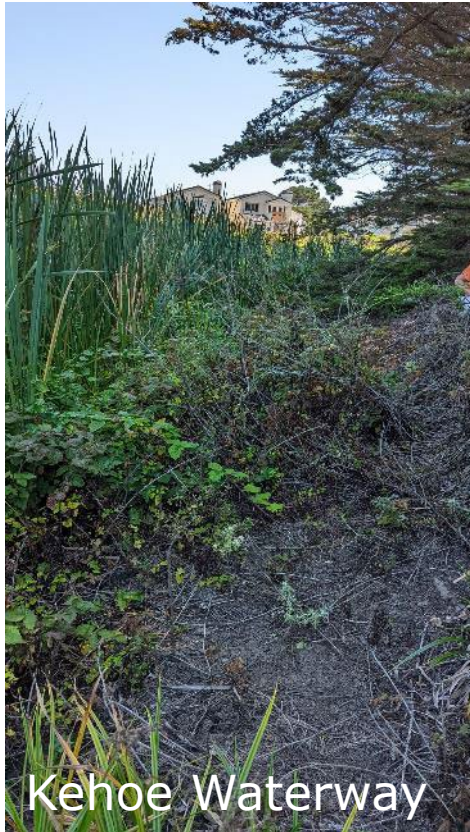
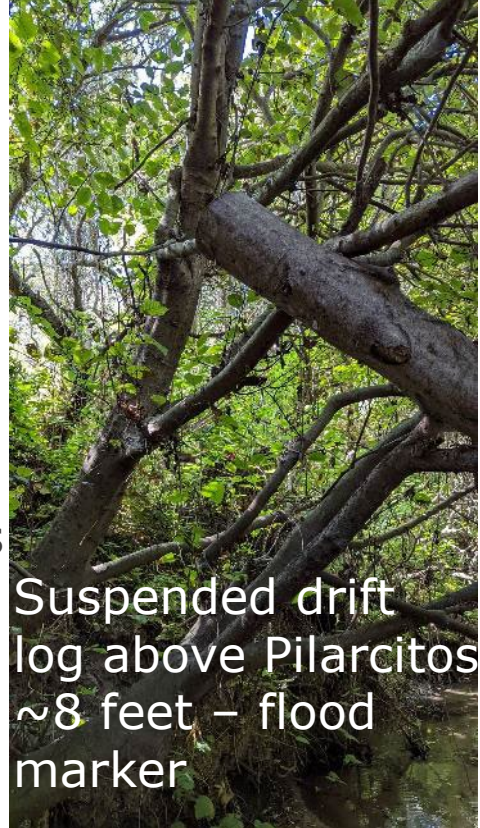
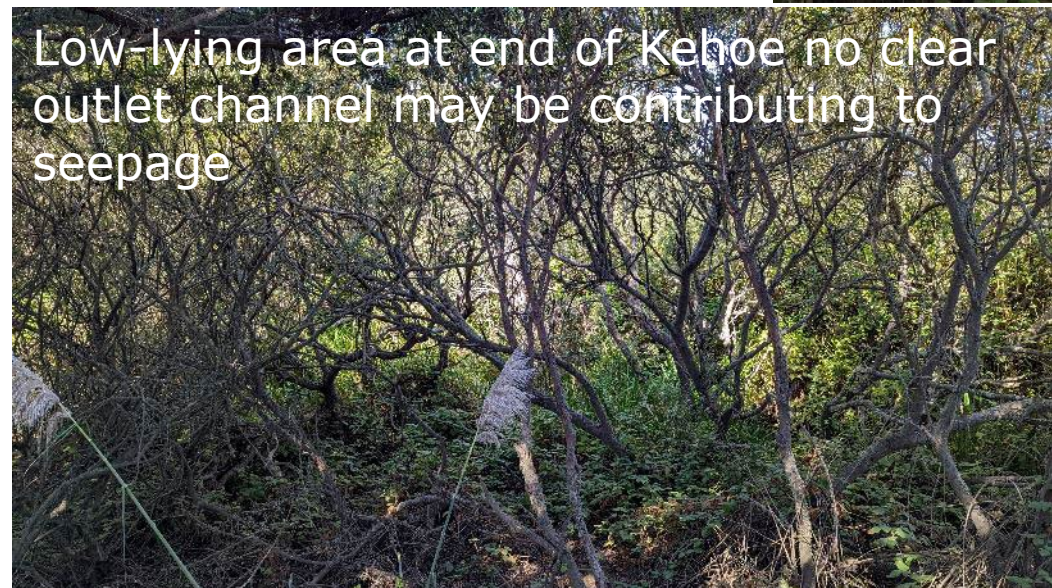
# Site Walk Highlights

- Team Members identified key site features and processes
- Lack of residual depth in lagoon = stream flow  $\sim$  beach seepage rates
- Contributed to conceptual site description

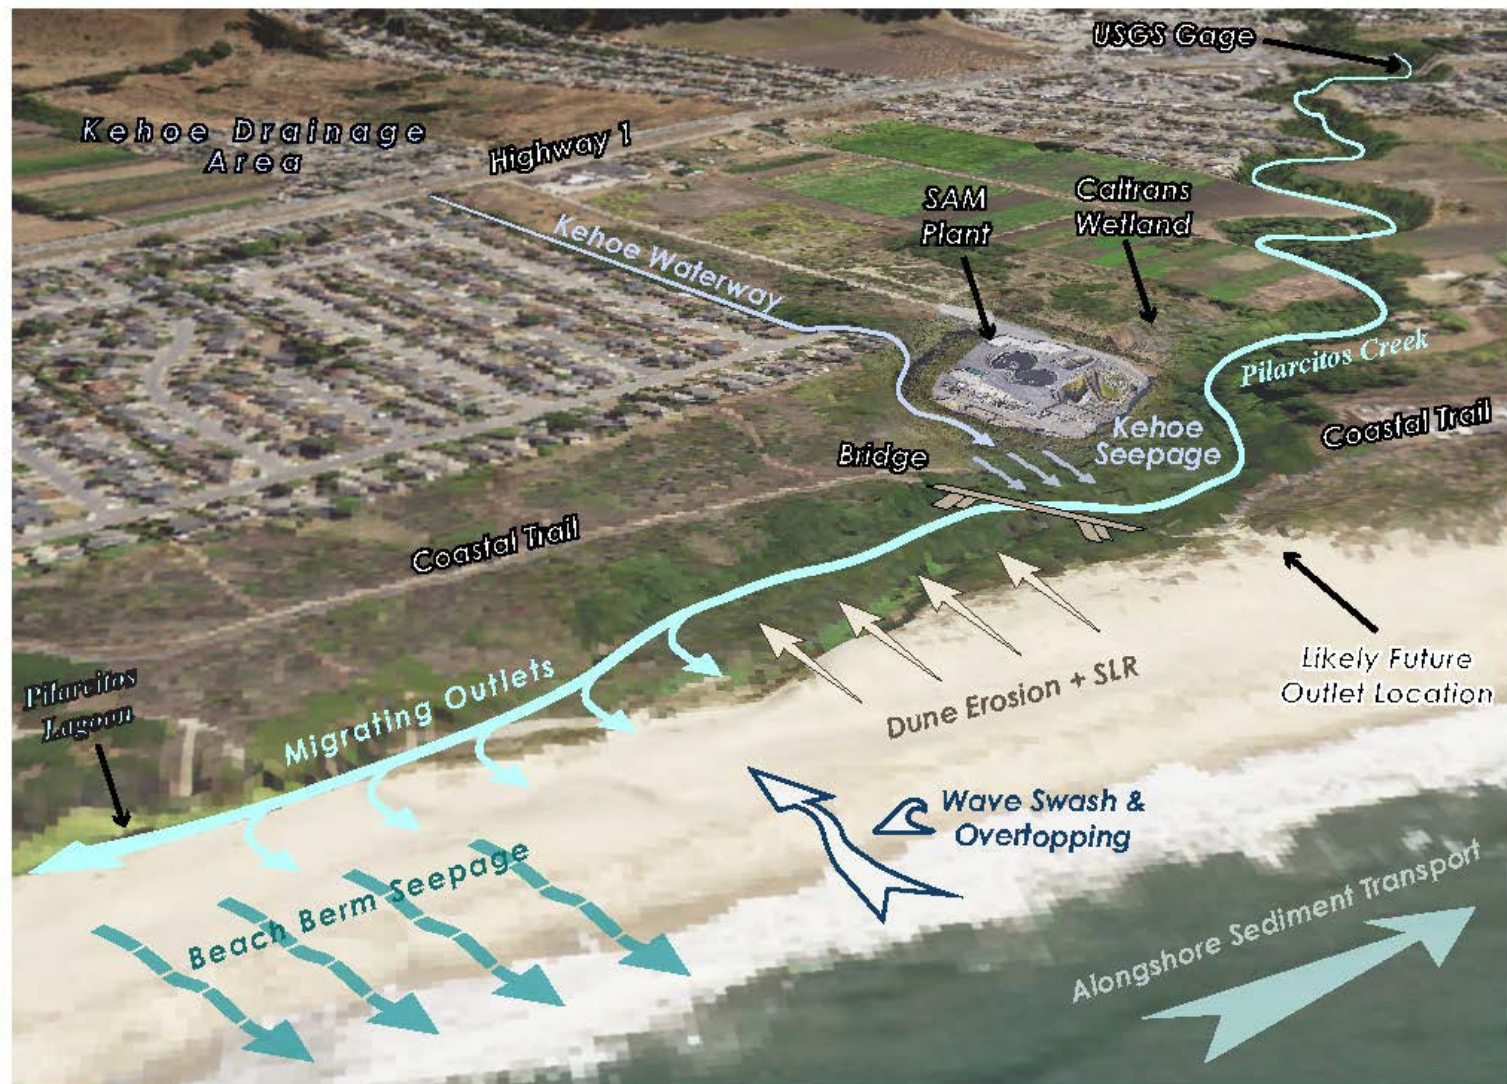
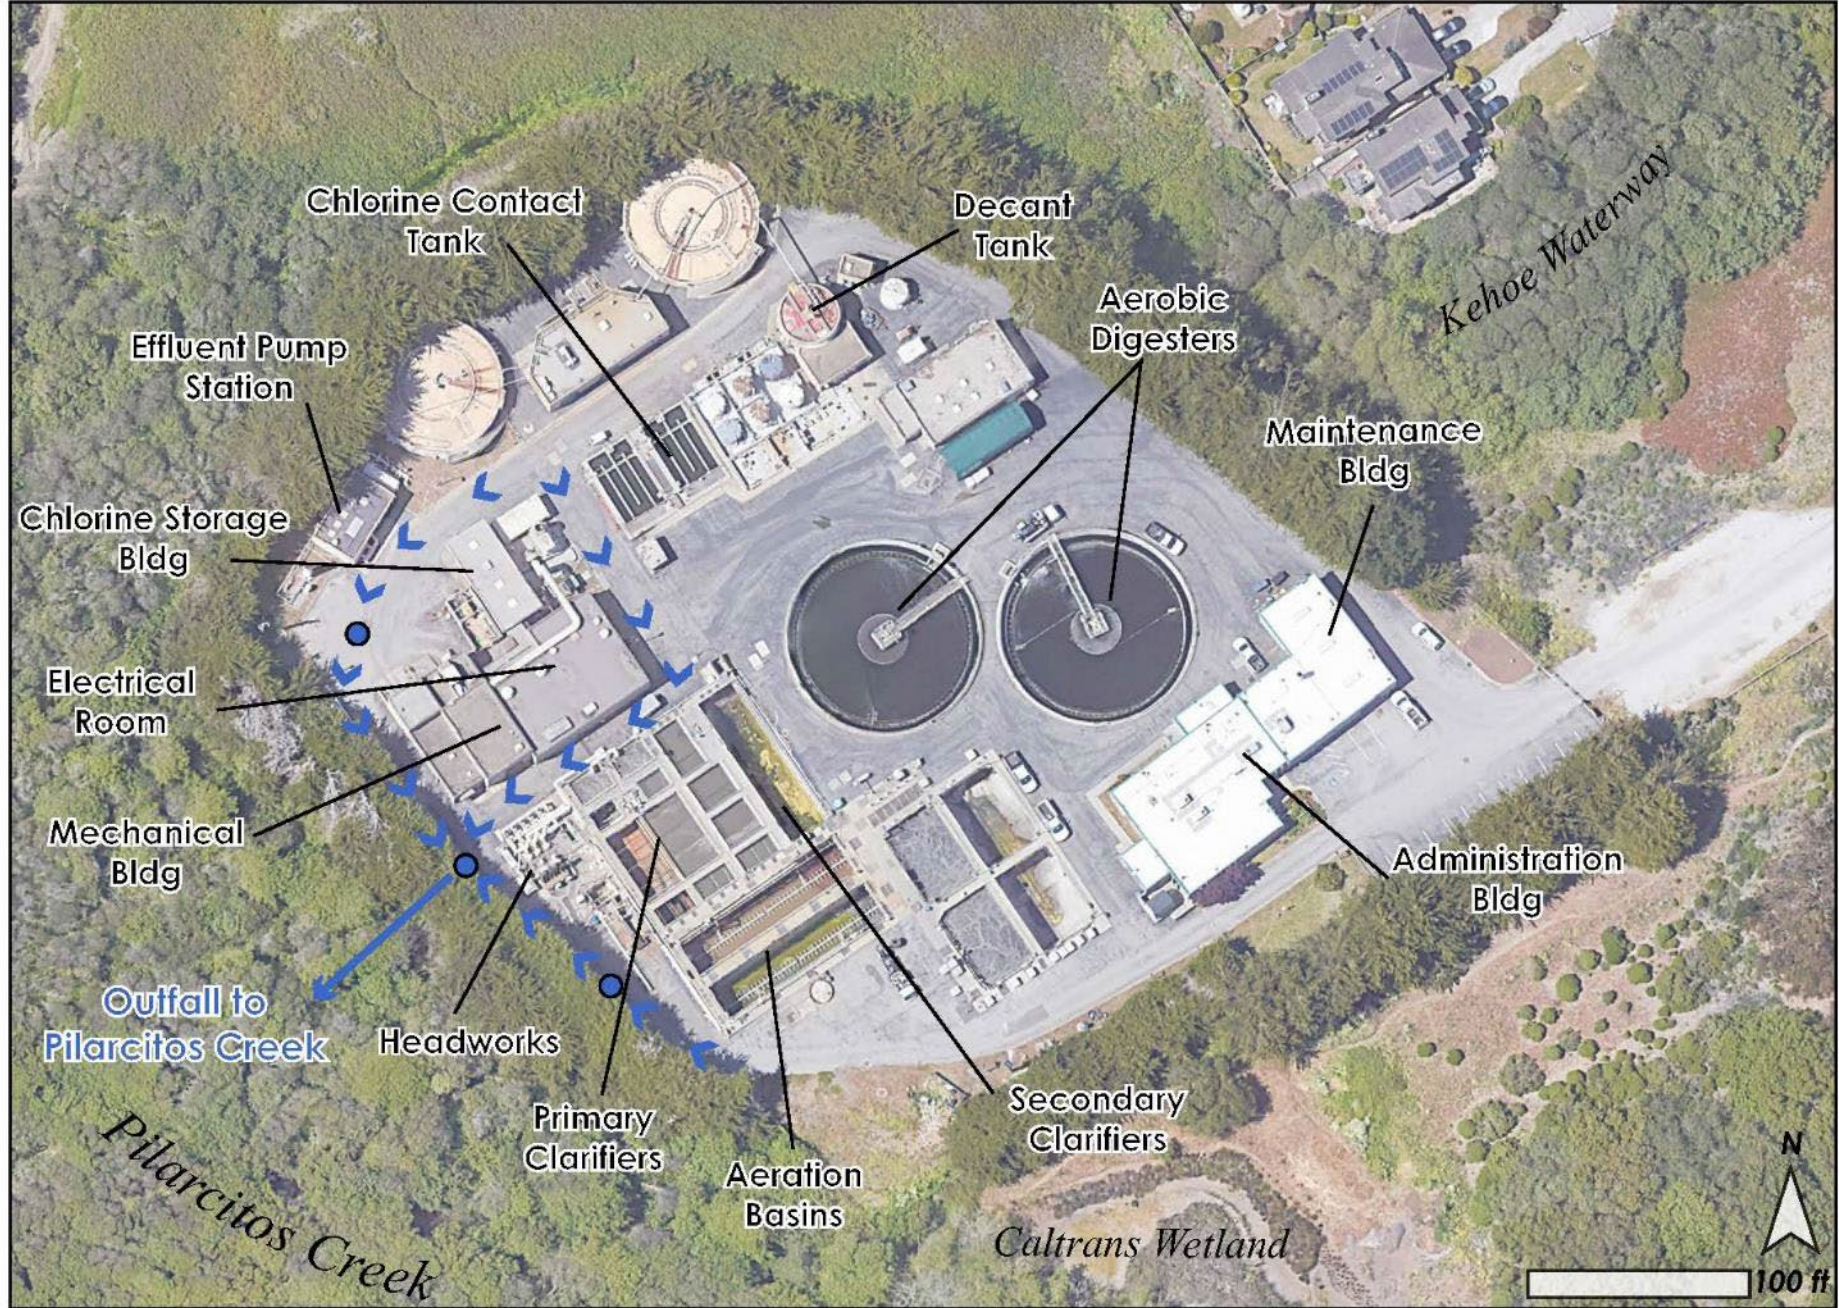
● Catch Basin

◀ Stormwater Flow

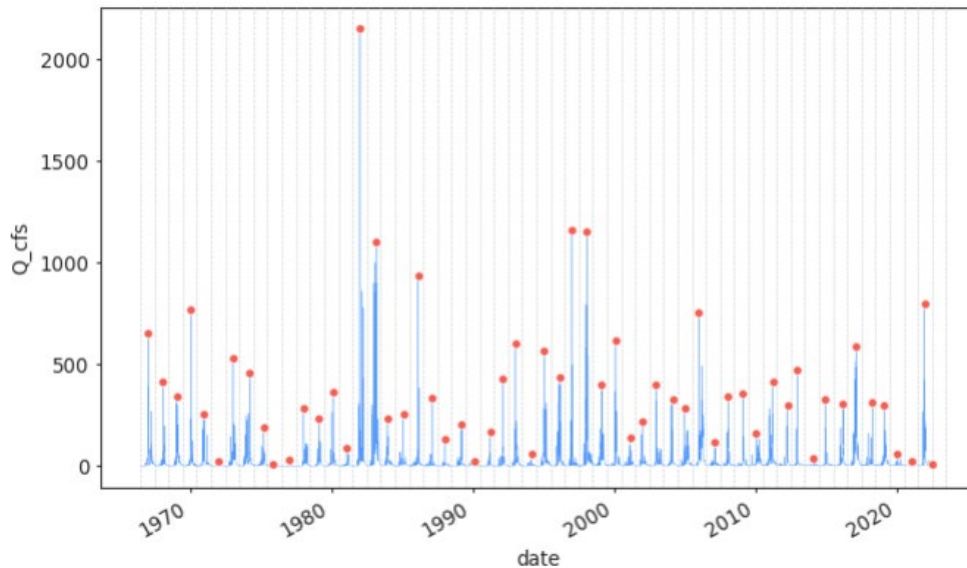
Pilarcitos Discharge –  
USGS gage #11162630

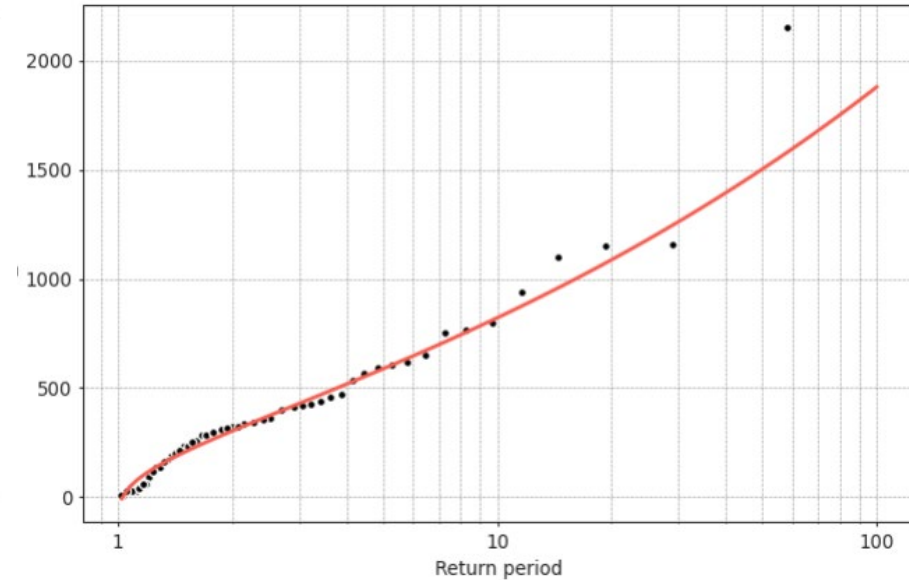
Pilarcitos Return Periods  
– Extreme Value Results

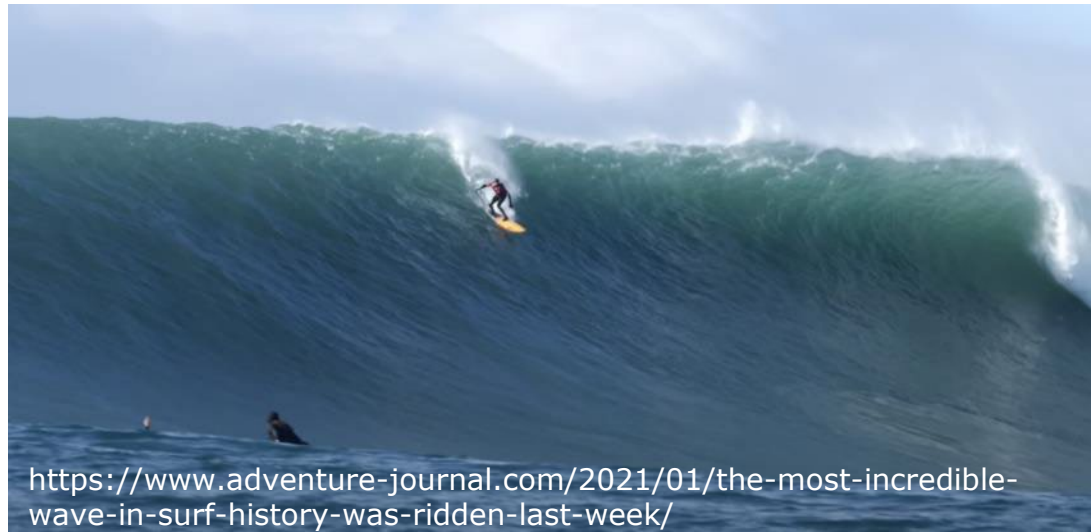
# Waves and Coastal

- USGS COSMOS wave data transformed to the site for historic and future projections
- Time series of Total Water Levels (wave runup + tides)
- Beach topography from various historic time periods
- Revising a dune erosion model (using FEMA guidance + storm duration)
- Includes historic trends (aka sediment budget)+ sea level rise changes + 100 year storm erosion
