SEWER AUTHORITY MID-COASTSIDE
Board of Directors Meeting Agenda
Regular Board Meeting 7:00 PM, Monday, August 23, 2021

SAM Administration Building, 1000 N. Cabrillo Highway, Half Moon Bay, CA 94019

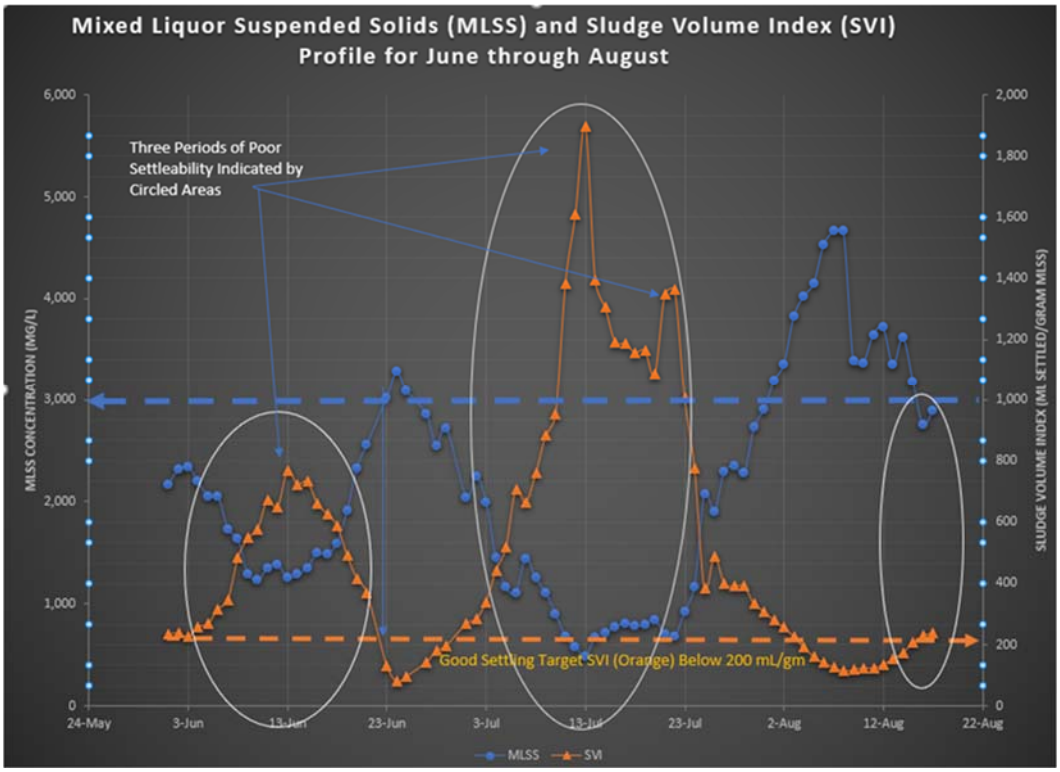
Figure 1. MLSS and SVI (May 30-August 17, 2021)

The poor settleability, is reflected by the Sludge Volume Index (SVI), which is a daily settleability test that measures the amount of solids that settle (in grams) per unit volume (liters). A profile of MLSS and SVI are shown in Figure This pattern has repeated, three times thus far during the period examined, as highlighted by the profile of the period shown in Figure 1.

Field observations by plant staff and initial microscopic exam indicated high amounts of filamentous growth and bulking conditions causing the poor settling to the point where nearly the entire sludge blanket was dispersed throughout the 14-foot depth of clarifier. Microscopic examinations have been conducted in June, July and August, with filaments present in abundance. Please see those reports for detailed information. Some filaments are typical in activated sludge, however, over Abundance of filaments contributes to the inability to form a good settling floc and bulking conditions observed in the secondary clarifier.

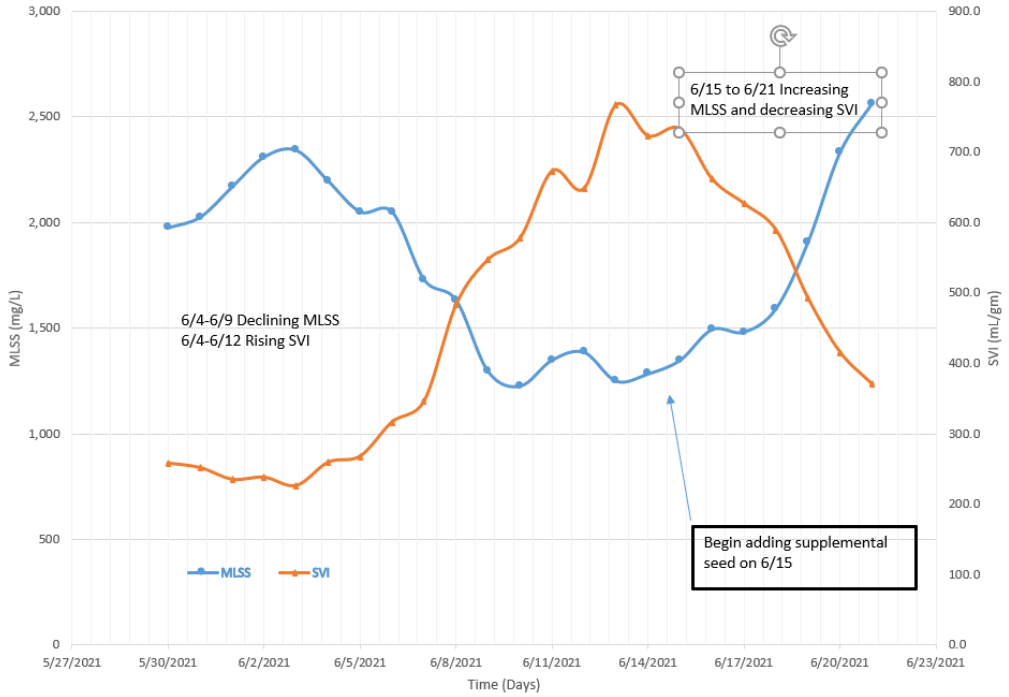
Figure 1. MLSS and SVI (May 30-June 21, 2021)

After the changeover to fine bubble diffuser in aeration basin 3 was completed in May, the MLSS continued to increase to 2,320 mg/L as of June 4, 2021 with an associated SVI of 226 mL/gm. After this point the MLSS decreased daily, settleability decreased and the associated SVI increased rapidly for the next four days even though the plant was reducing wasting. Aeration basin MLSS reached a low of 1,228 mg/L on June 8th. A profile of MLSS and SVI are shown in Figure 1.

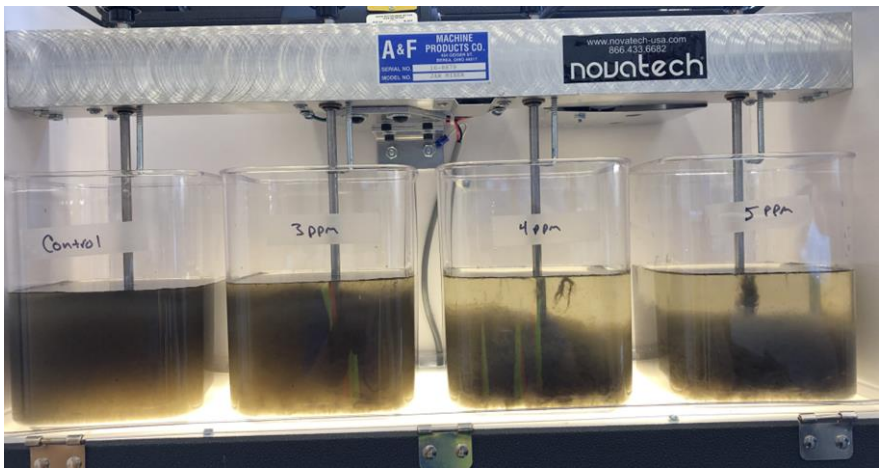
Figure 2. Polymer jar testing.

A representative from the polymer provider, Polydyne came out to the site on June 16, 2021 to screen various wastewater polymer products to help with settling. A high charge high molecular weight polymer product was identified that provided clearer supernatant relative to the current polymer product at a dose as low as 2.5 ppm and seemed to be optimal at a jar test dose of 4 ppm. Figure 2, below, shows a picture from the polymer testing, after about 20 minutes of settling.

The doses identified in jar testing are relatively high for secondary polymer addition, without specialized mixing equipment, and the application dose should be verified based on full scale application. A recommendation is to initially target a lower dose of 1 to 2 ppm on full scale, and slowly increase based on observed performance as it benefits settling. Once excess polymer is observed on the surface and/or benefits to settling diminish, the application dose should be reduced.

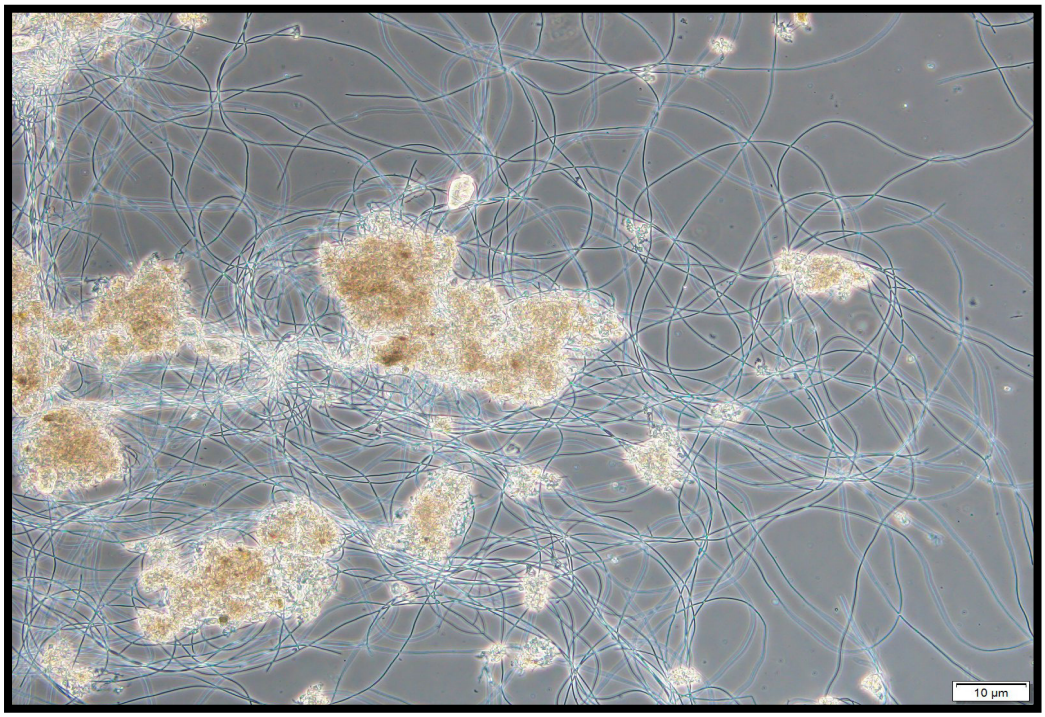
100X phase contrast, wet mount. Some pin, small to medium size floc.

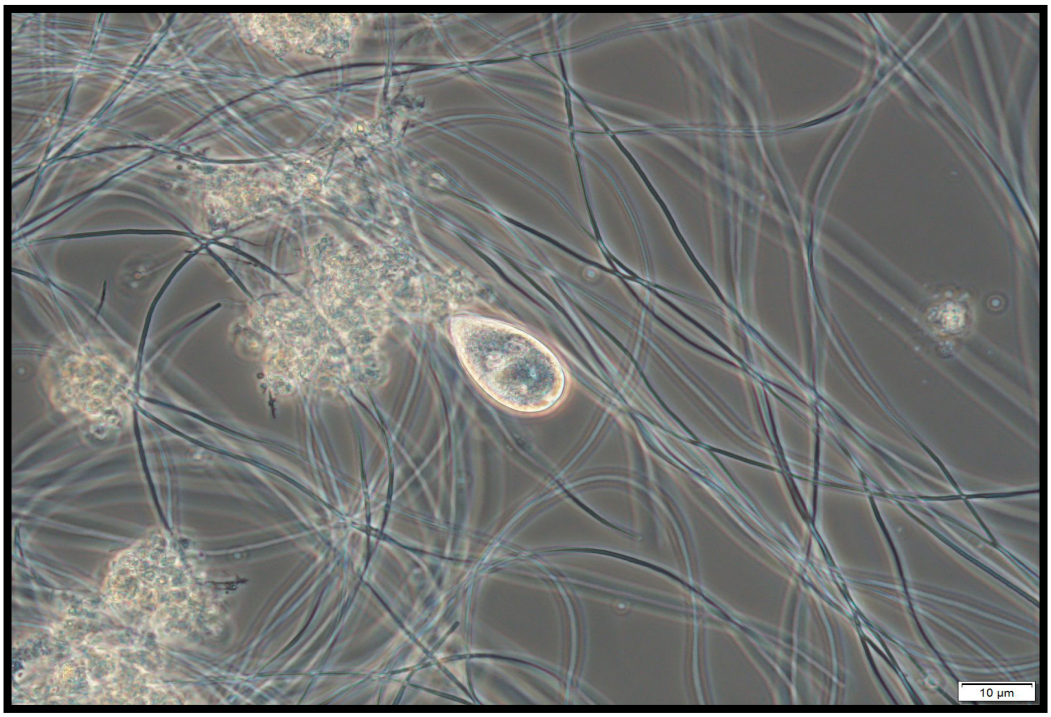
400X phase contrast, wet mount. Closer look at the MLSS with excessive amounts of filaments.

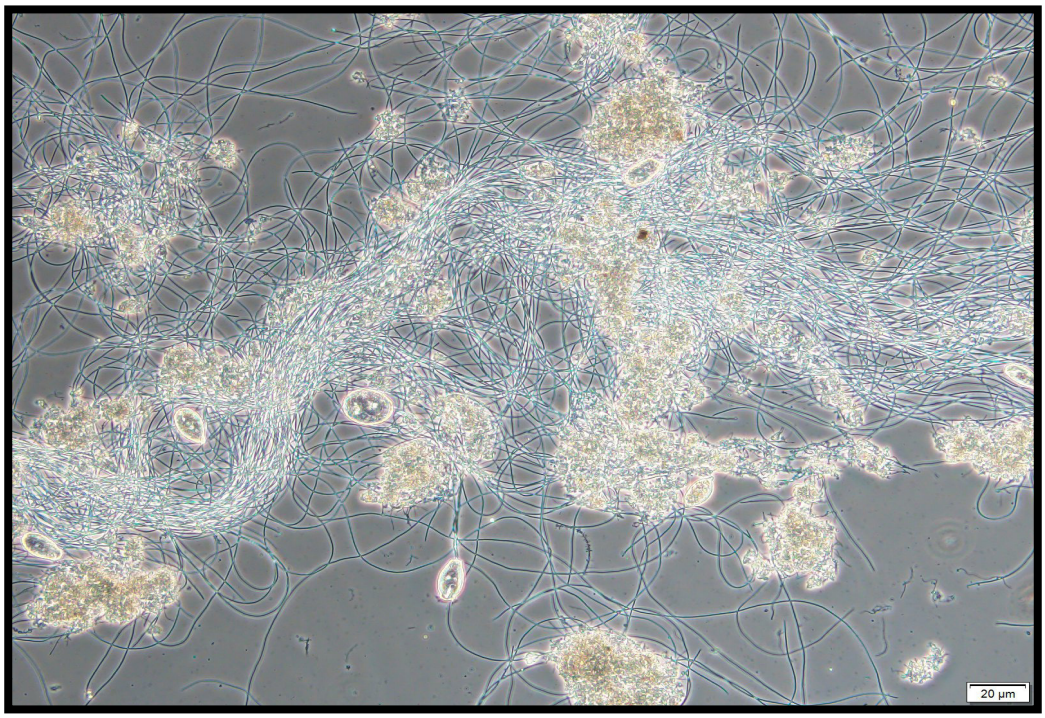
100X phase contrast, wet mount. Note the bridging occurring between floc pieces.

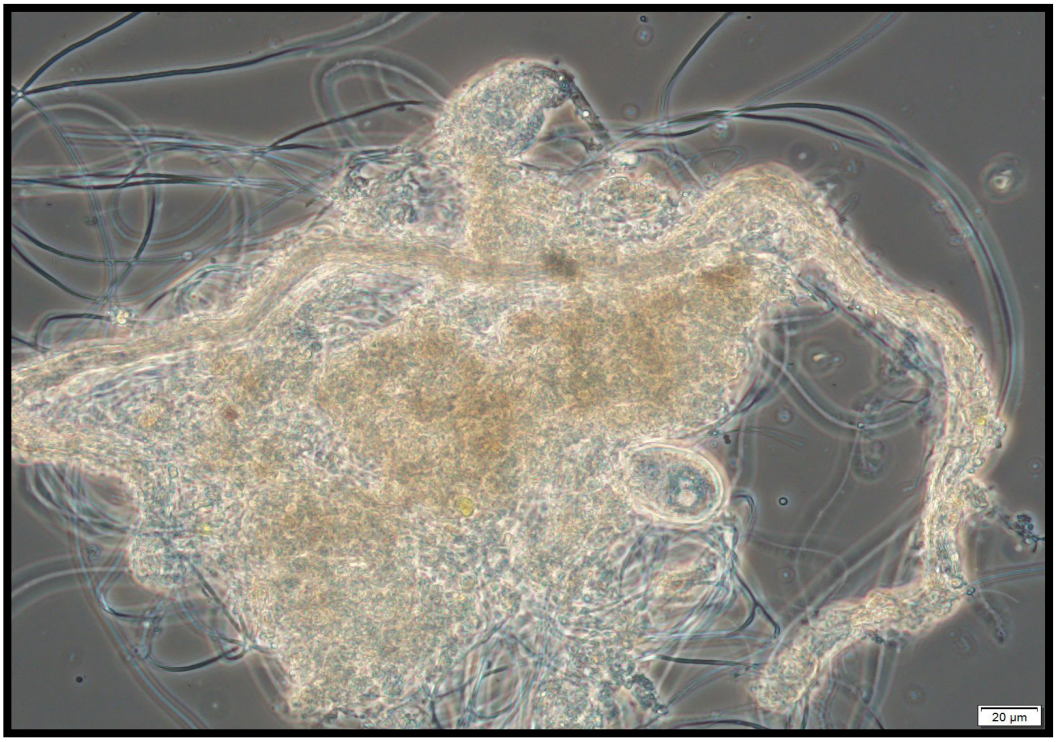
400X phase contrast, wet mount. Closer look at the RAS sample.

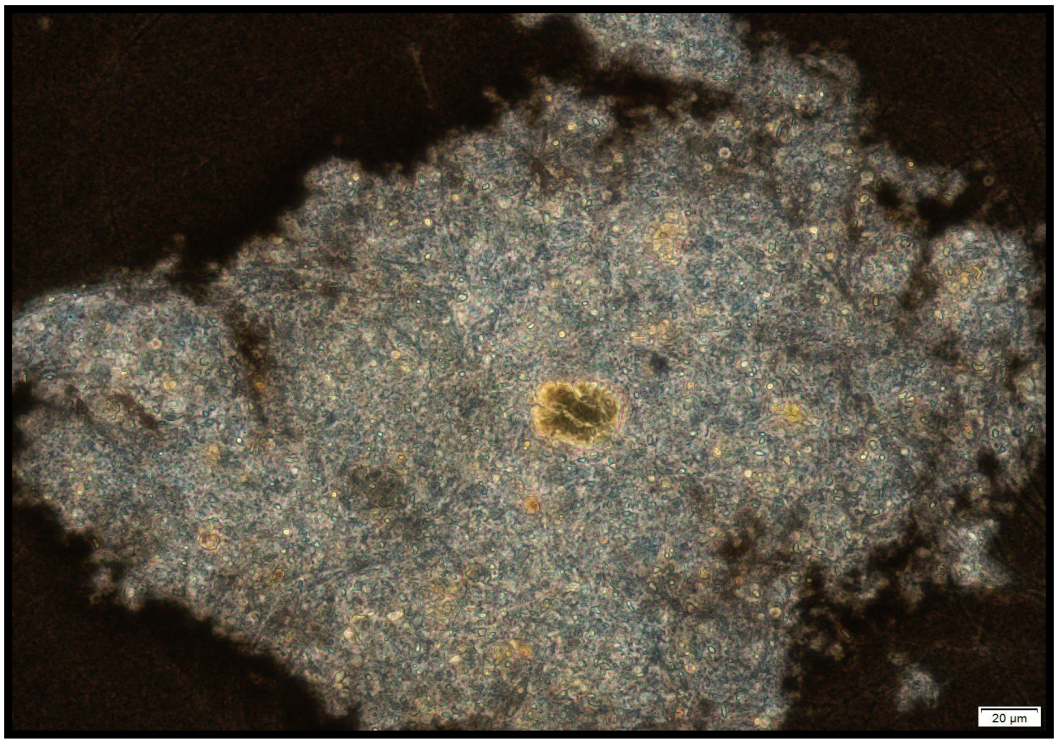
400X phase contrast, India Ink. A moderate level of polysaccharides were measured in the MLSS sample during the india ink stain.

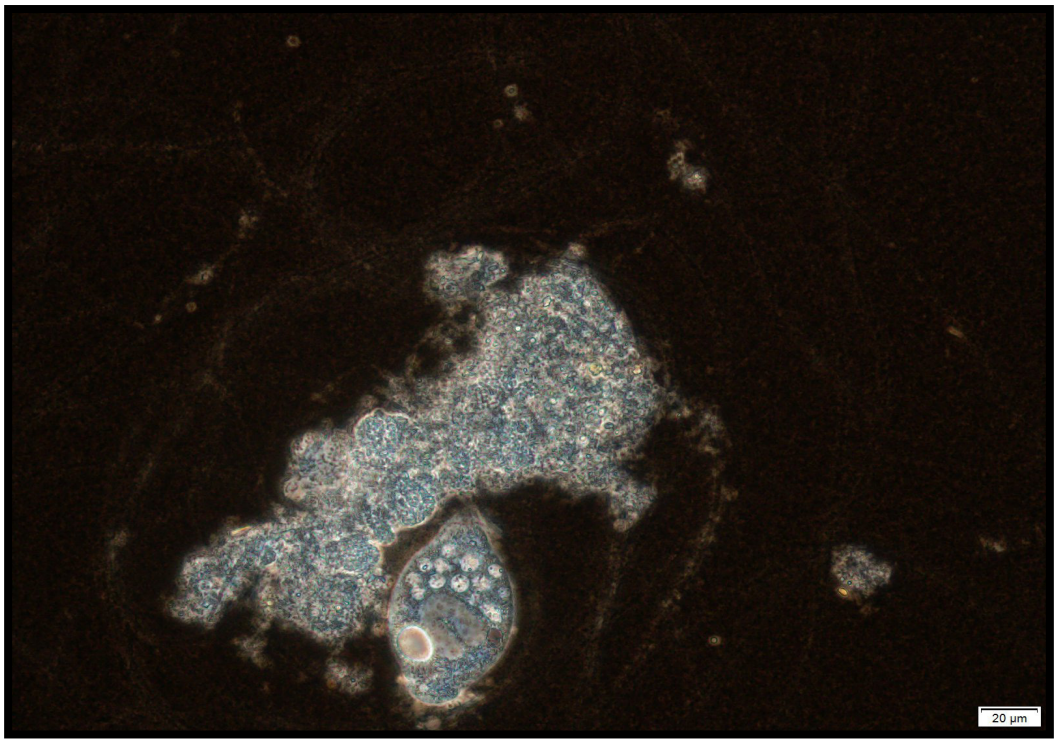
400X phase contrast, India Ink. The RAS sample was also observed having a moderate amount of polysaccharides.

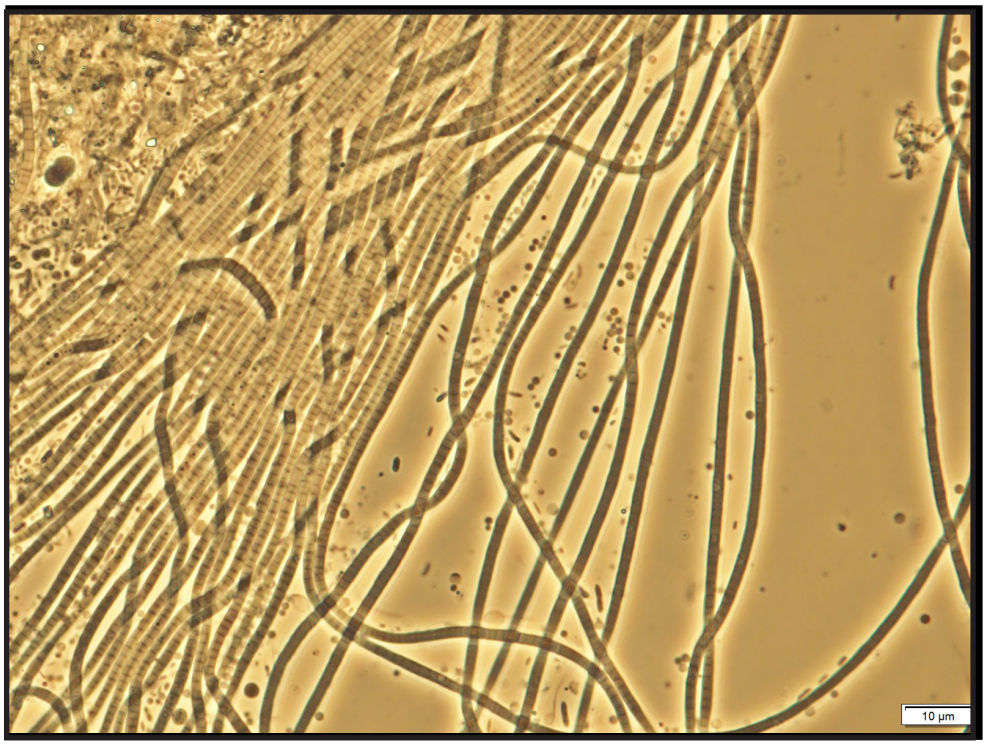
1000X phase contrast, wet mount. *Type 021N* was the most common filament observed.

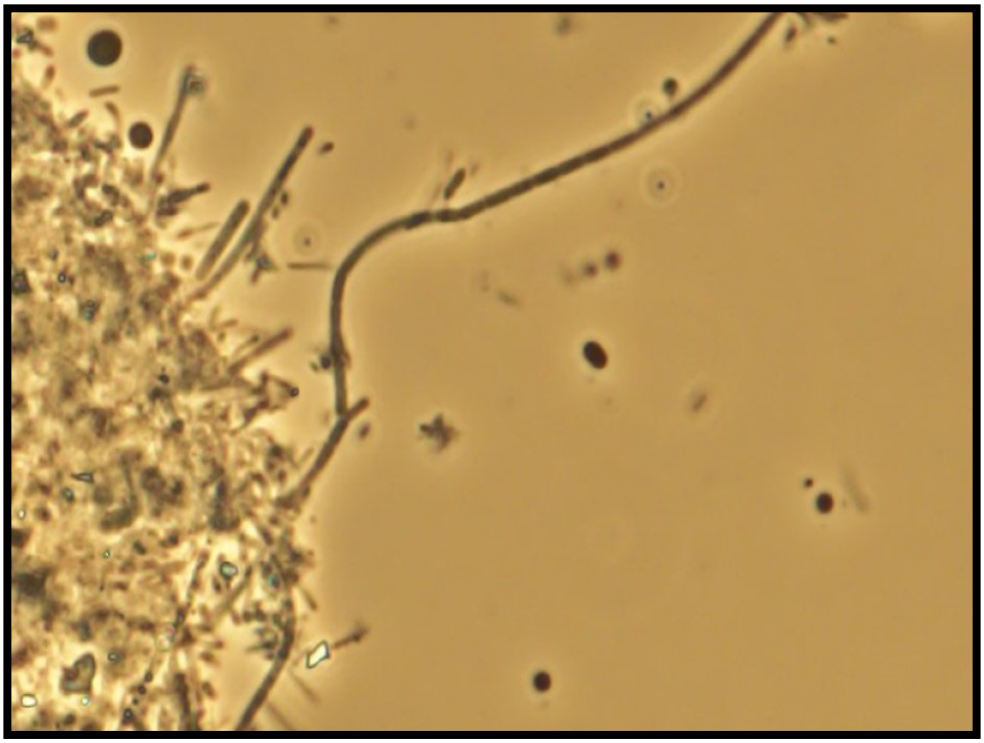
1000X phase contrast, wet mount. S. natans has sausage shaped cells.

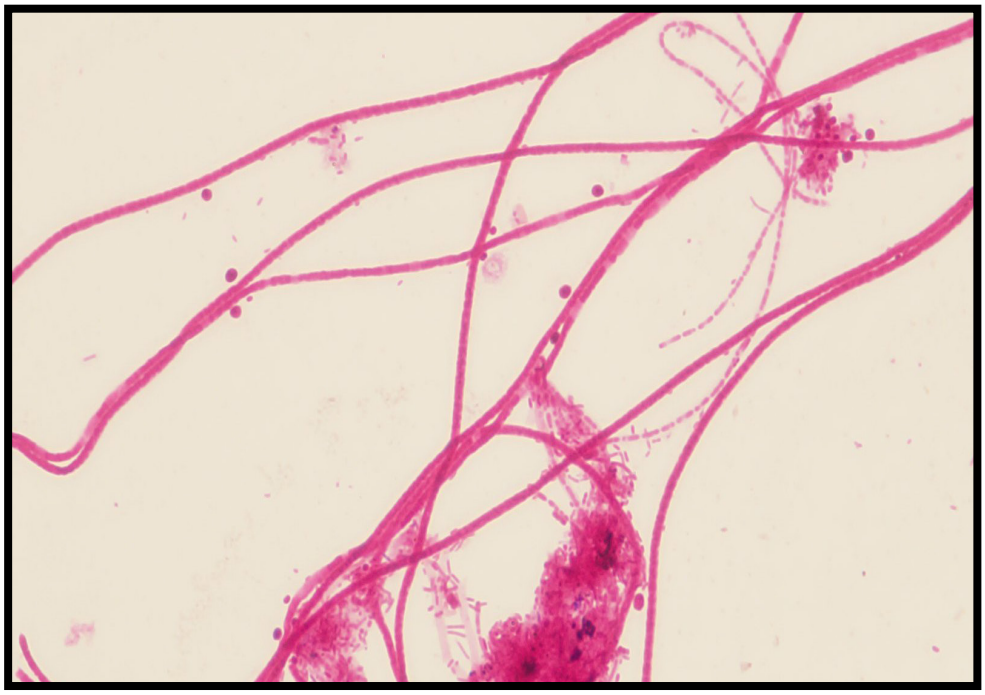
1000X bright field, Gram stain. MLSS All filaments stained Gram negative.

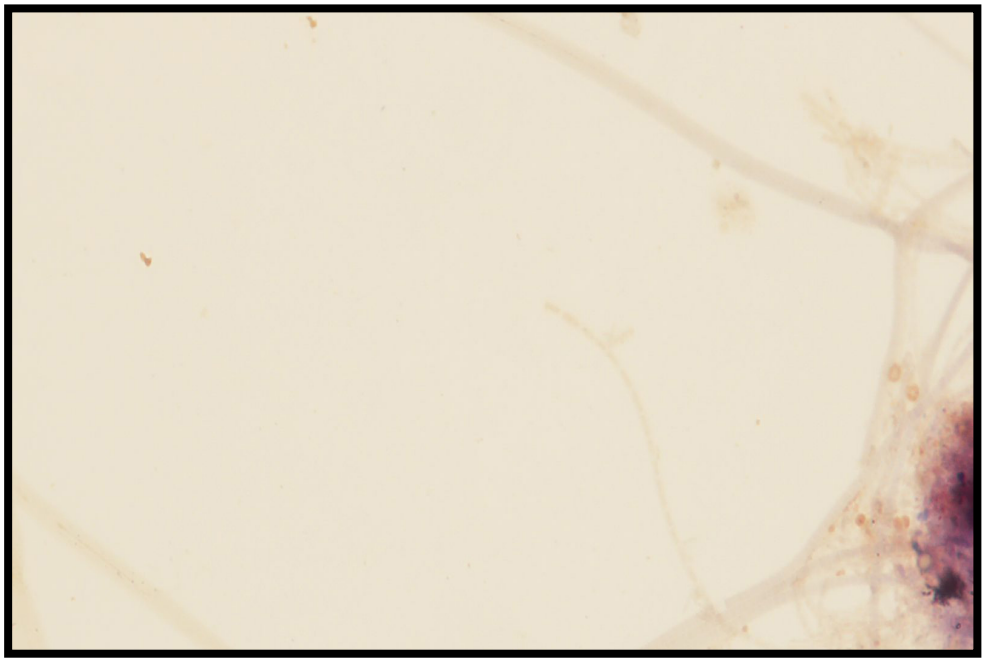
1000X bright field, Neisser stain. All filaments stained Neisser negative.

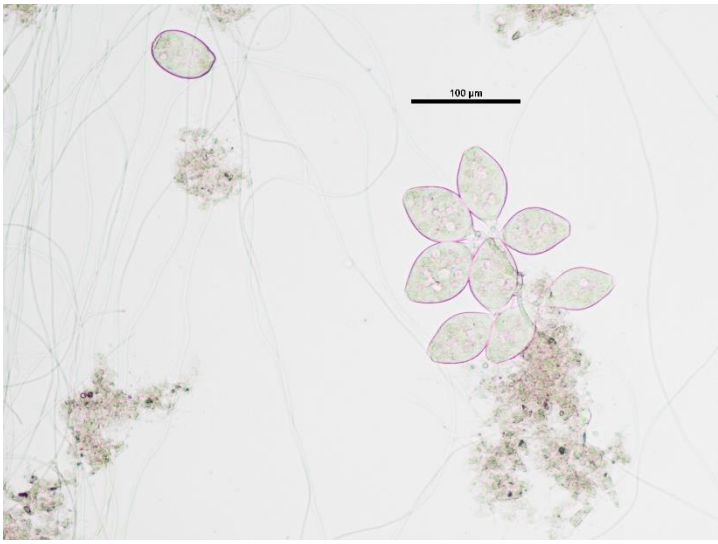
Figure 1. 100X magnification (m): The Influent ML sample contained low colonies of stalked ciliates and overall medium levels of stalked ciliates. There were also low to medium levels of swimming ciliates.

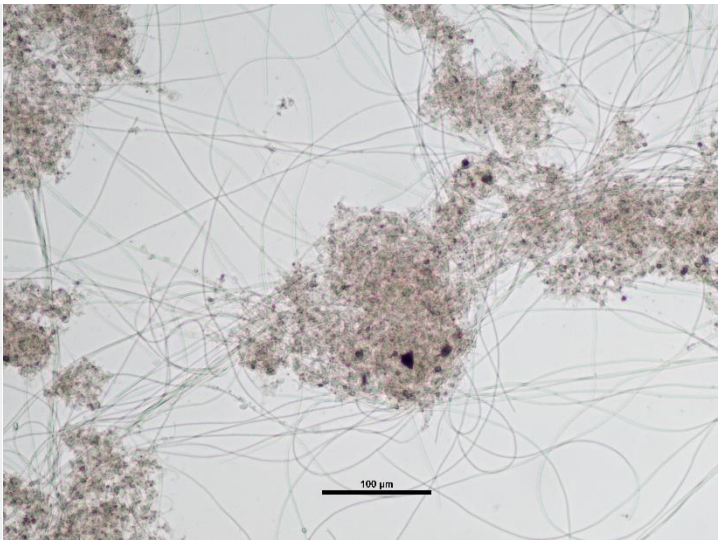
Figure 2. 100X (m): There were high levels of filaments outside of the floc in the Influent ML sample. These filaments are long and can promote inter-floc bridging, which will increase sludge volume and lead to sludge bulking.

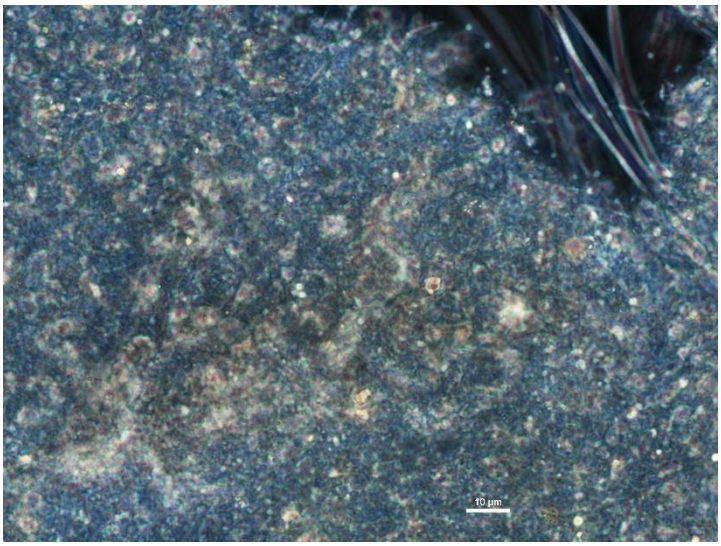
Figure 3. 400X (m), Phase contrast: The flocs in the Influent ML sample were mostly small (<100um) and condensed. There were medium levels of very large floc (>500um). The average floc size was 119.14um and white in color indicating good oxygen penetration. This is expected with small flocs that are not very dense. There were also high levels of free bacteria in this sample.

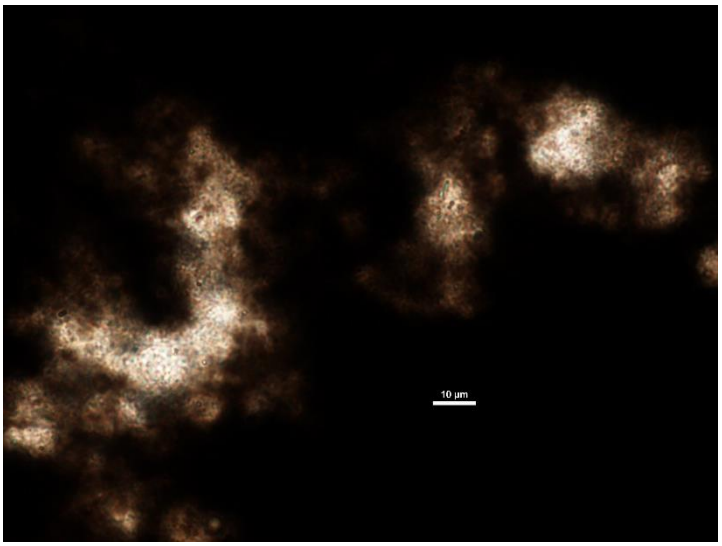
Figure 4. 400X (m), India ink stain: The floc in the Influent ML sample overall had medium levels of extracellular polymeric substances (EPS) in the condensed areas. EPS is a glue-like substance that allows bacteria to stick together to produce floc. Medium levels of EPS are necessary to produce floc with a strong structure that can withstand sheer force.

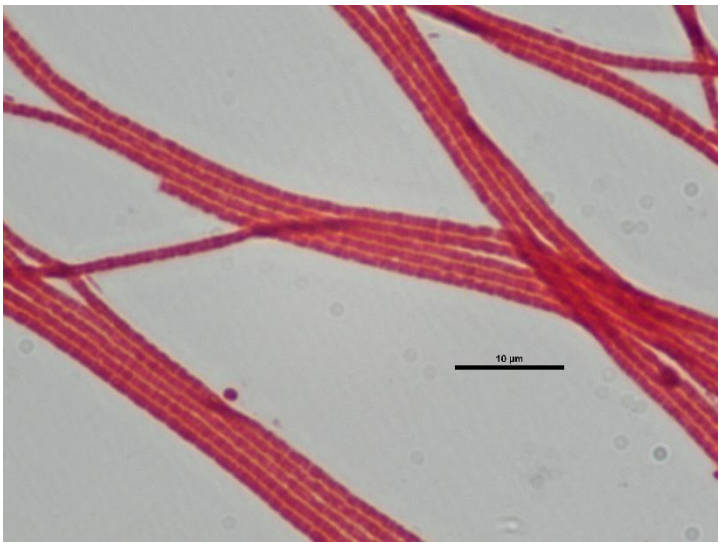
Figure 5. 1000X (m), Gram Stain: There were high levels of Type 021N present in the Influent ML sample. Type 021N grows in environments with septic compounds, low DO, and/or low levels of usable nitrogen.

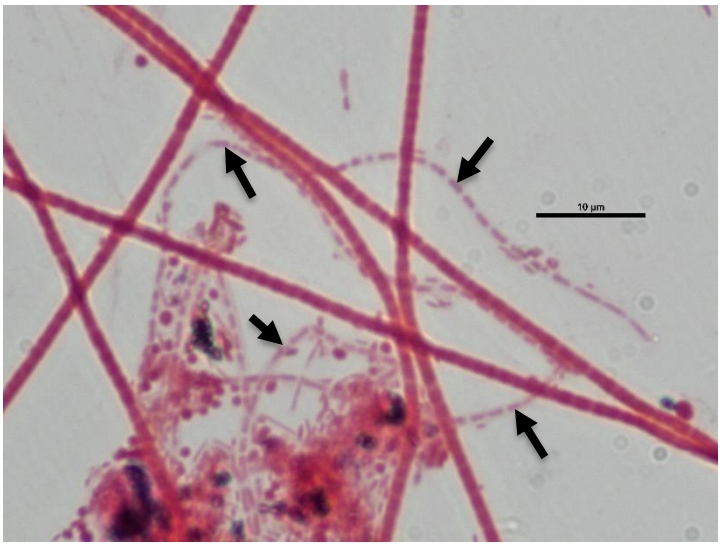
Figure 6. 1000X (m), Gram Stain: The Influent ML sample contained medium levels of *S. natans*/Type 1701 (arrows). *S. natans*/Type 1701 is found in environments with septic compounds, low DO, and high BOD loading.

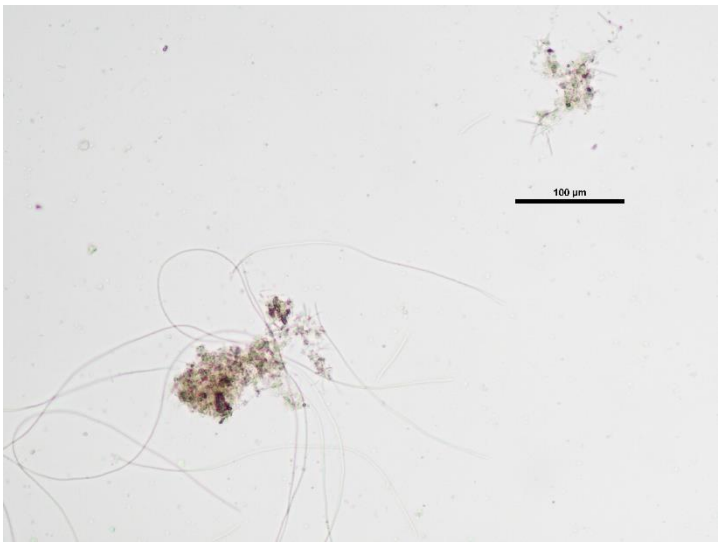
Figure 7. 100X (m): The Influent Foam sample was similar in composition to the Influent ML sample. this indicates that the foam is composed of small floc and other light particles being pushed to the water-air interface.

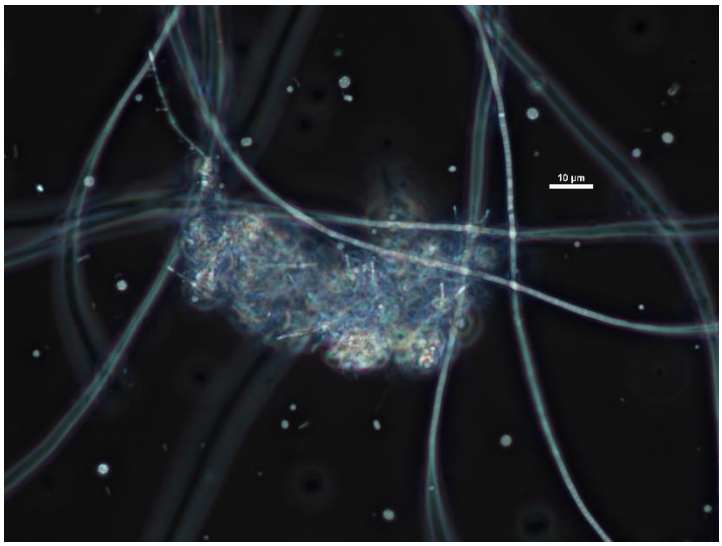
Figure 8. 400X (m), Phase contrast: There were also high levels of free bacteria in this sample (glowing spots) along with the mentioned small flocs and filaments of Type 021N growing free in the bulk liquid. Type 021N is known to sometimes form a slimy scum at the surface of aeration basins when this filament becomes abundant.

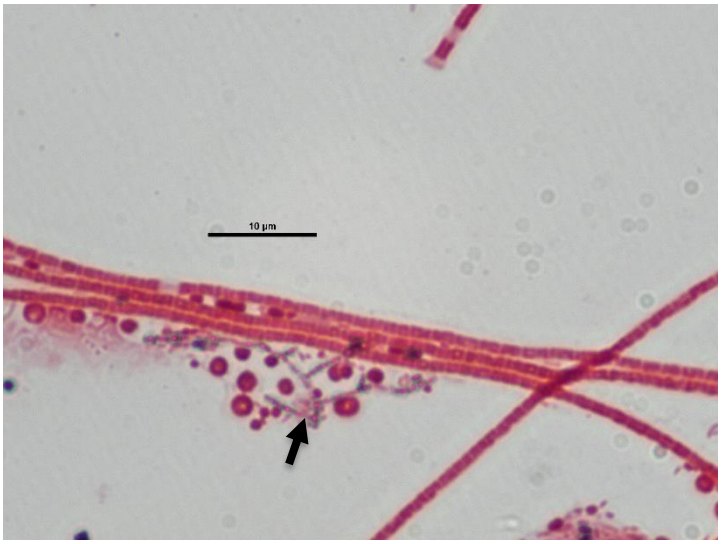
Figure 9. 1000X (m), Gram Stain: There were high levels of Type 021N (red filaments) in the Foam sample and medium levels of Nocardia-like filaments (arrow). Nocardioforms are known to cause foaming when present in high levels.

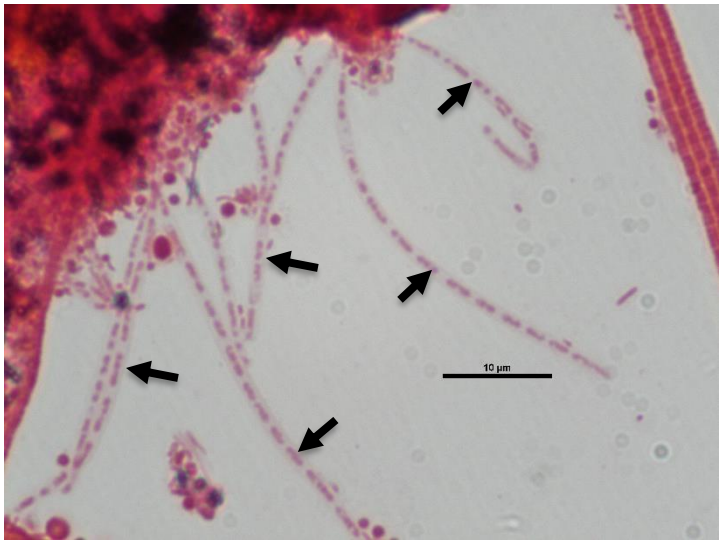
Figure 10. 1000X (m), Gram Stain: As with the Influent ML sample, the Influent Foam sample had low to medium levels of *S. natans*/Type 1701 (arrows).

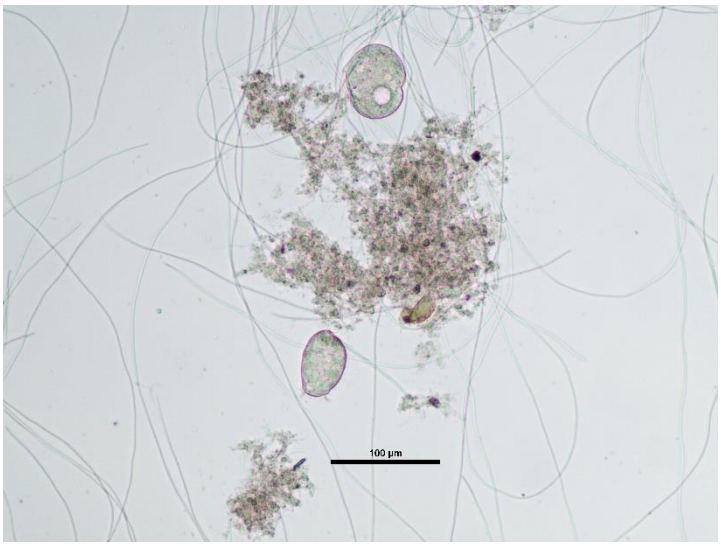
Figure 11. 100X (m): The Effluent ML sample was similar to the Influent ML samples but have had more branched filaments free in the bulk liquid. There were also low levels of nematodes present (not shown).

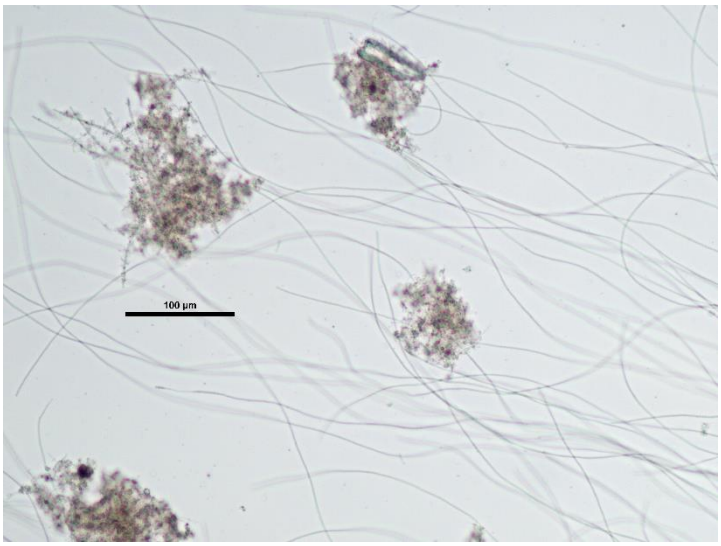
Figure 12. 100X (m): The Effluent ML sample also contained floc that were mostly small in size with an average diameter of 114.96um. There were also high levels of filaments mostly free in the bulk liquid.

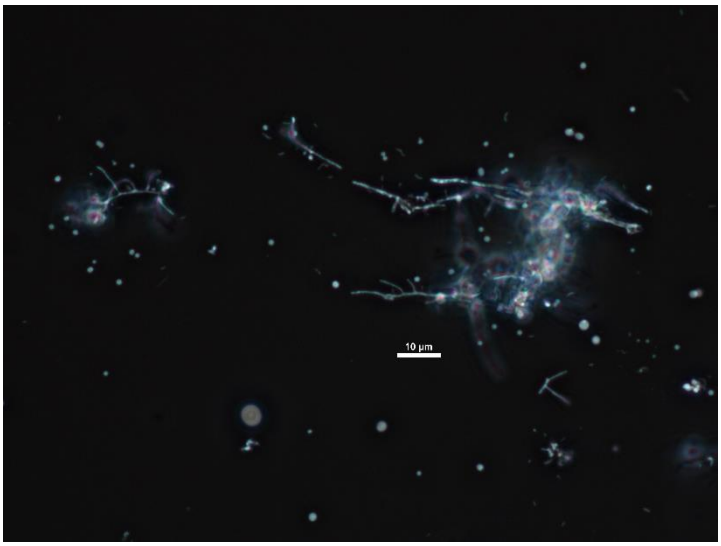
Figure 13. 400X (m), Phase contrast: The small flocs in the Effluent ML were white in color indicating good oxygen penetration. This is expected with small flocs that are not very dense. There were also high levels of free bacteria and free small clusters of branched filaments in this sample.

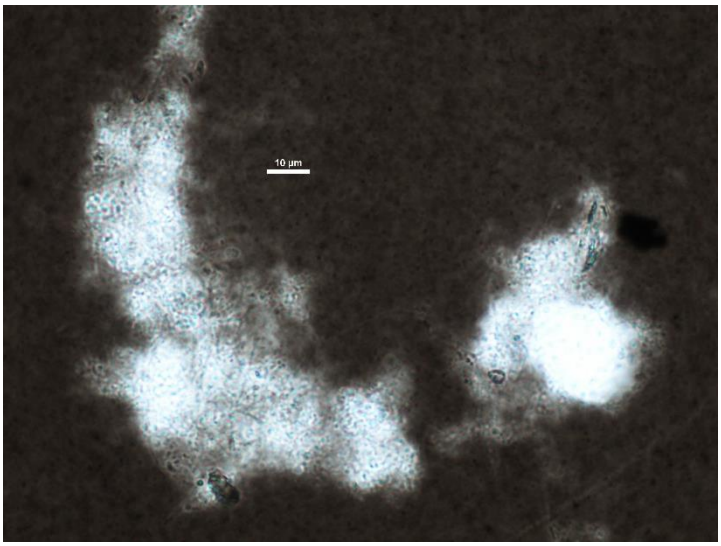
Figure 14. 400X (m), India ink stain: The Effluent ML flocs had mostly areas of medium levels of EPS with a few condensed areas with high EPS. There was possibly oil in this sample since the bulk liquid excluded the stain in some areas and there may have been a few oil droplets observed.

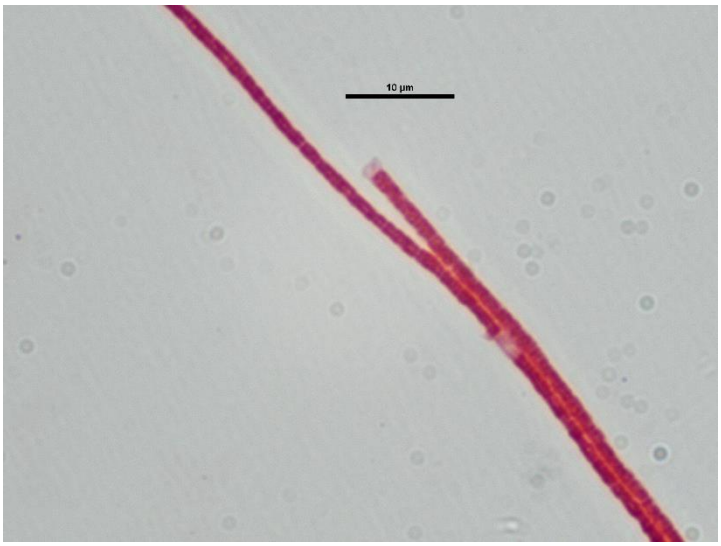
Figure 15. 1000X (m), Gram Stain: There were medium to high levels of Type 021N mostly observed outside of the floc structure in the Effluent ML sample.

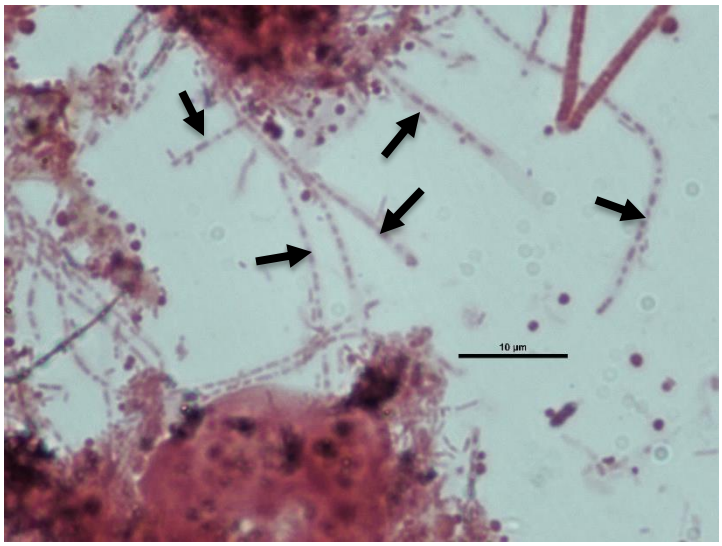
Figure 16. 1000X (m), Gram Stain: There were high levels of *S. natans*/Type 1701 (arrows) observed extending from the flocs in the Effluent ML sample.

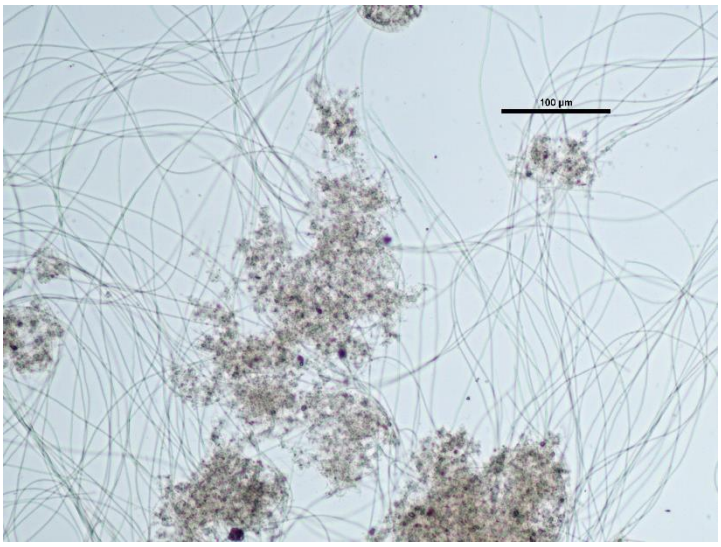
Figure 17. 100X (m): The Effluent Foam sample contained stringy solids of mostly small to medium sized flocs and high levels of filaments free in the bulk liquid.

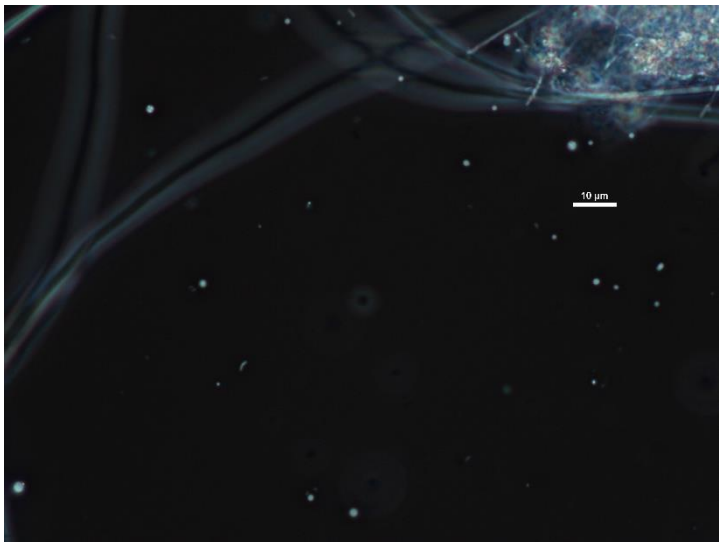
Figure 18. 400X (m), Phase contrast: There were also high levels of free bacteria (bright dots) present in the Effluent Foam sample.

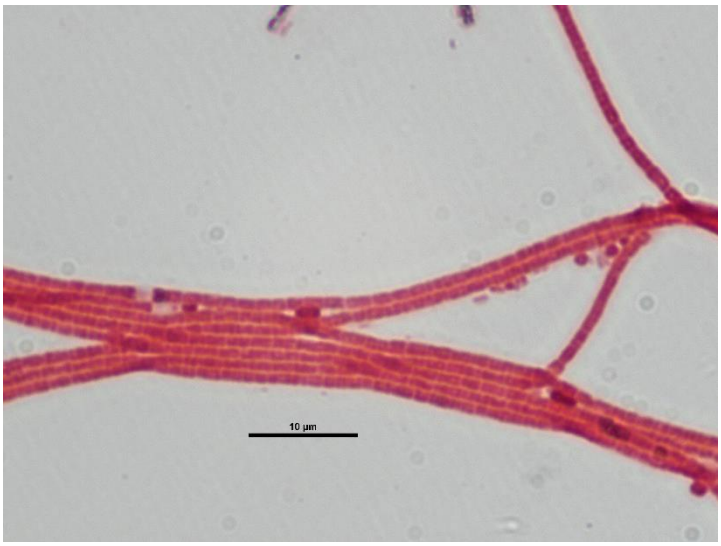
Figure 19. 1000X (m), Gram Stain: The Effluent Foam was much like the Influent Foam with high levels of Type 021N and low to medium levels of *S. natans*/Type 1701.

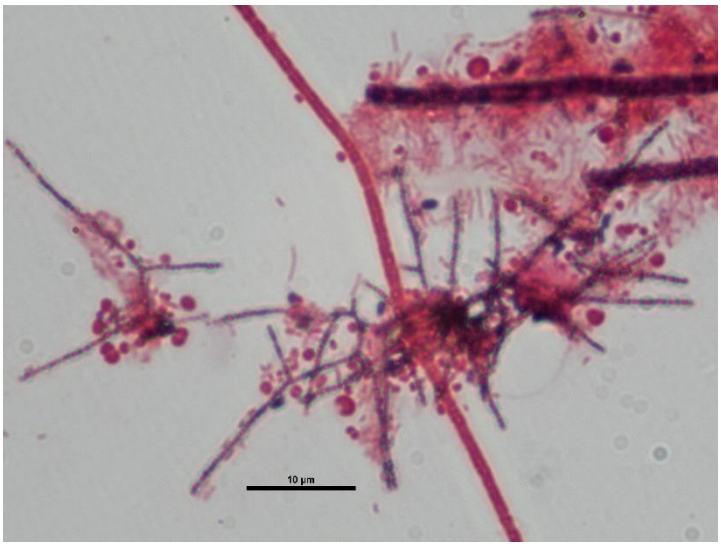
Figure 20. 1000X (m), Gram Stain: The Effluent Foam sample had medium levels of Nocardia-like branched filaments. There may have been slightly more Nocardioforms in this sample than the Influent Foam sample.

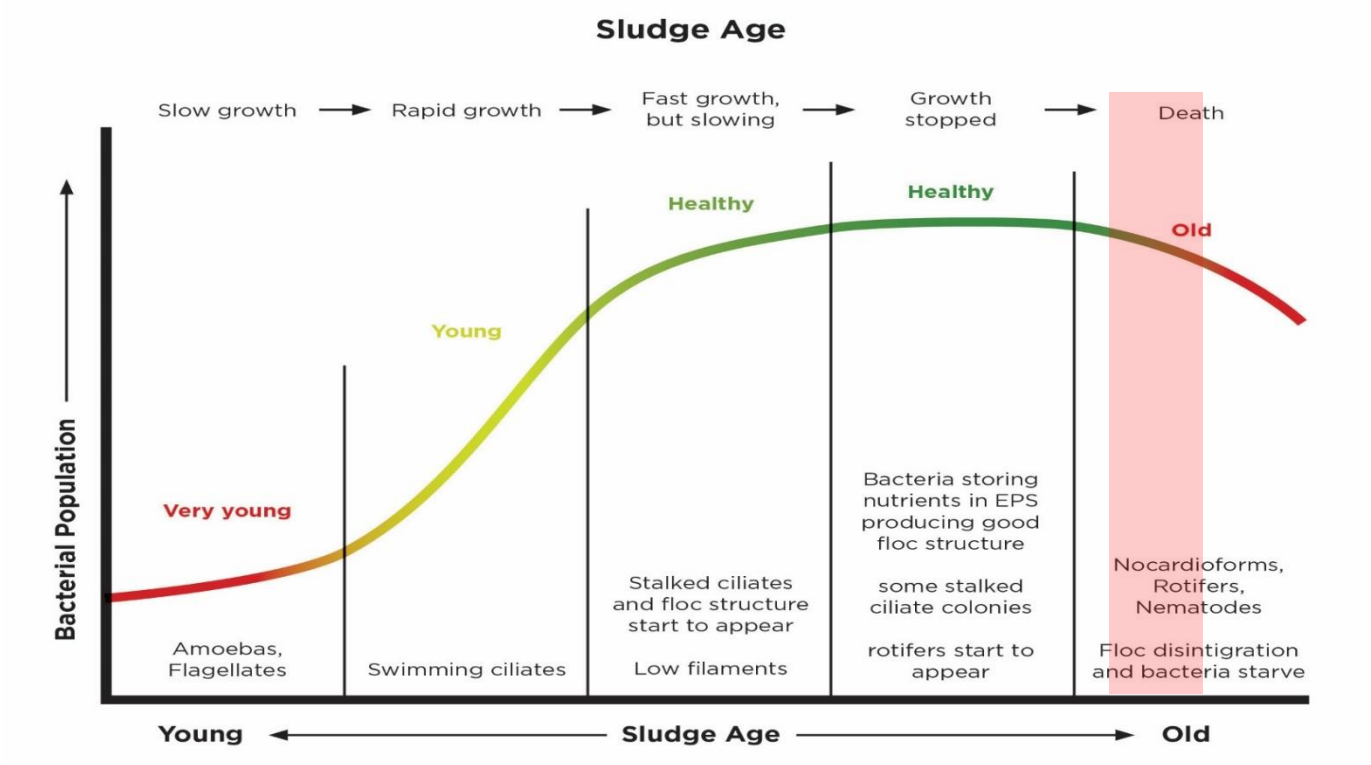
The sludge age of the Sewer Authority ML was on the older end in both the Influent and Effluent ML samples. There were colonies of stalked ciliates present, Nocardioforms which can grow in low to medium amounts with old sludge age, and low nematodes observed.

(The red shaded area in the diagram below represents the effective sludge age of the Sewer Authority ML samples)
