Pillar Point Harbor

Updated Marina Facility Condition Survey Report

Prepared for:
San Mateo County
Harbor District

May 2021

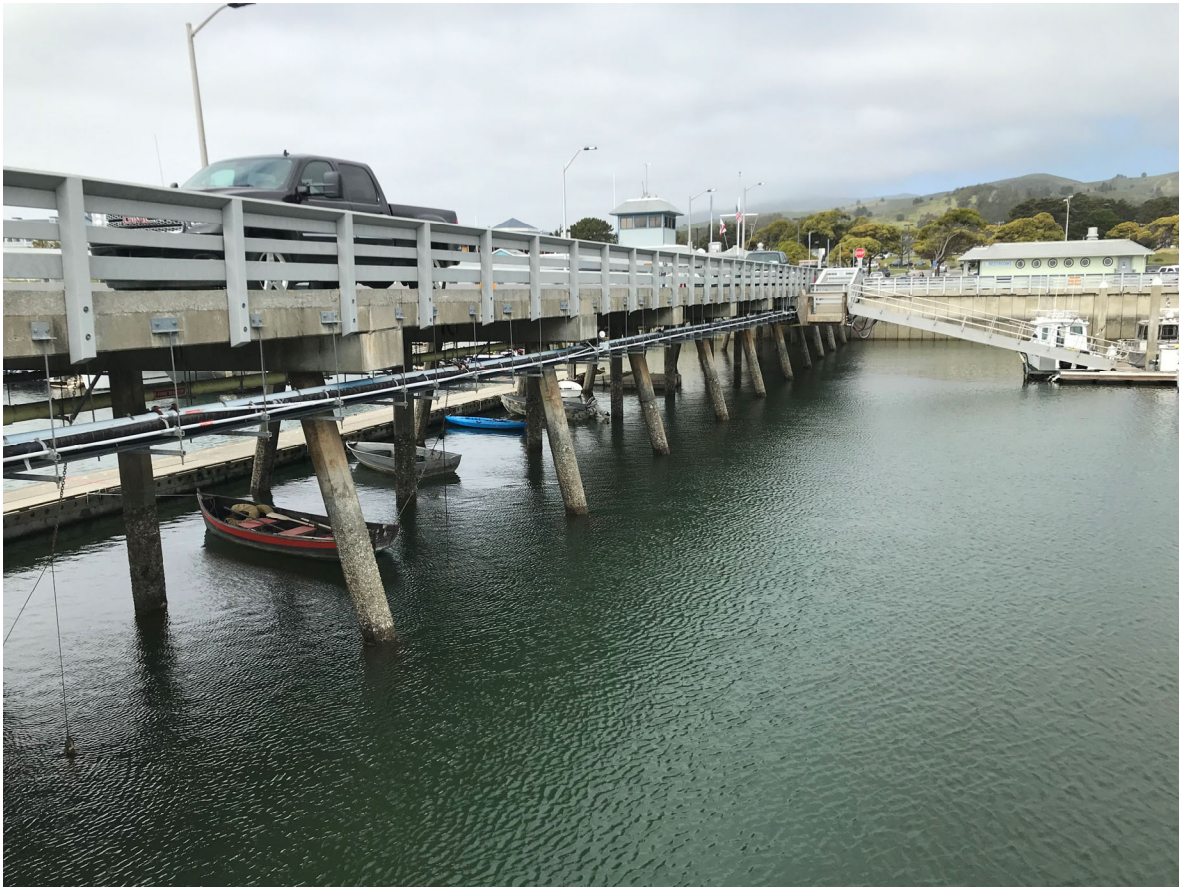
2 – View of east side of Johnson Pier

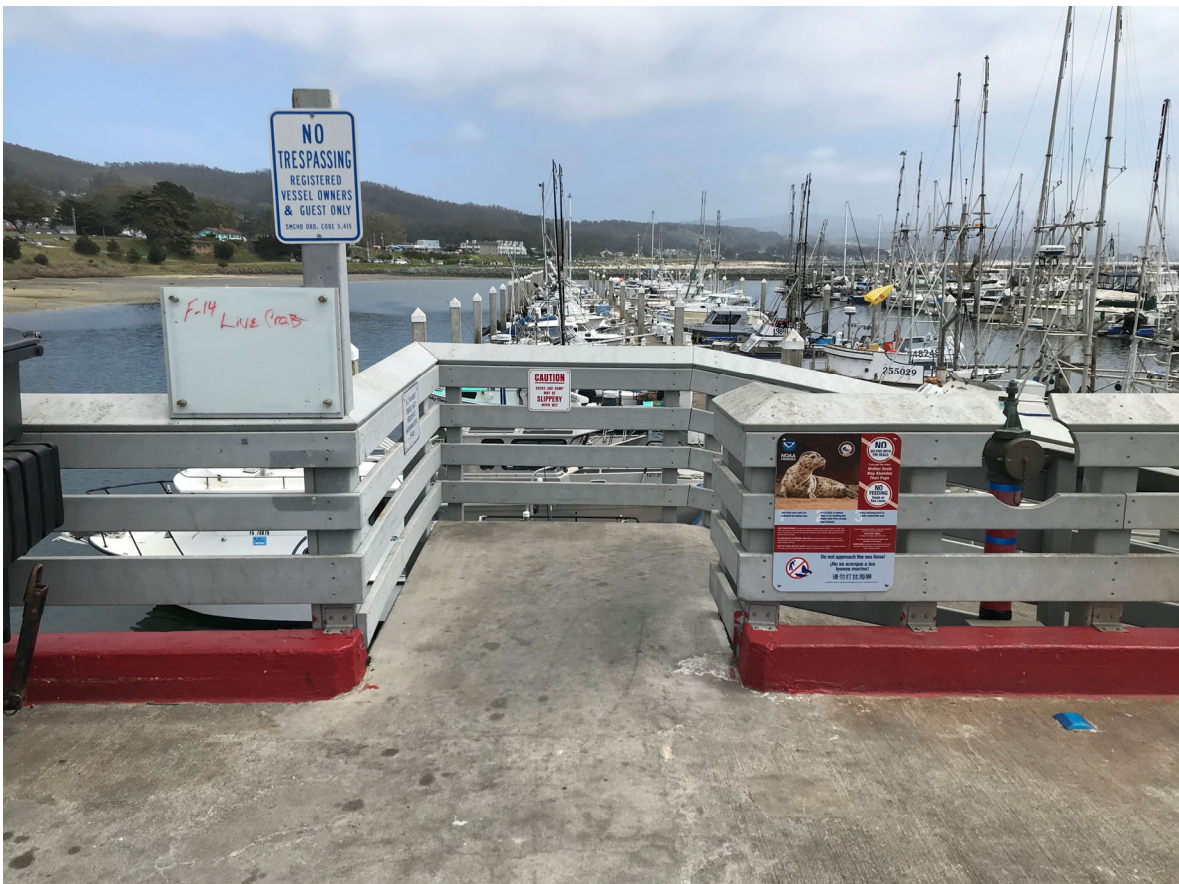
15 – View of dock access from pier

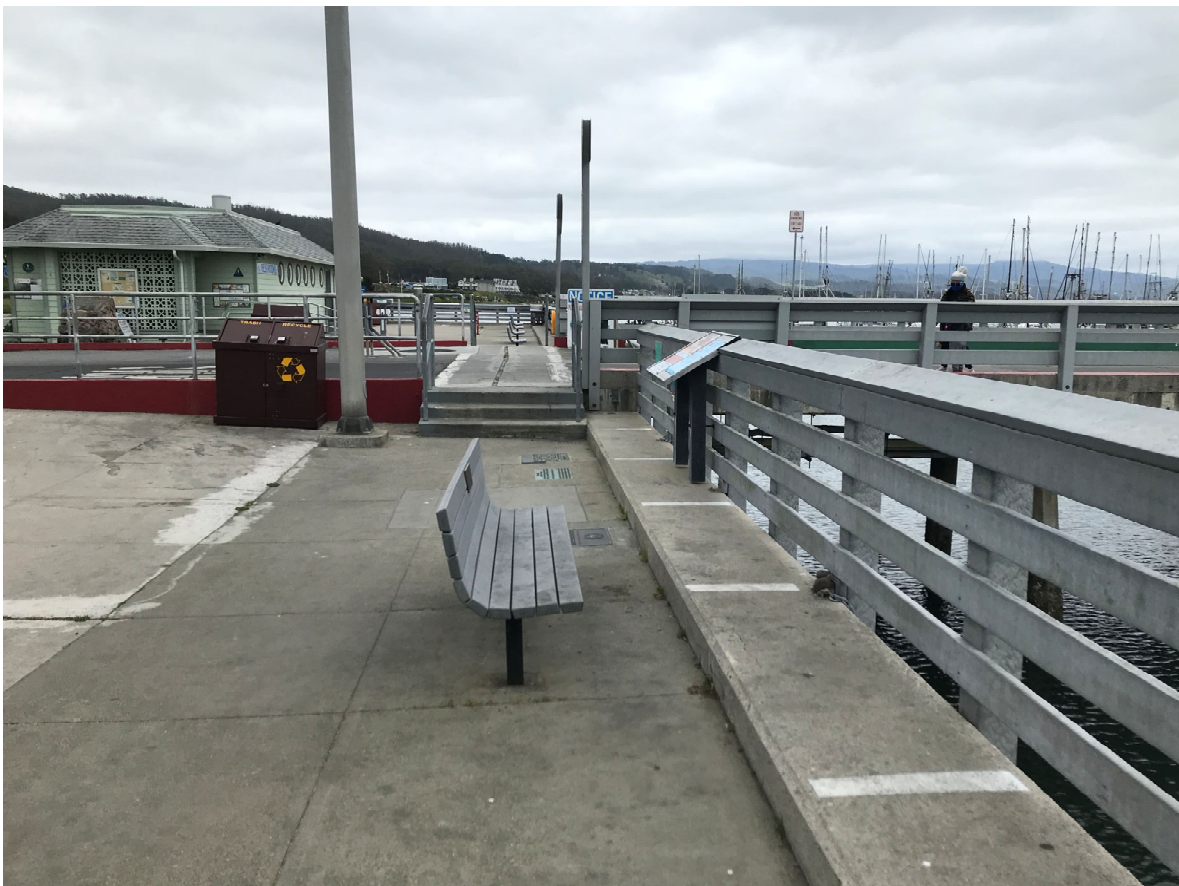
17 – View of promenade at base of pier

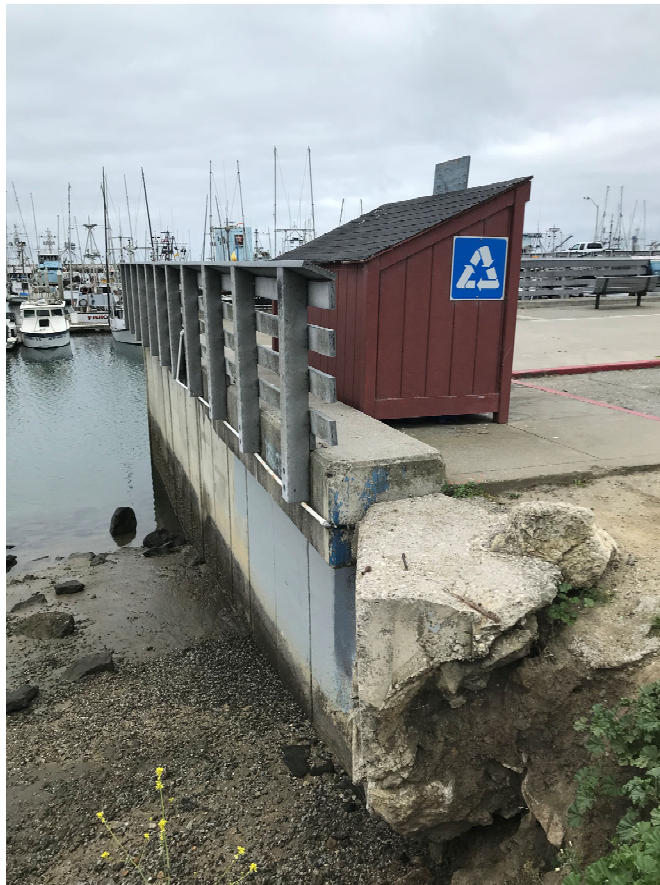
19 – View of promenade and east end of sheet pile wall (with exposed concrete block)

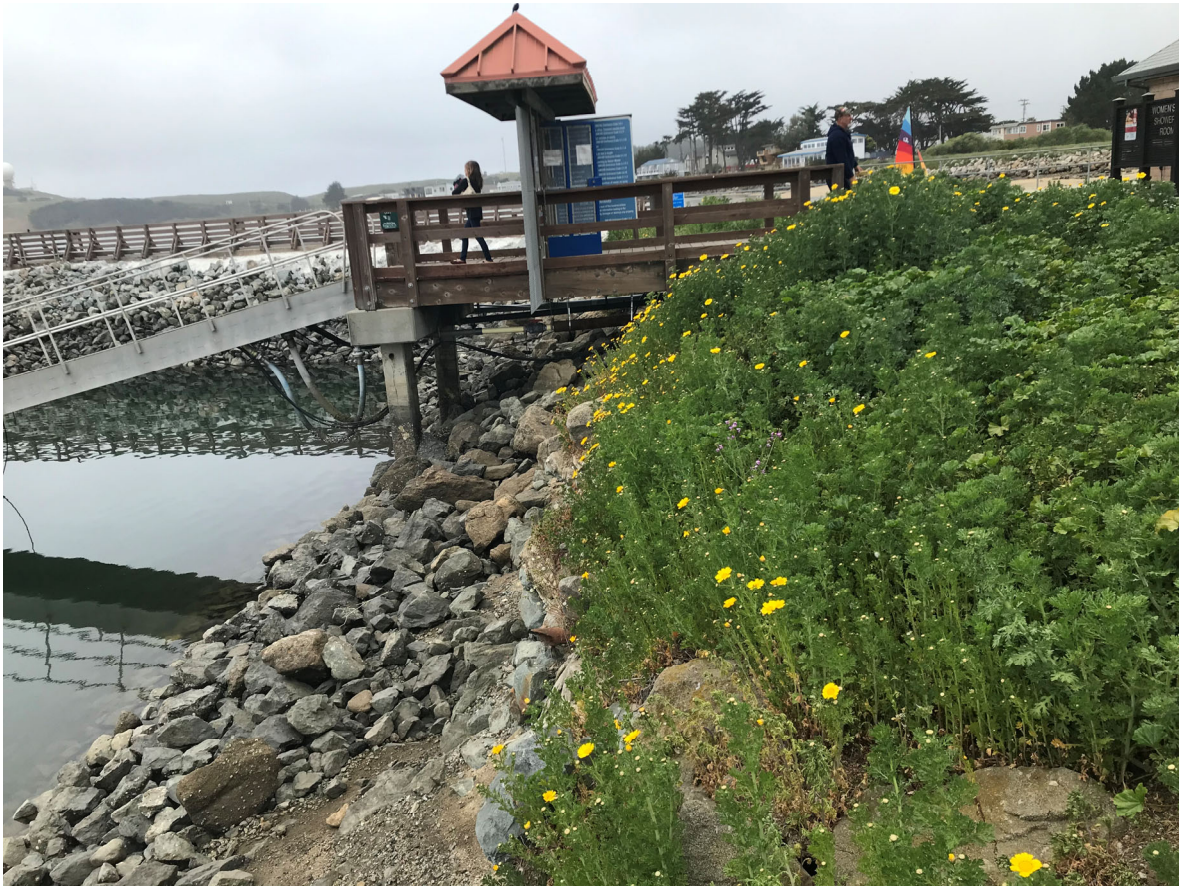
22 – View of rock slope and Docks A-C gangway platform

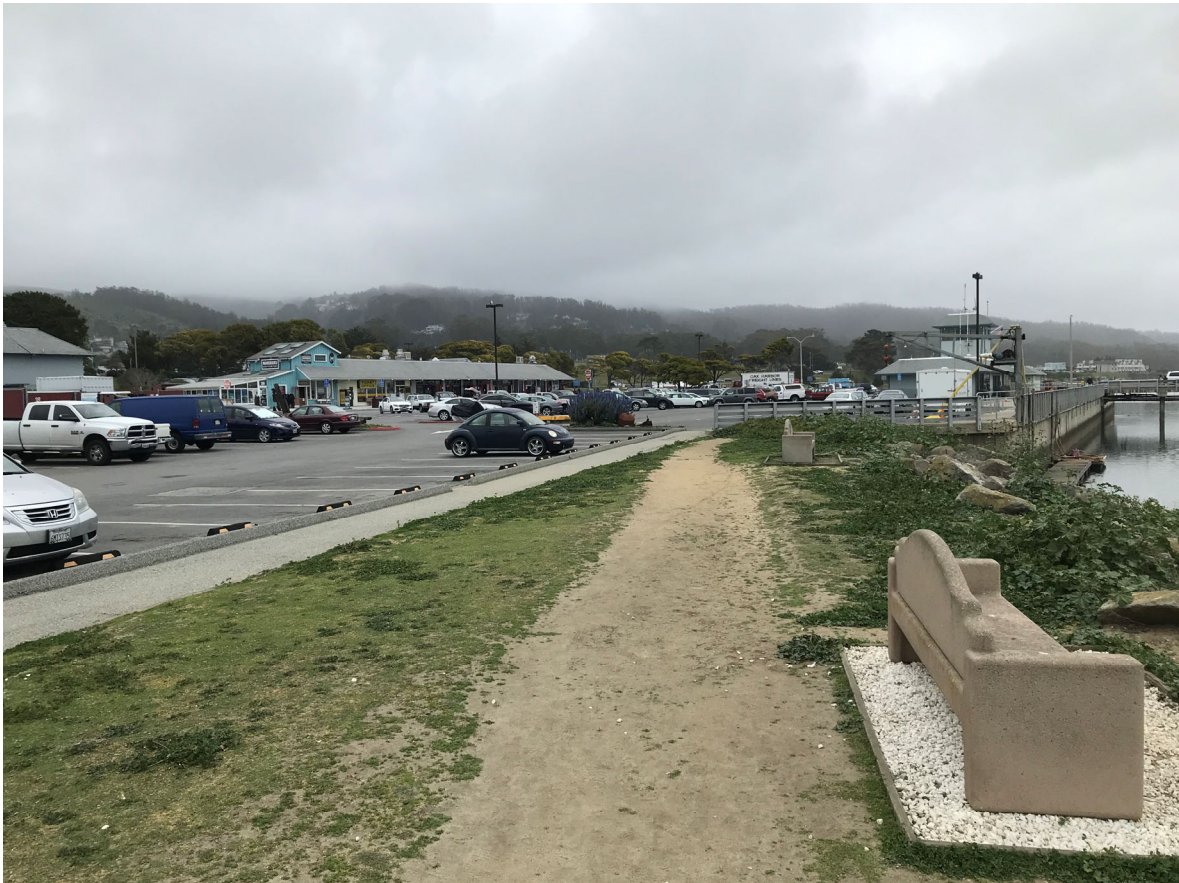
25 – View of benches, sidewalk and dirt path at top of rock slope

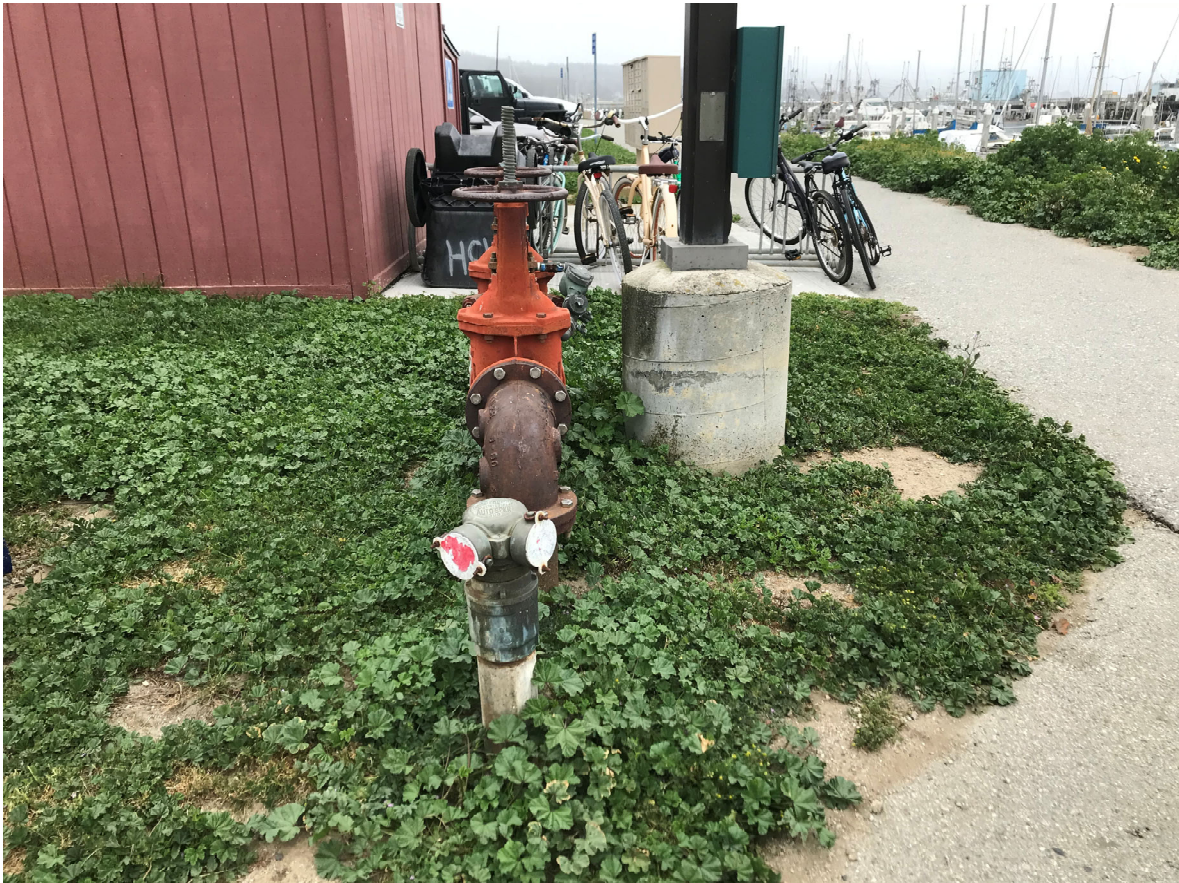
37 – View of water service valves (FDC in foreground needing signage)

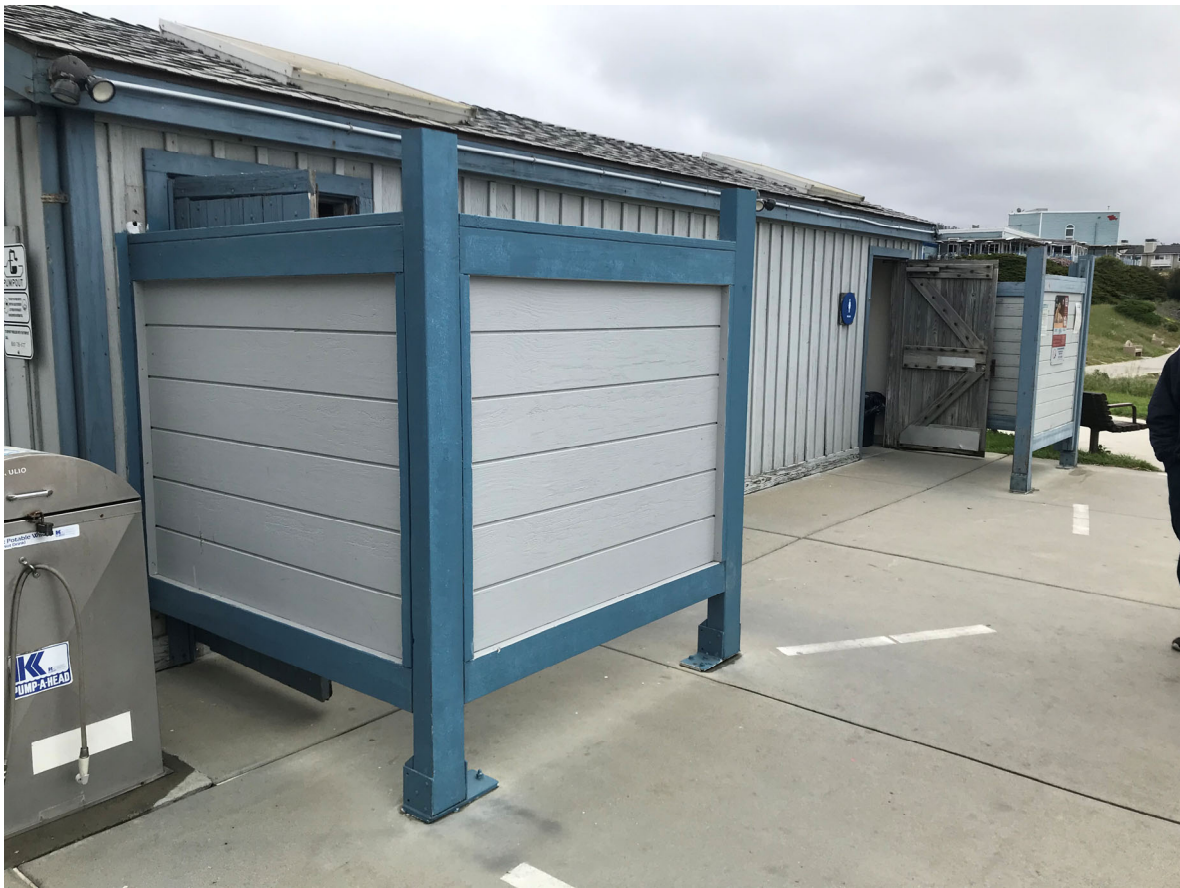
- East Restroom at Boat Ramp – Appears to be in “poor” condition, with an anticipated remaining useful life 5 to 10 years before needing major renovations or replacement

44 – View of East Restroom with new men's privacy screen

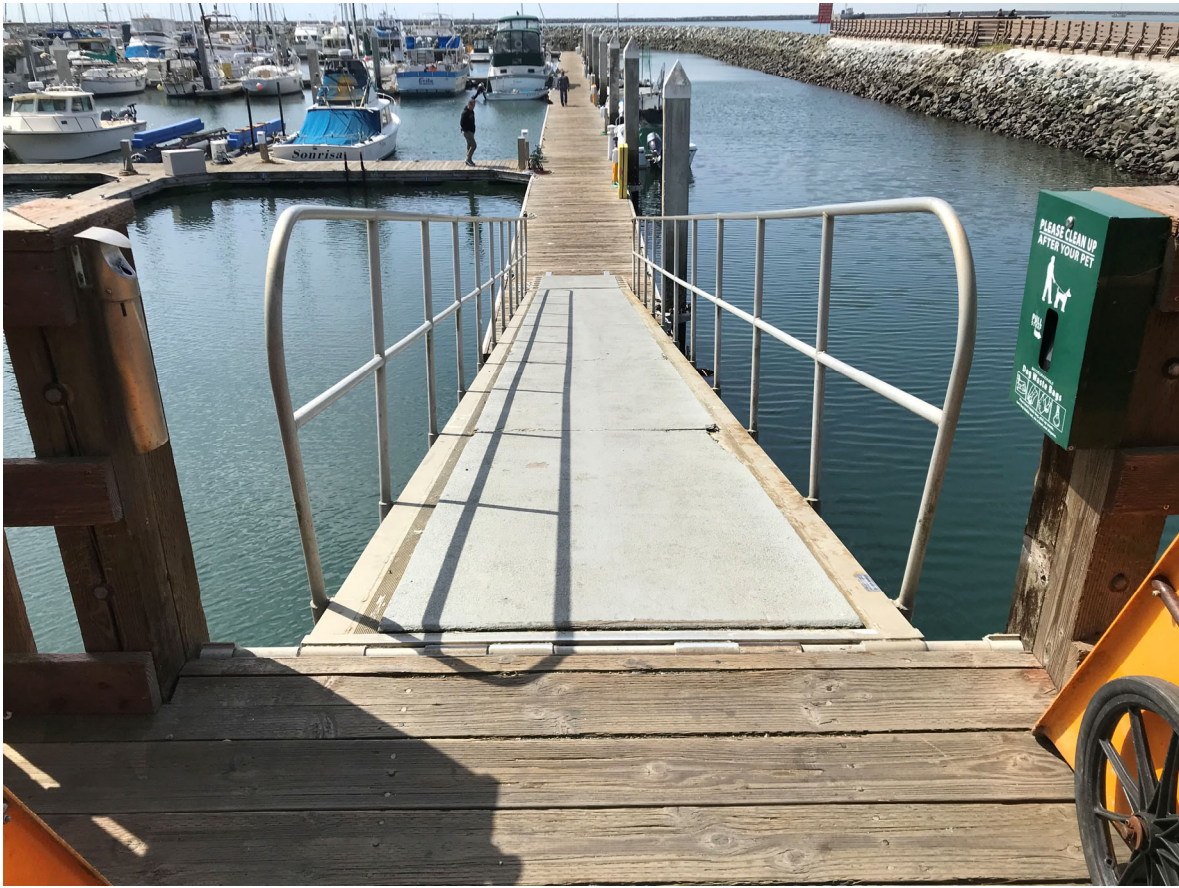
- Docks A thru C (majority recreational boat owners) – Wooden docks with conditions range from “serious” to “poor” indicating a need of replacement within 10 years

50 – View of Dock A-C gangway and main walkway

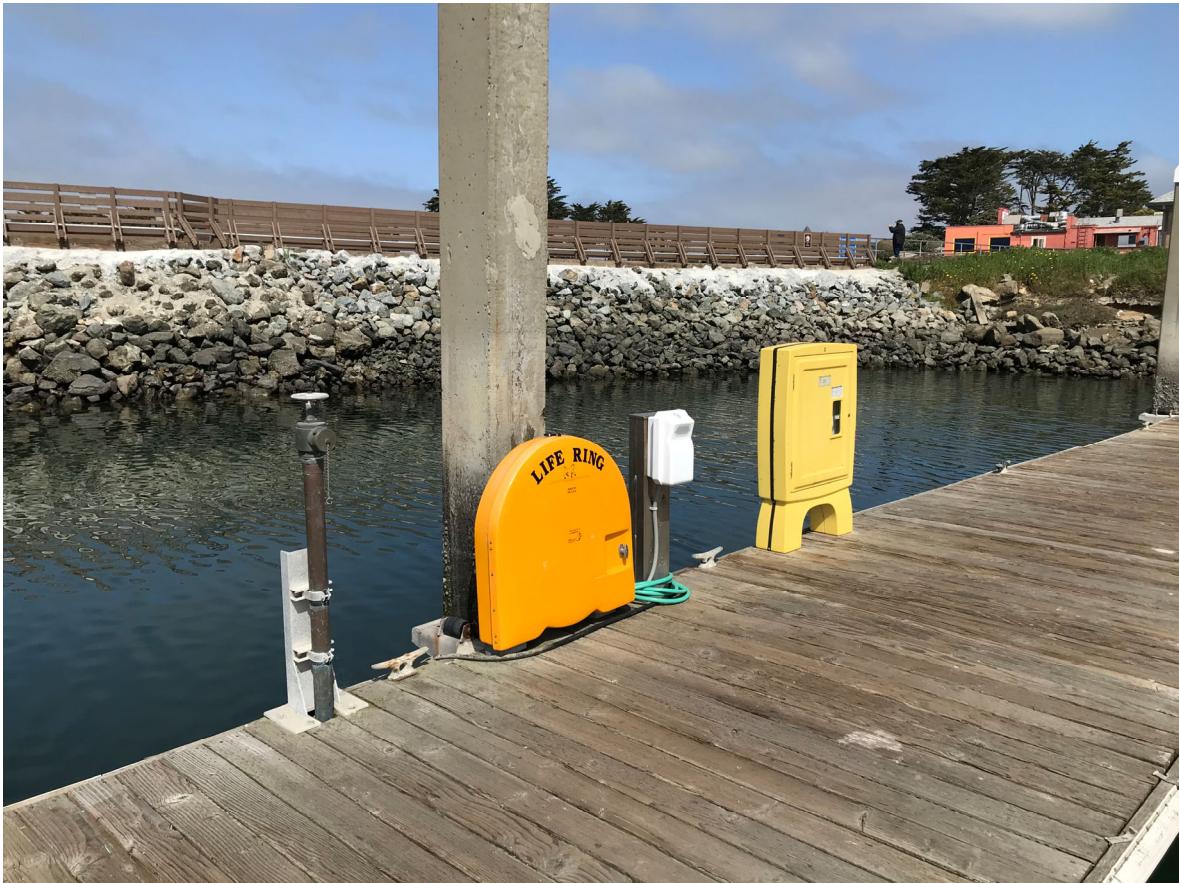
51 – View of Dock A-C fire protection and safety equipment

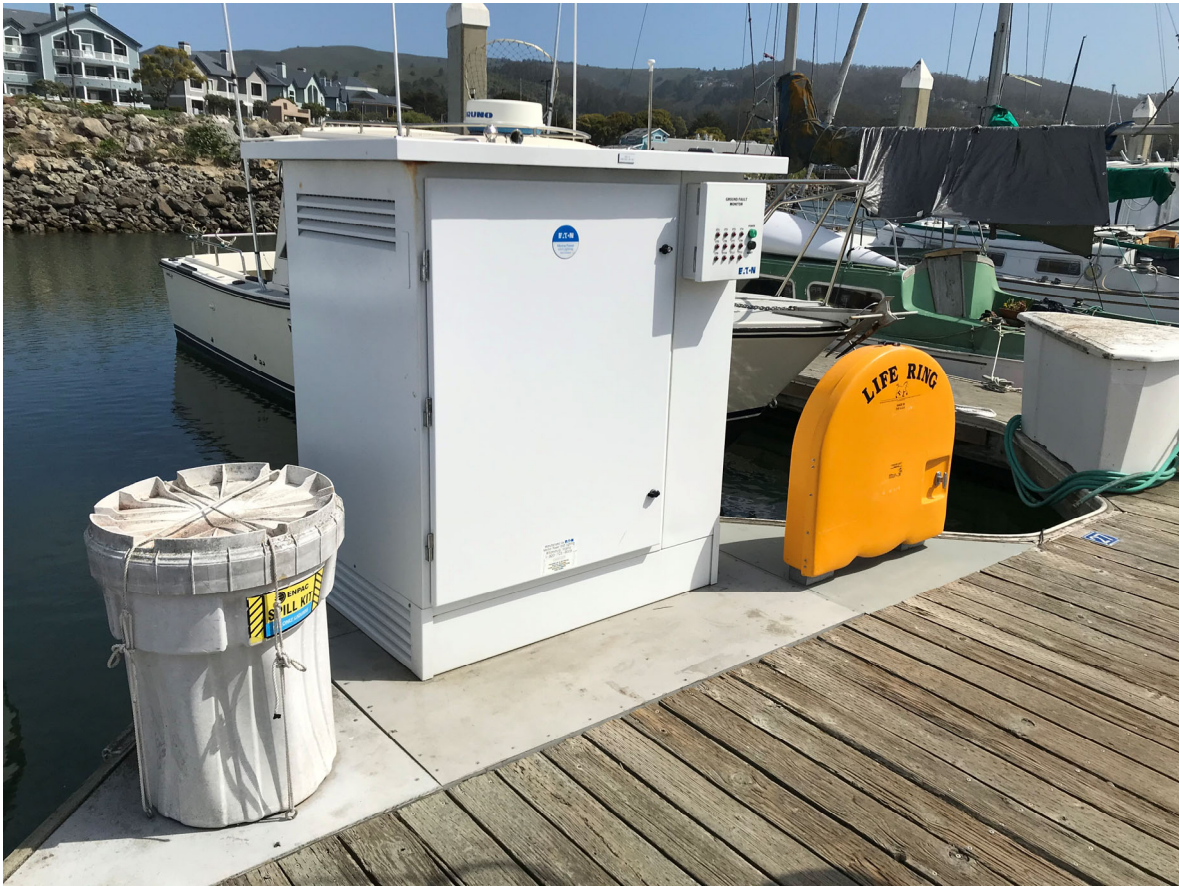
52 – View of Dock A-C upgraded electrical transformer

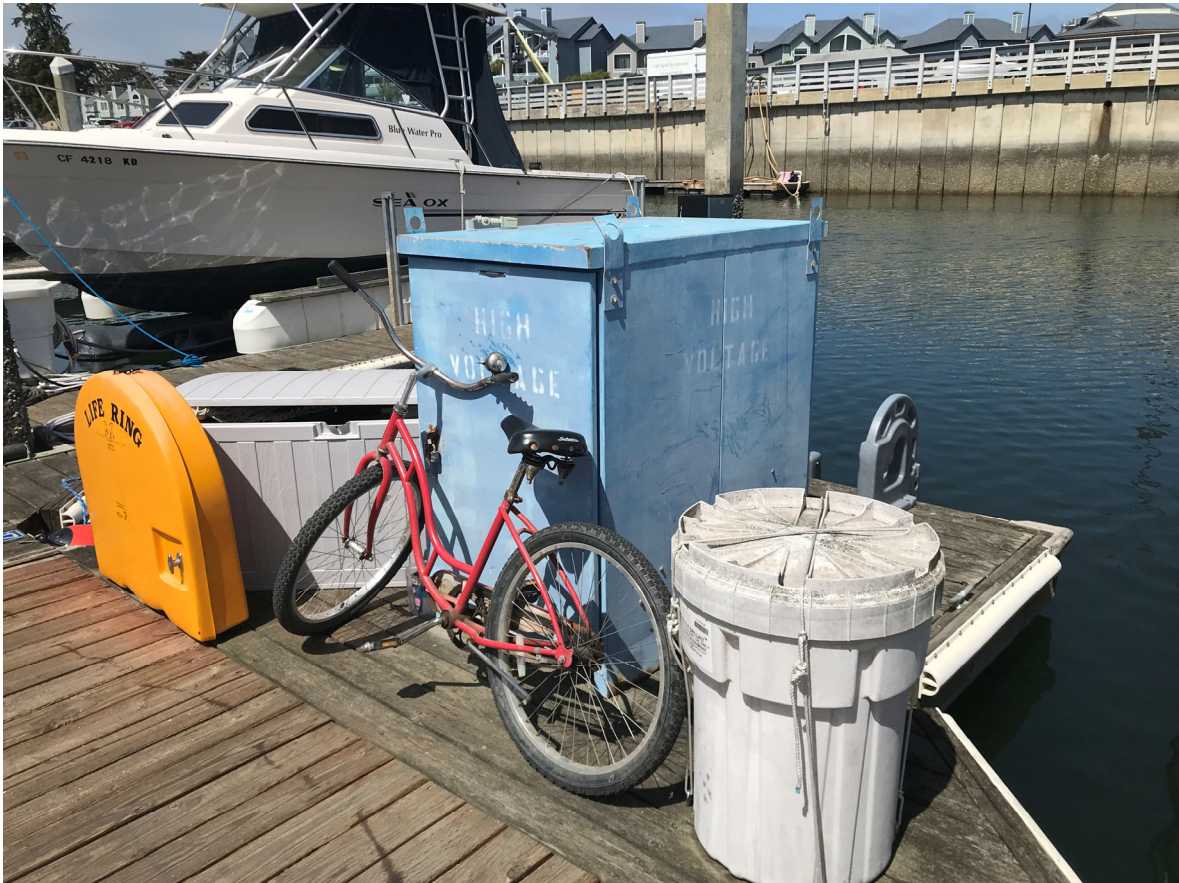
59 – View of electrical transformer on Dock D

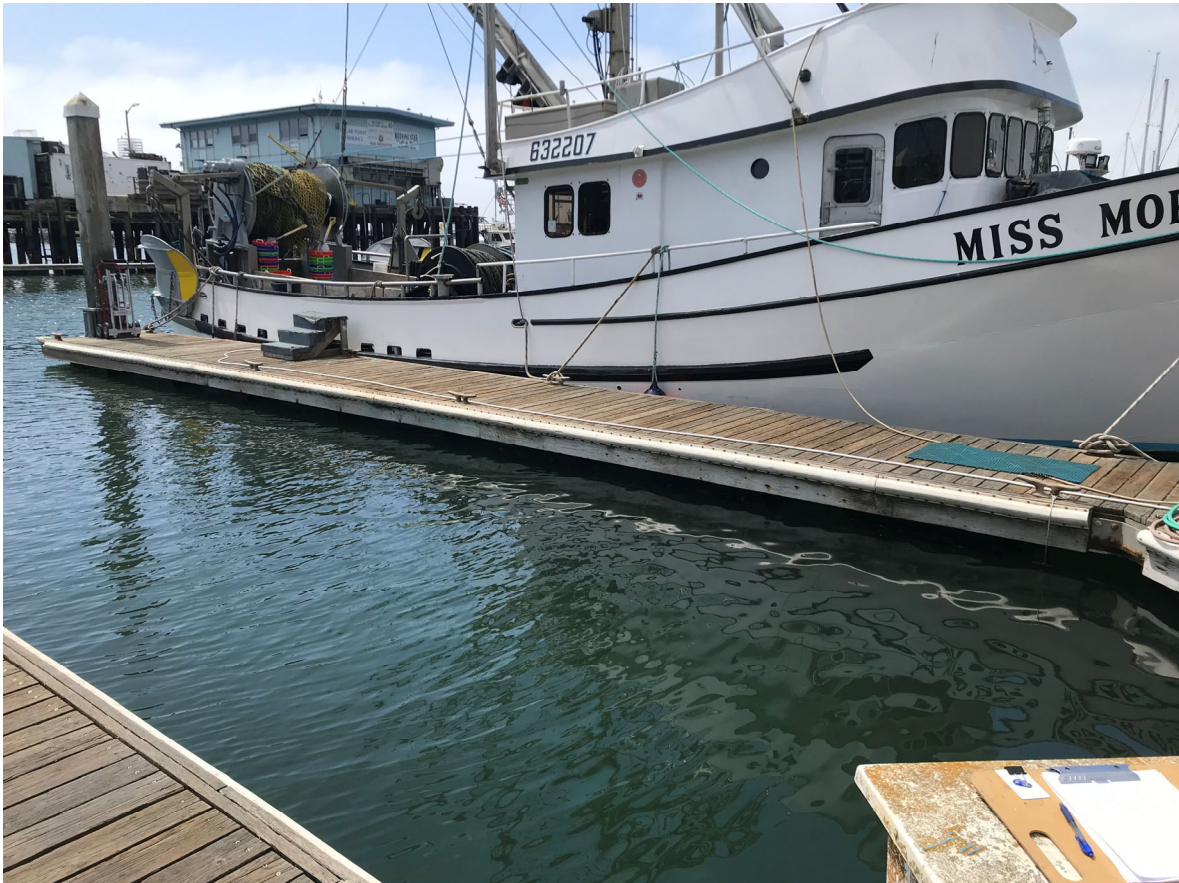
61 – View of typical Dock E finger

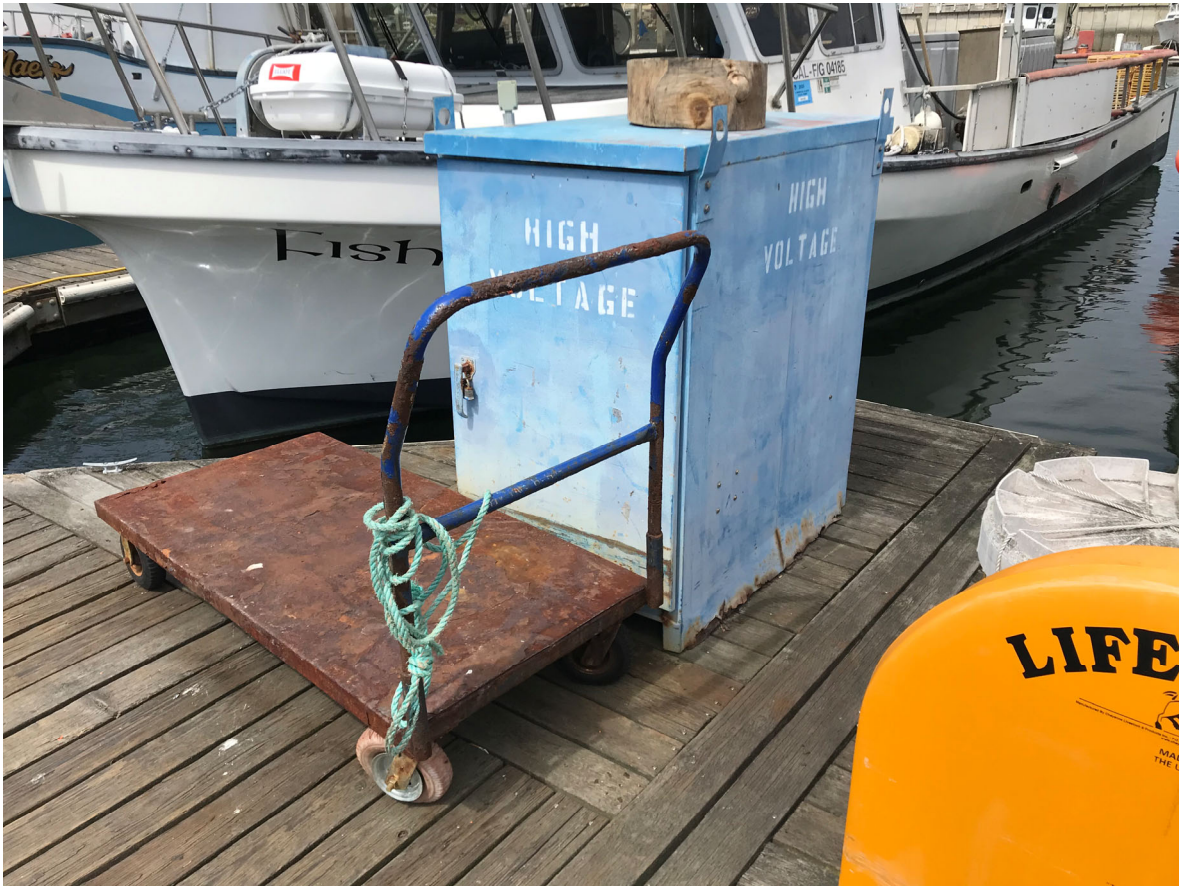
62 – View of Dock E electrical transformer

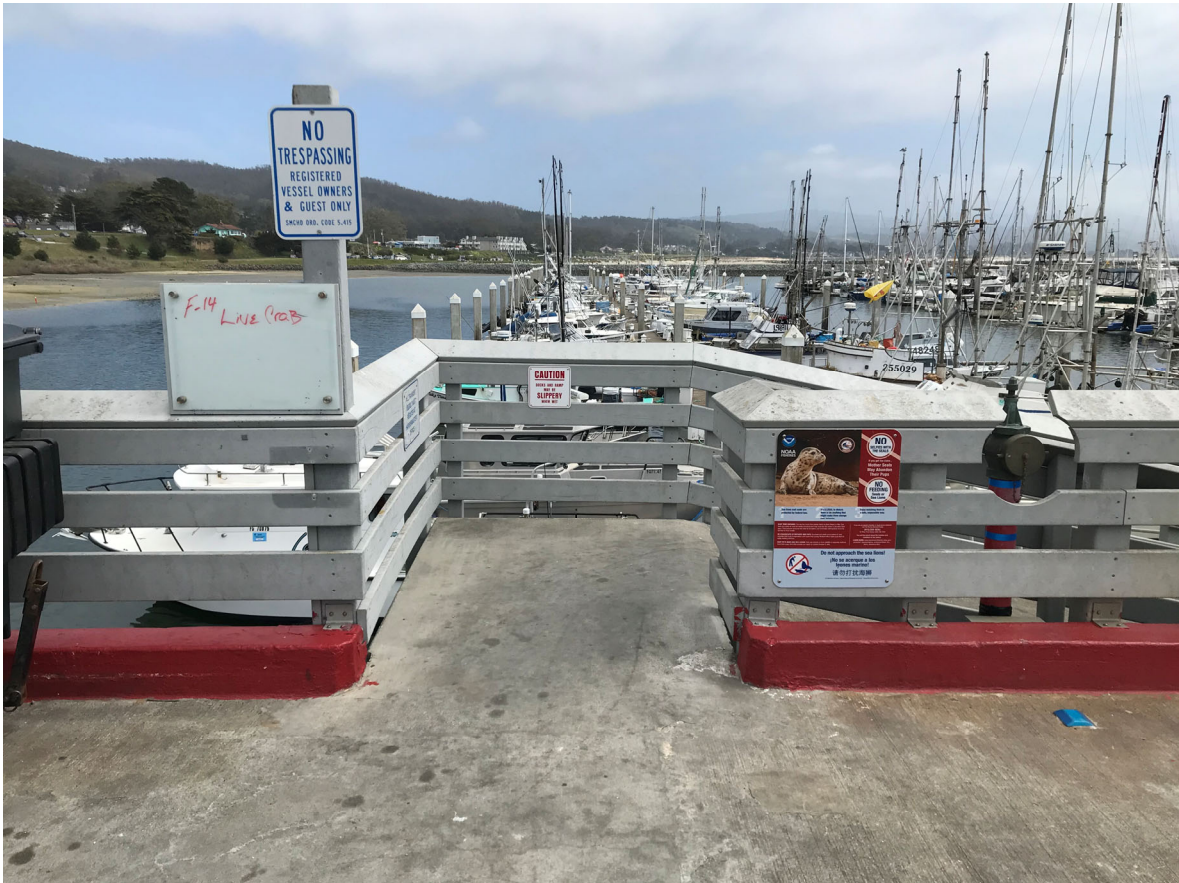
63 – View of entrance to Dock F

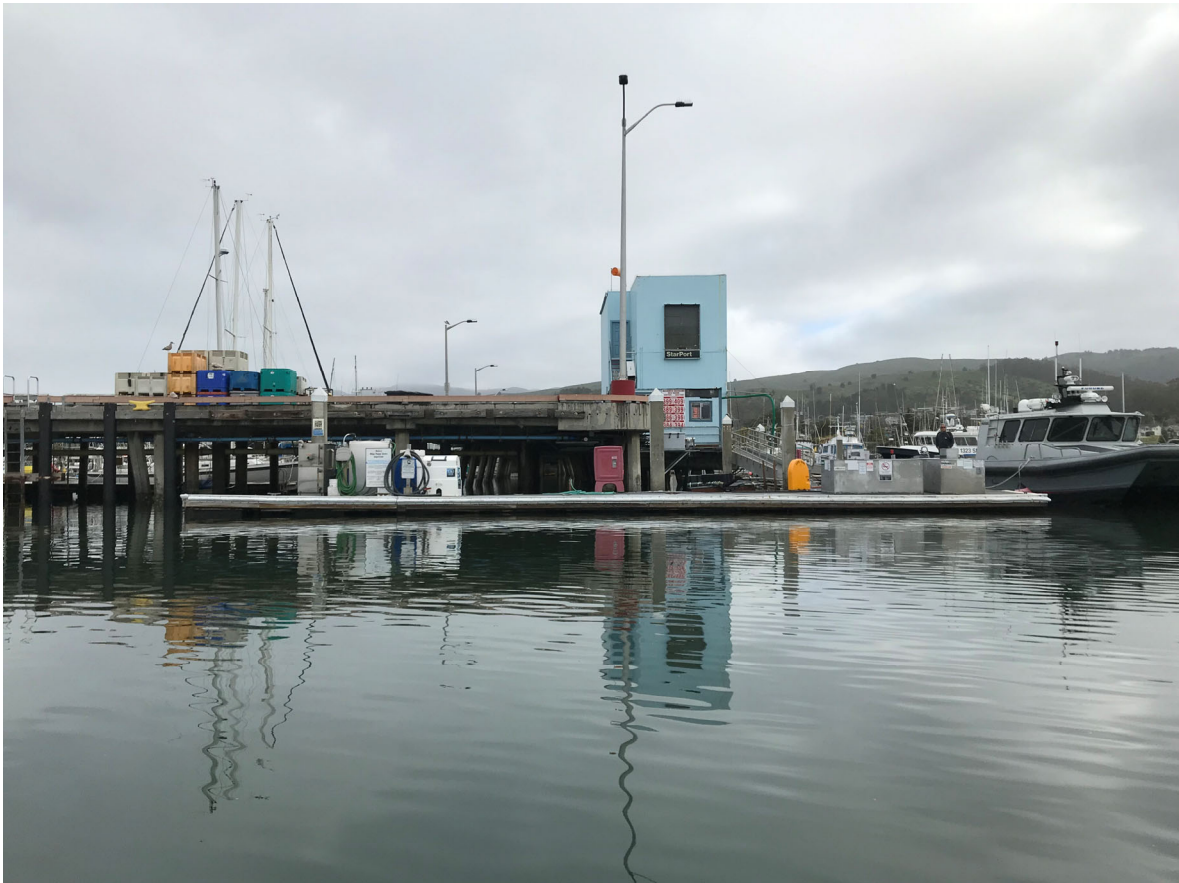
71 – View of Fuel Dock from water

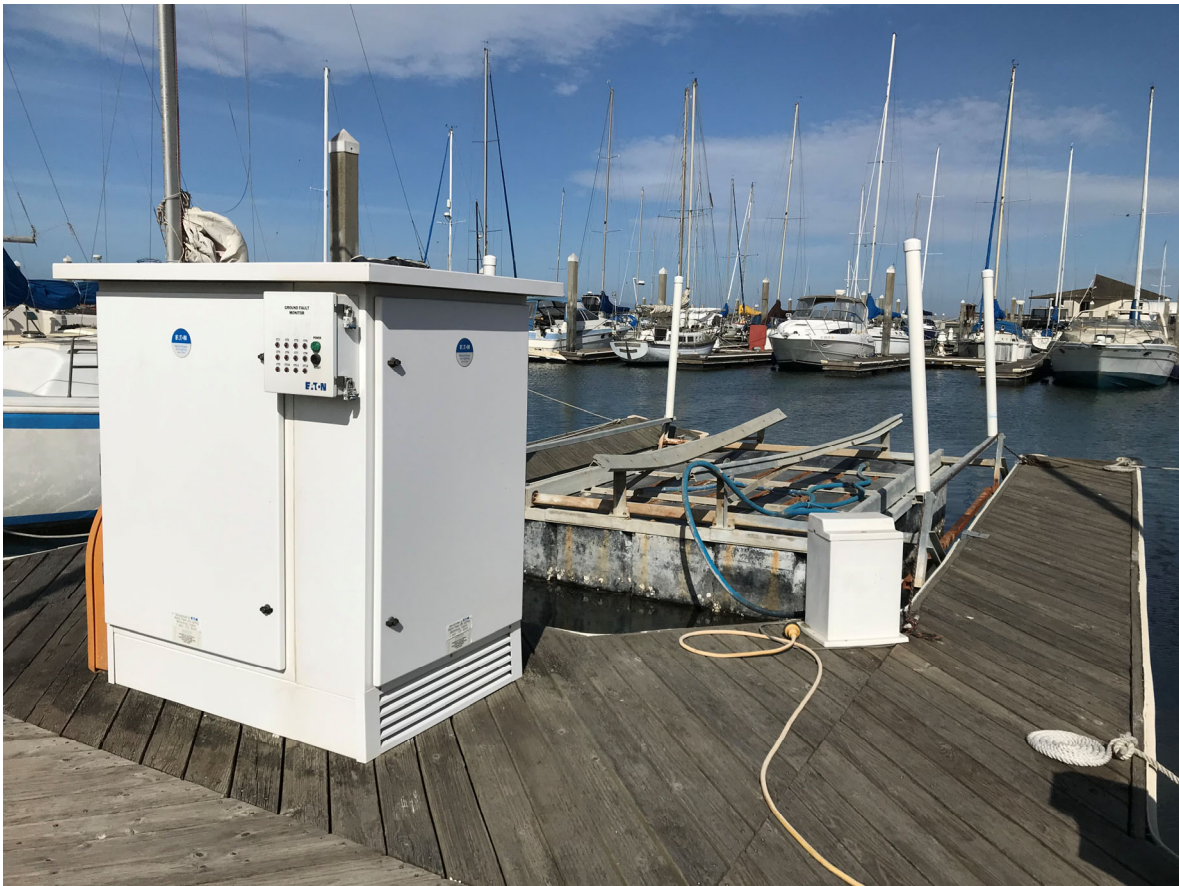
15 – View of Dock 4 electrical transformer and finger
