Pillar Point Harbor

Updated Marina Facility Condition Survey Report

Prepared for:
San Mateo County
Harbor District

May 2021

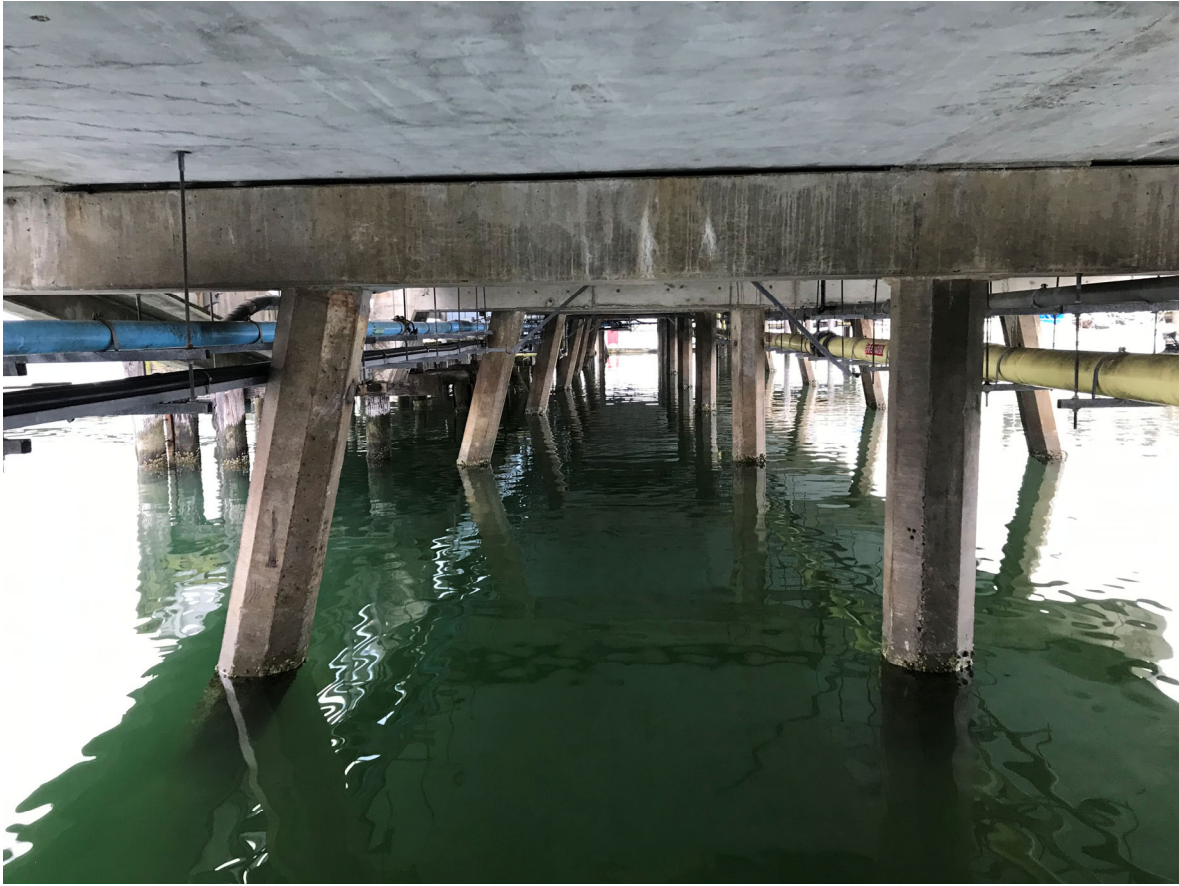
- Support Piles and Pile Bents – The majority of piles and pile bents are in “good” condition; some of the reinforced concrete beams (or bents) supporting portions of the deck at the end of the pier were noted to be in “poor” condition and in need of repair in the next 5 to 10 years due to overstressing by excessive loading, and one pile under Fish Buyer Building noted to also be in “poor” condition and in need of repair in the next 5 to 10 years
- Decking and Bullrail – Well maintained and in “good” condition
- Railing – Relatively new plastic lumber and well maintained in “good” condition
- Pier Utilities – Recently renovated under pier and well maintained in “good” condition

6 – View of support piles, deck, bents and utilities under pier

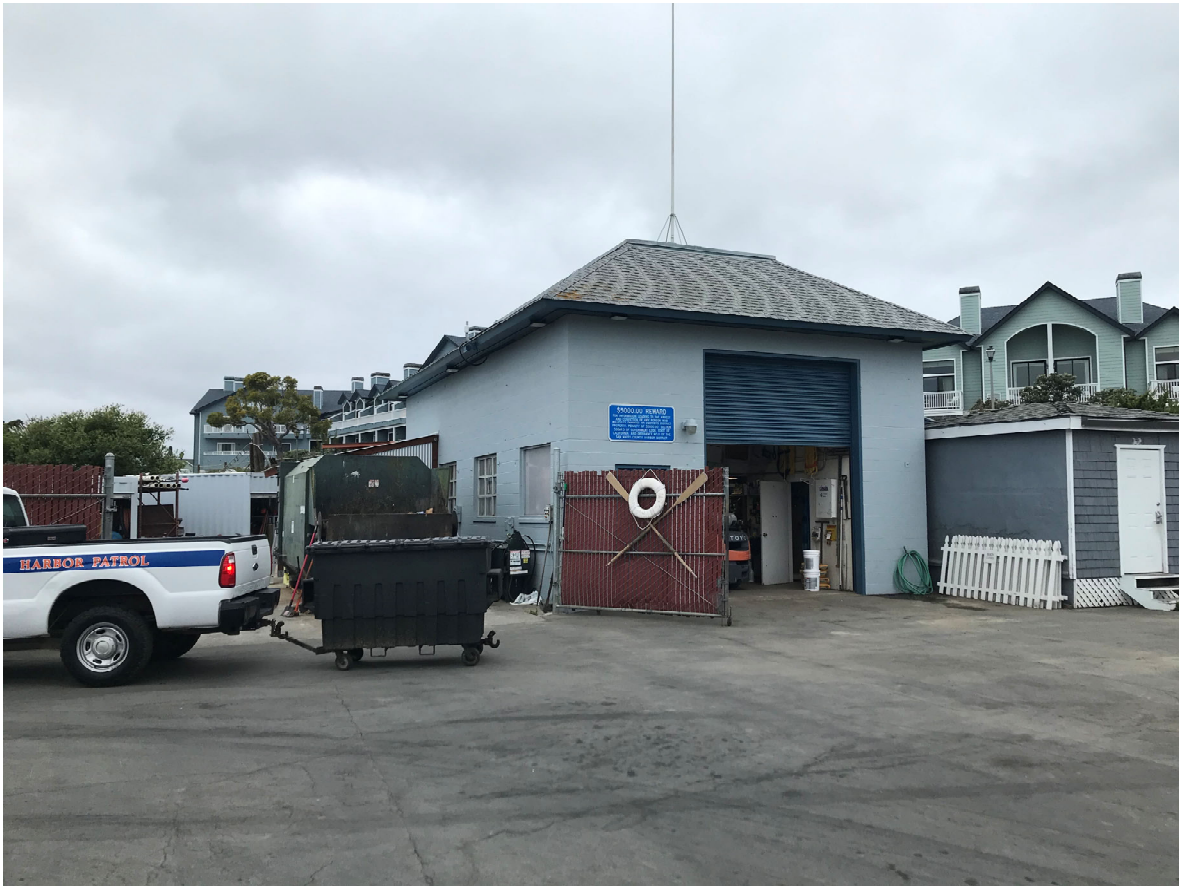
- Maintenance Building – New paint and exterior doors, well maintained and noted to be in overall “satisfactory” condition with a remaining useful life of 20 to 30 years

28 – View of Maintenance Building

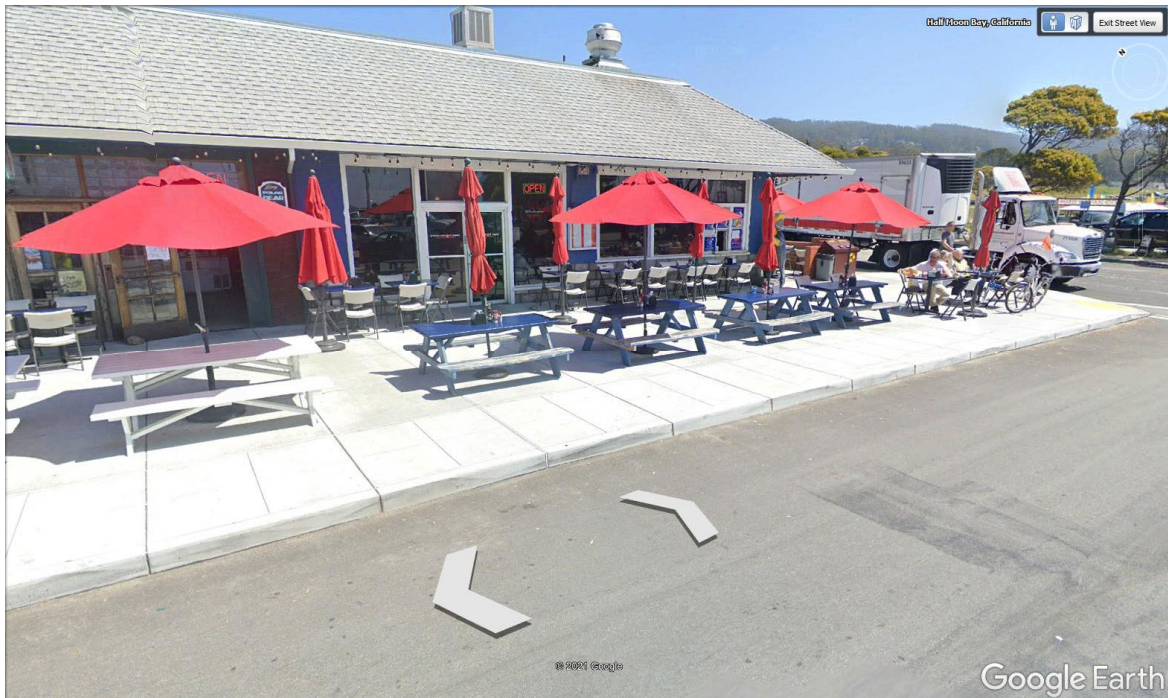
- Tenant Row Building – In overall “fair” condition structurally with a remaining useful life of 10 to 20 years before needing major renovations; interior upgrades tenant responsibility

34 – View of Tenant Row Building extended patio seating (Google Earth Pro)

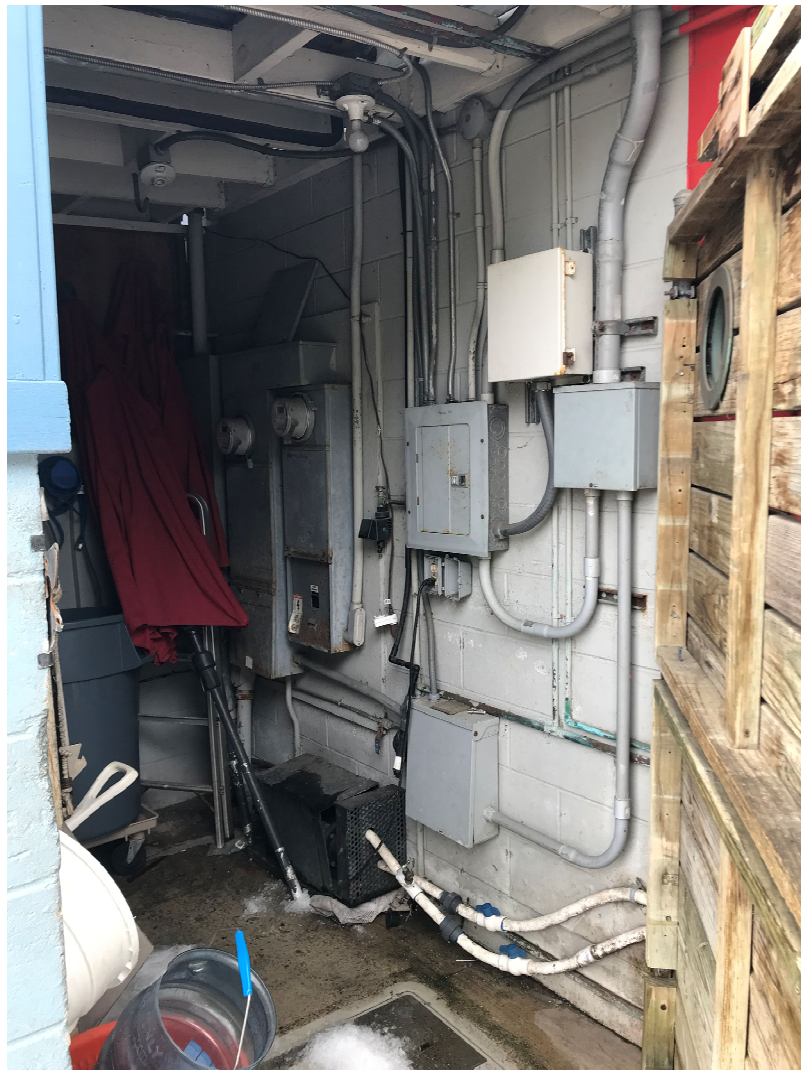
35 – View of Tenant Row Building electrical panels and storage area

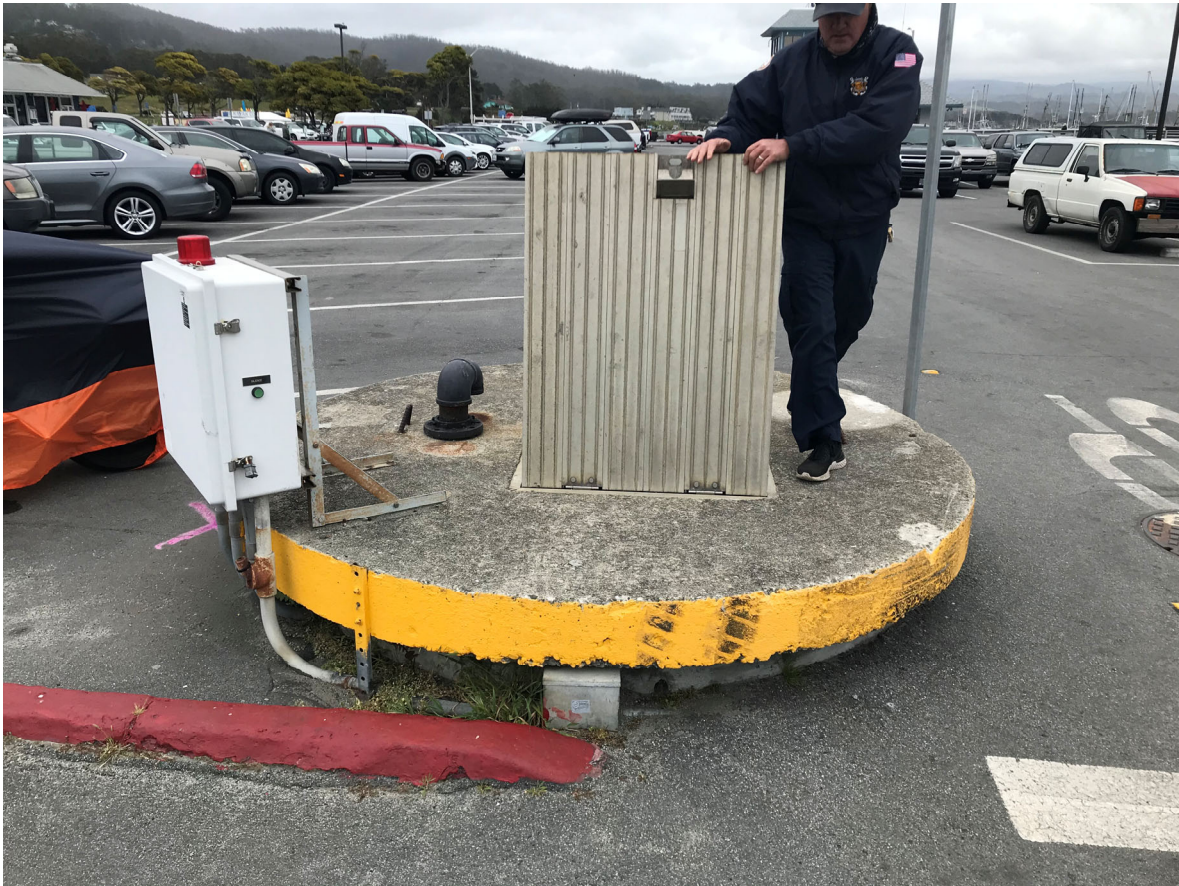
36 – View of sewer lift station in Parking Lot A

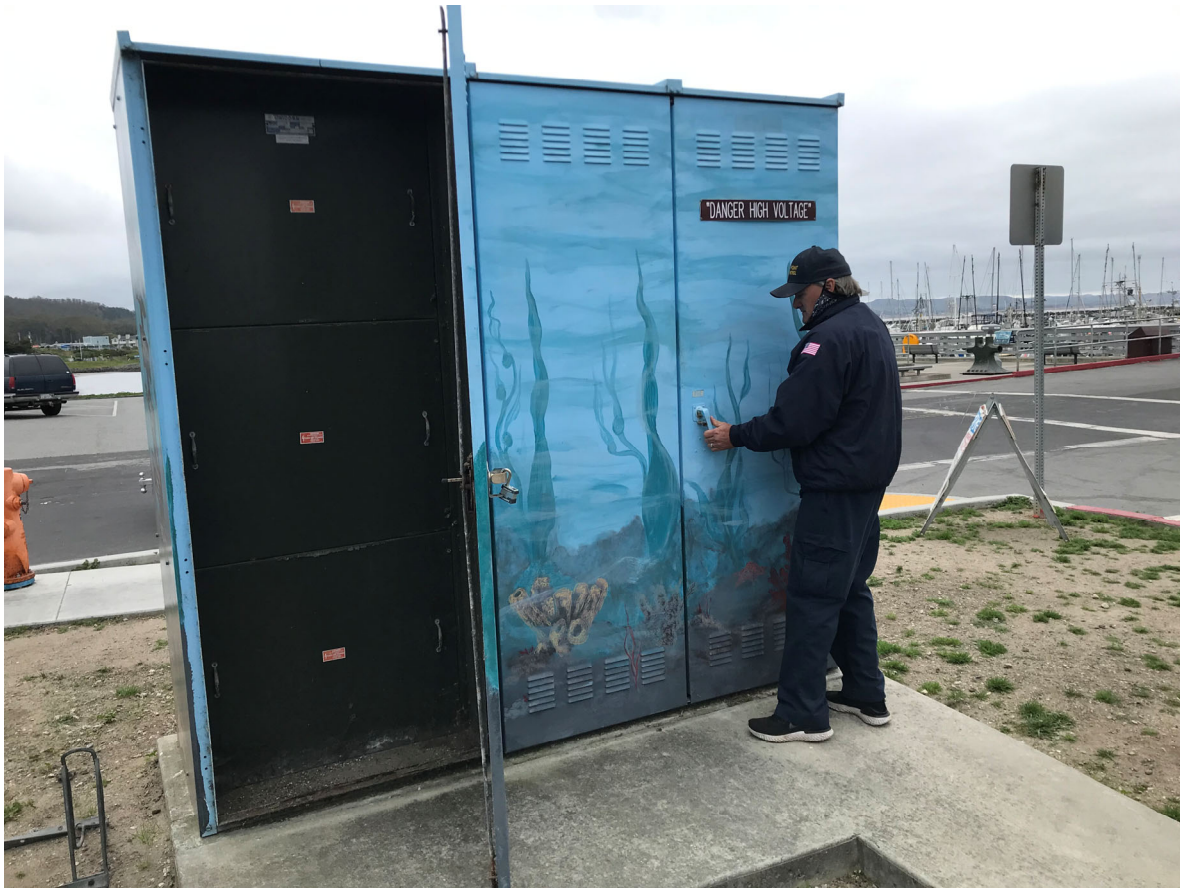
38 – View of main harbor distribution panel from Edison transformer

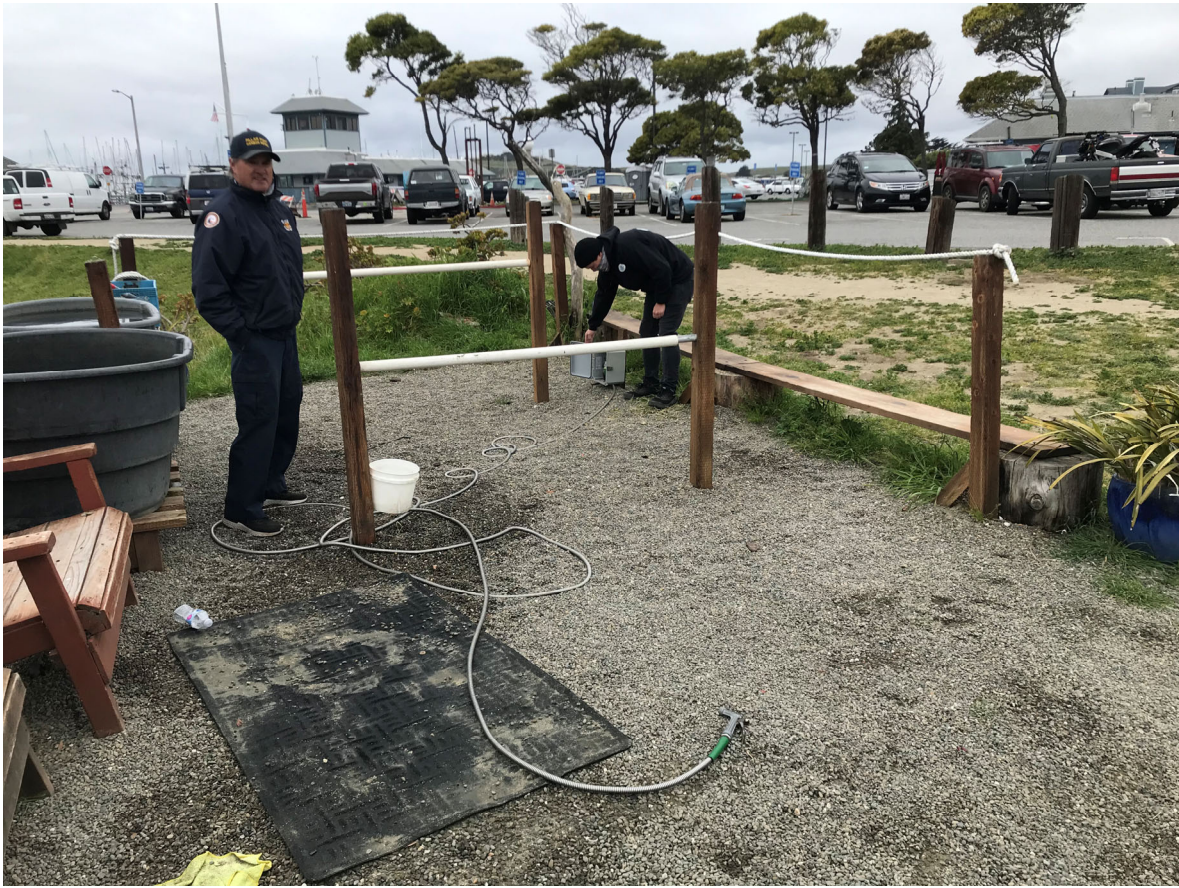
40 – View of kayak and SUP washdown area

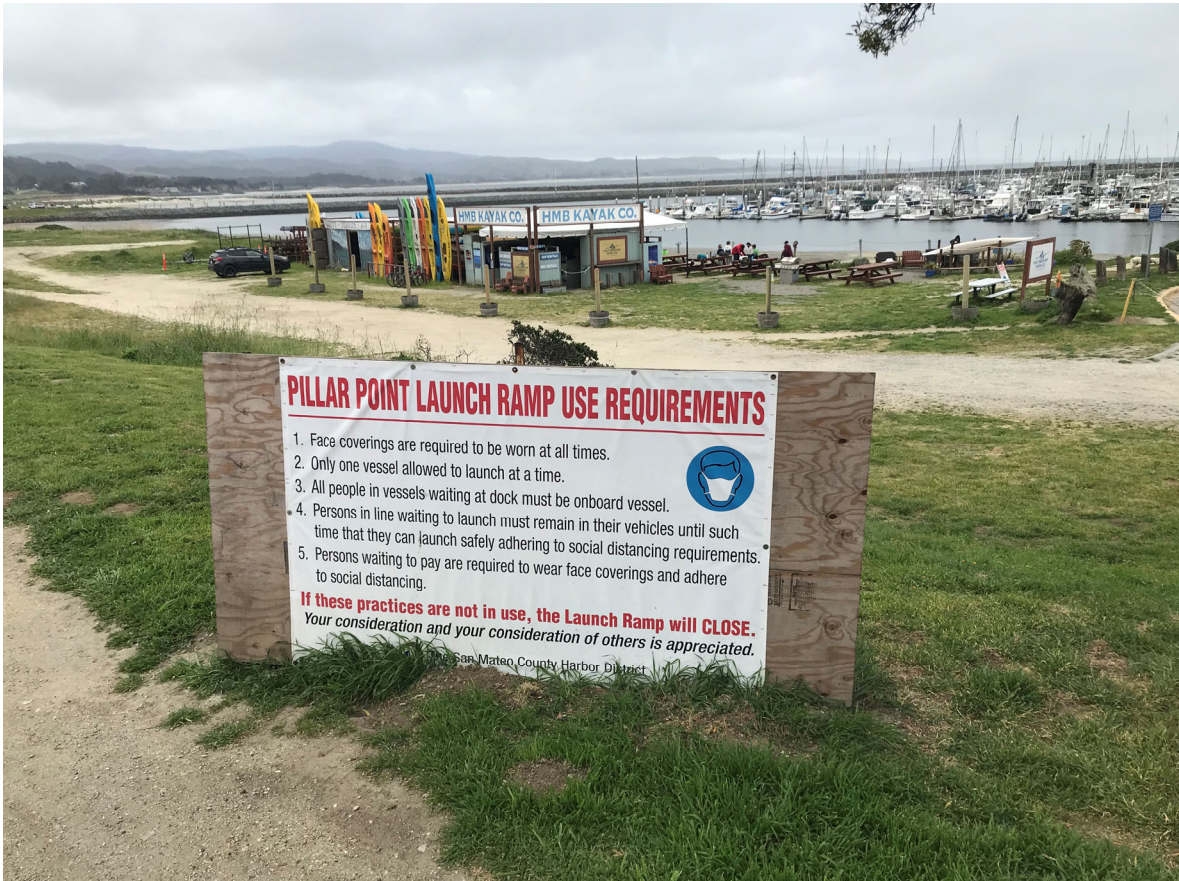
41 – View of kayak and SUP rental and launch area

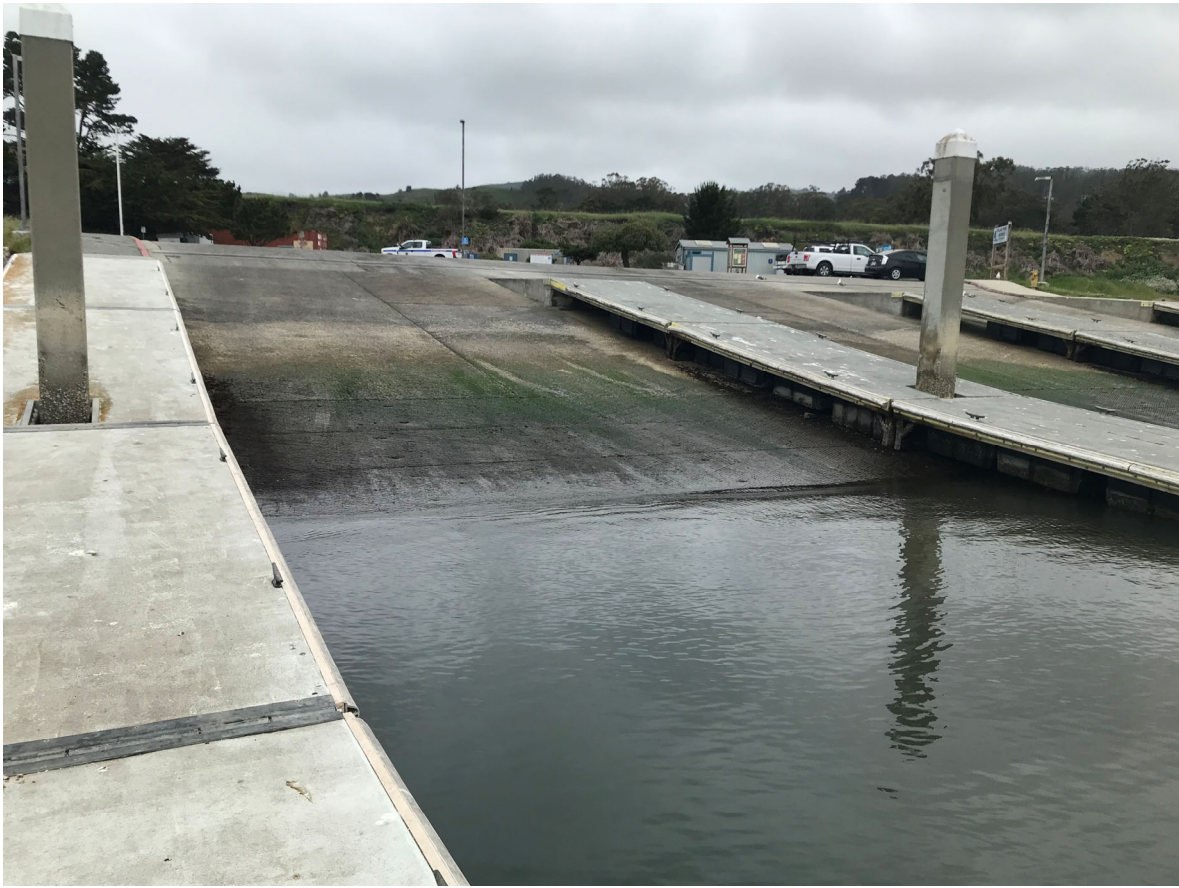
Boat Launch Ramp - Surface and boarding float docks were observed to be in “fair” condition with an anticipated remaining useful life 10 to 20 years, and the concrete pavement at the top of ramp is considered to be in “poor” condition with an anticipated remaining useful life of 5 to 10 years before needing replacement. The asphalt concrete roadway from the launch ramp to the boat trailer parking area is more heavily degraded and considered to be in “serious” condition with an anticipated remaining useful life of 2 to 5 years before needing replacement.

42 – View of boat launch ramp and boarding docks

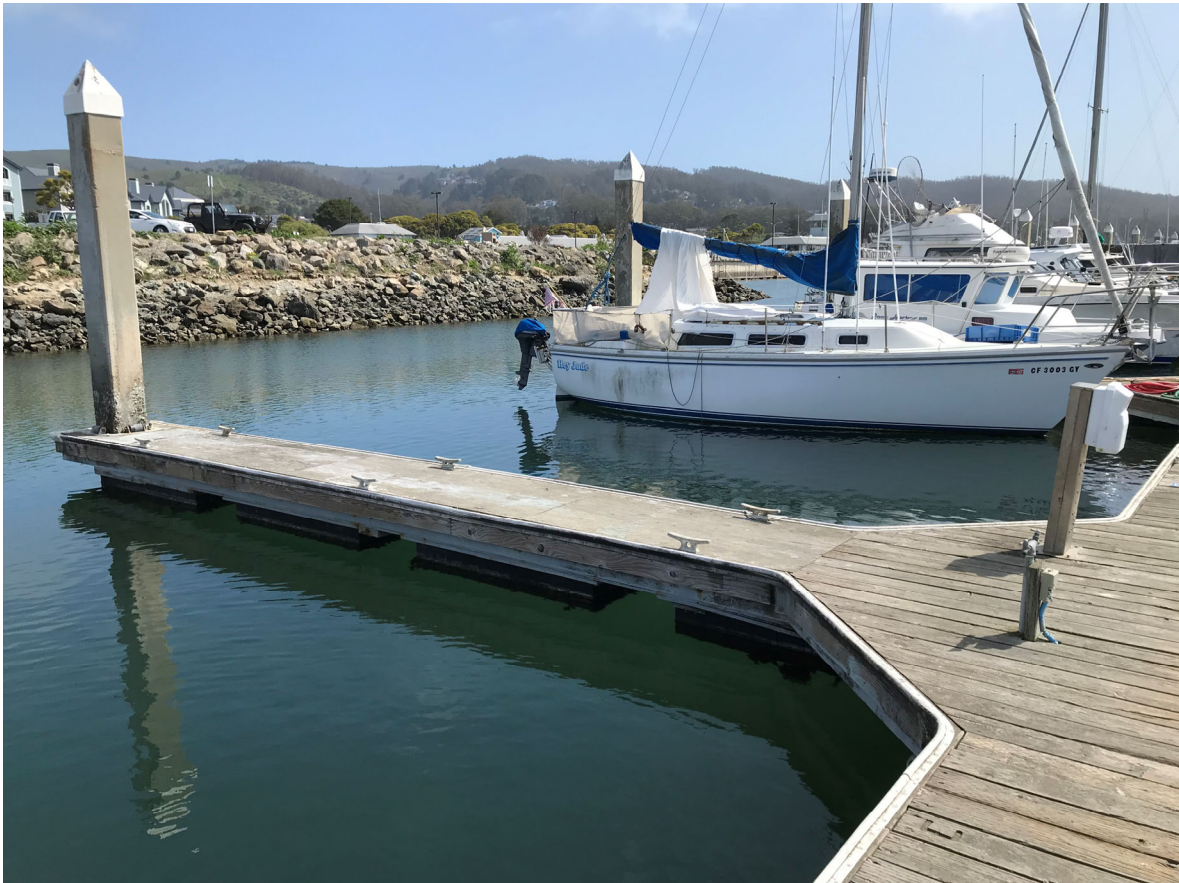
53 – View of typical Dock A finger

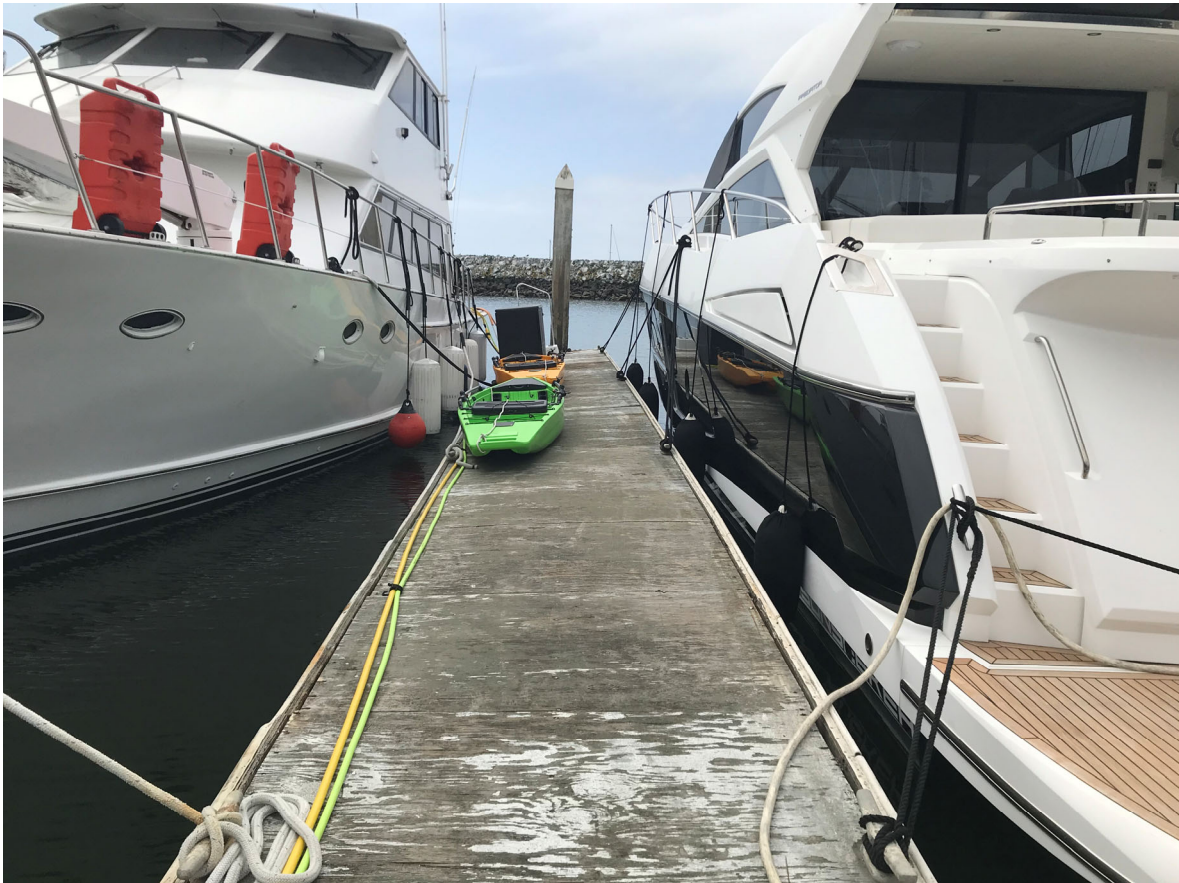
55 – View of typical Dock C finger

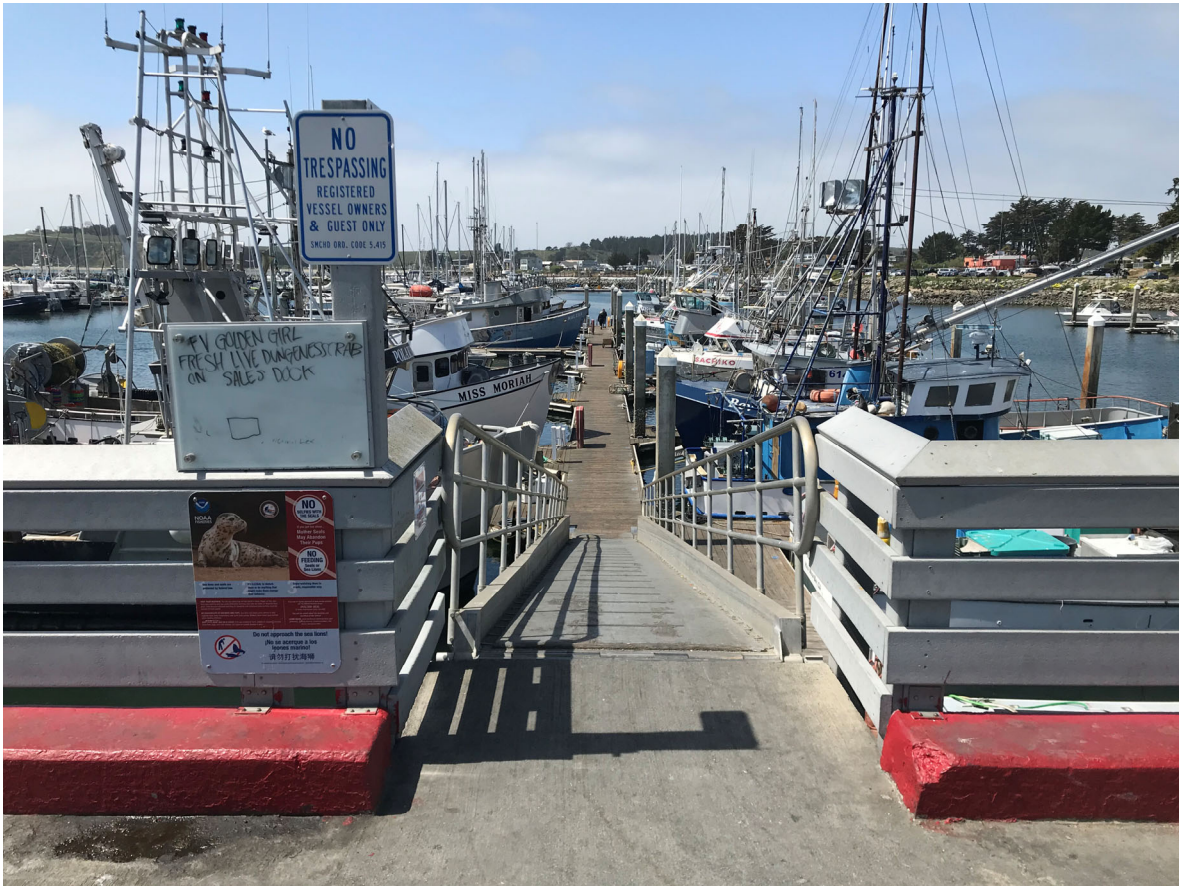
60 – View of entrance to Dock E

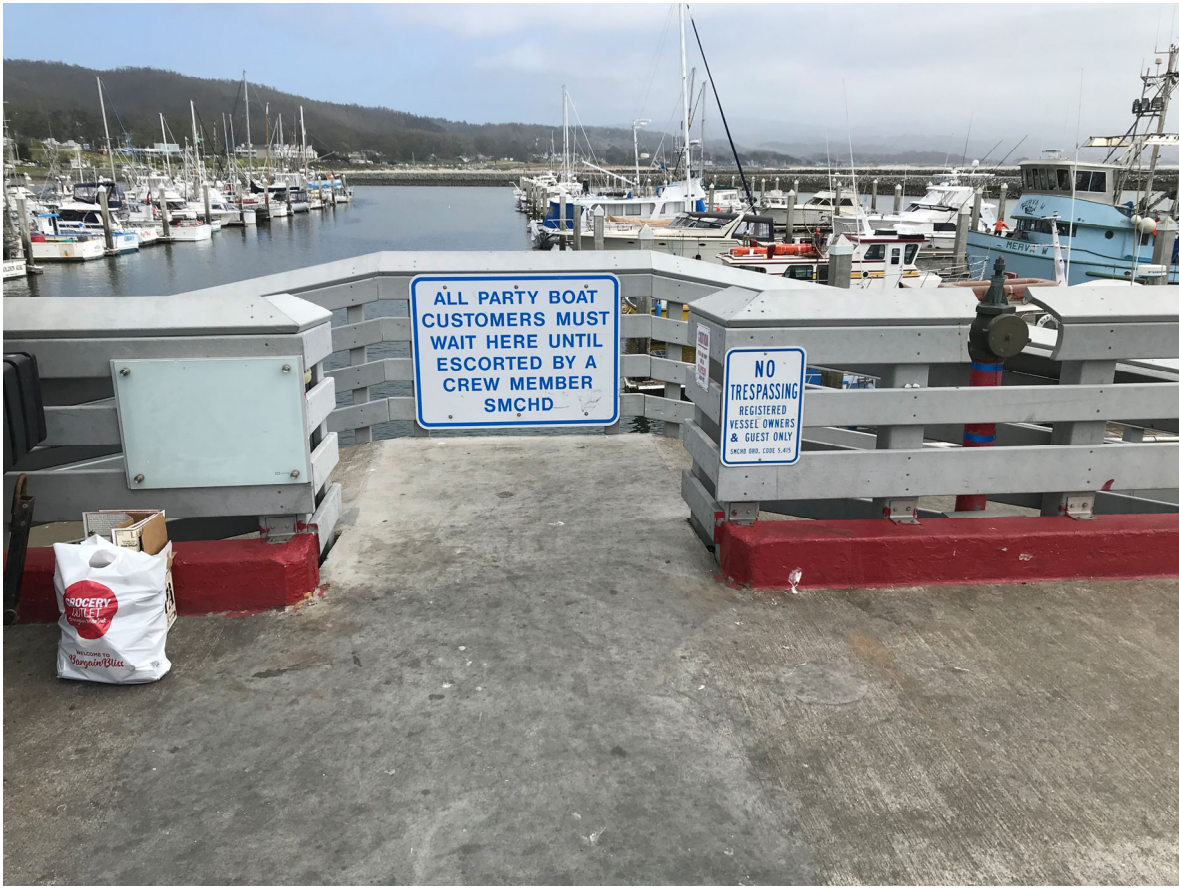
66 – View of entrance to Dock H

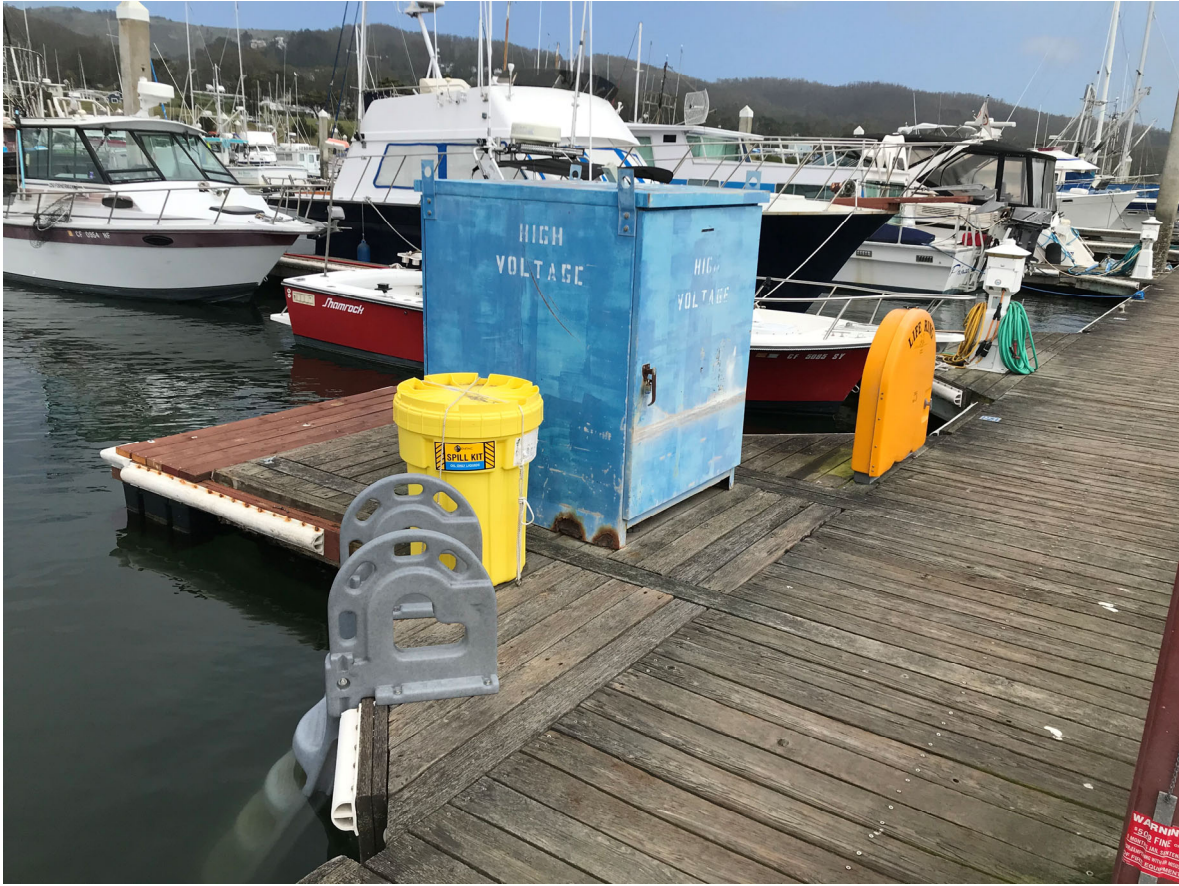
68 – View of Dock H electrical transformer

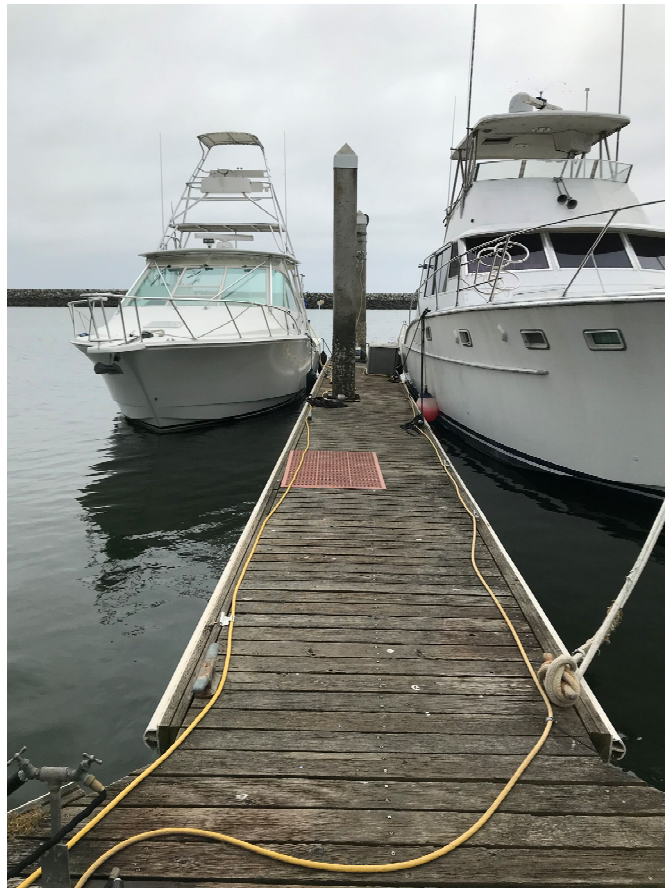
69 – View of typical Dock H finger

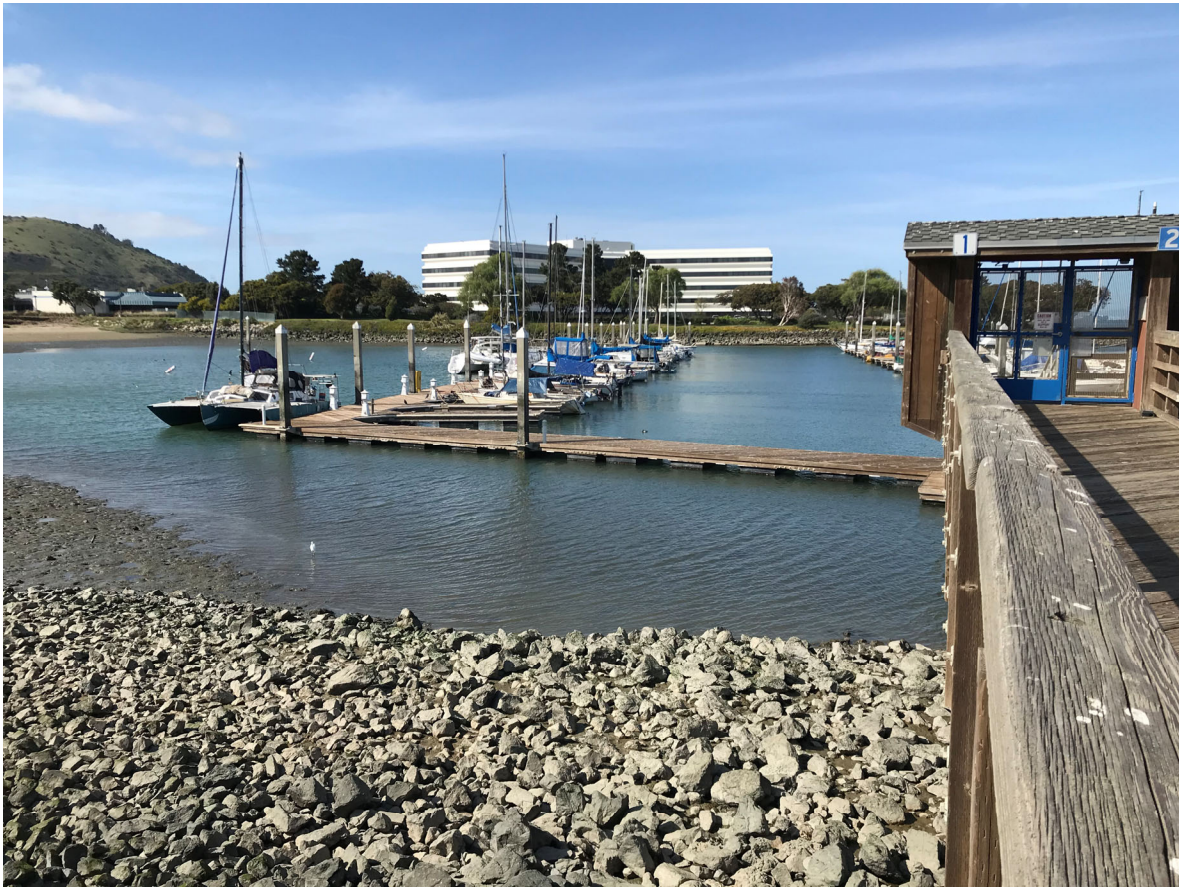
- West Basin – Public Docks 1 thru 6: Docks observed to be in “serious” to “poor” condition indicating a need of replacement within 10 years; upgraded electrical system, large percentage of slip fingers out of cross slope tolerance for walking surfaces

2 – View of West Basin Dock 1

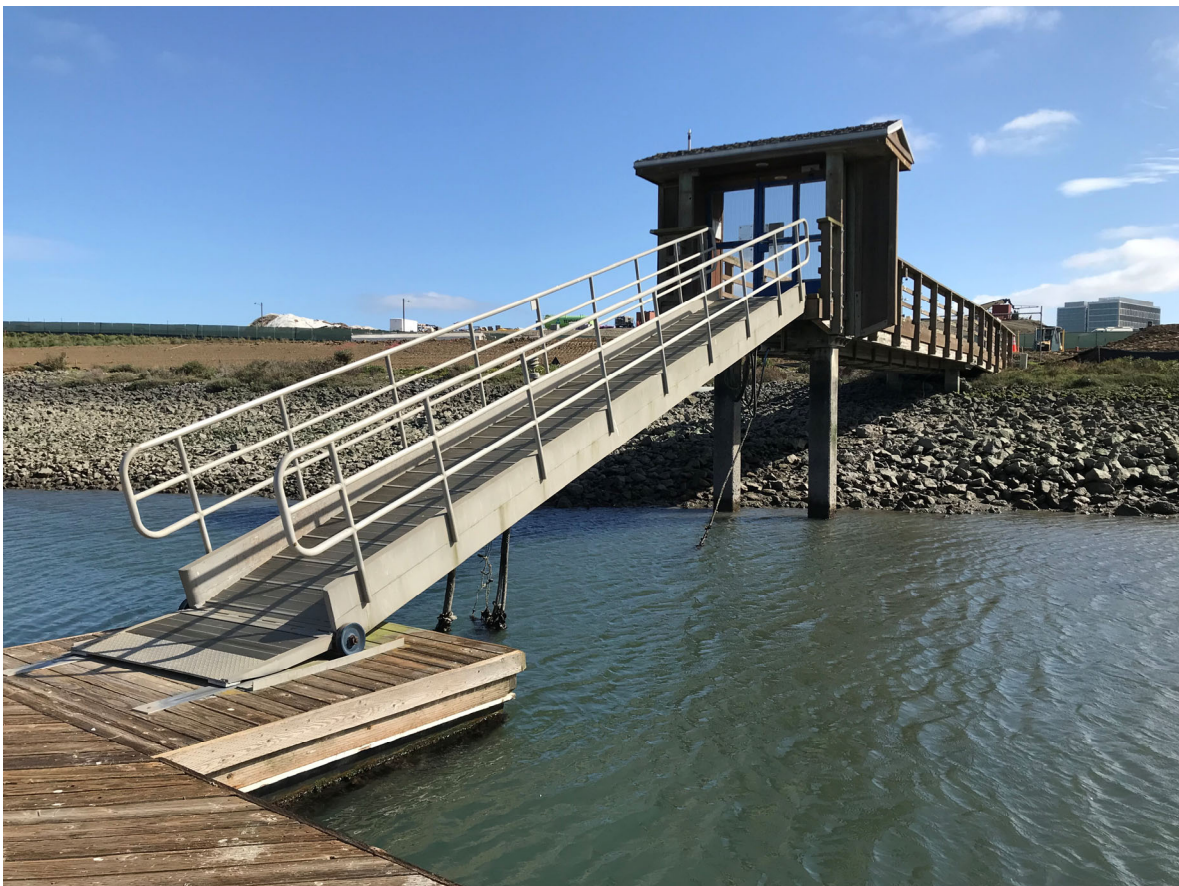
3 – View of West Basin Docks 1 and 2 Gangway Platform

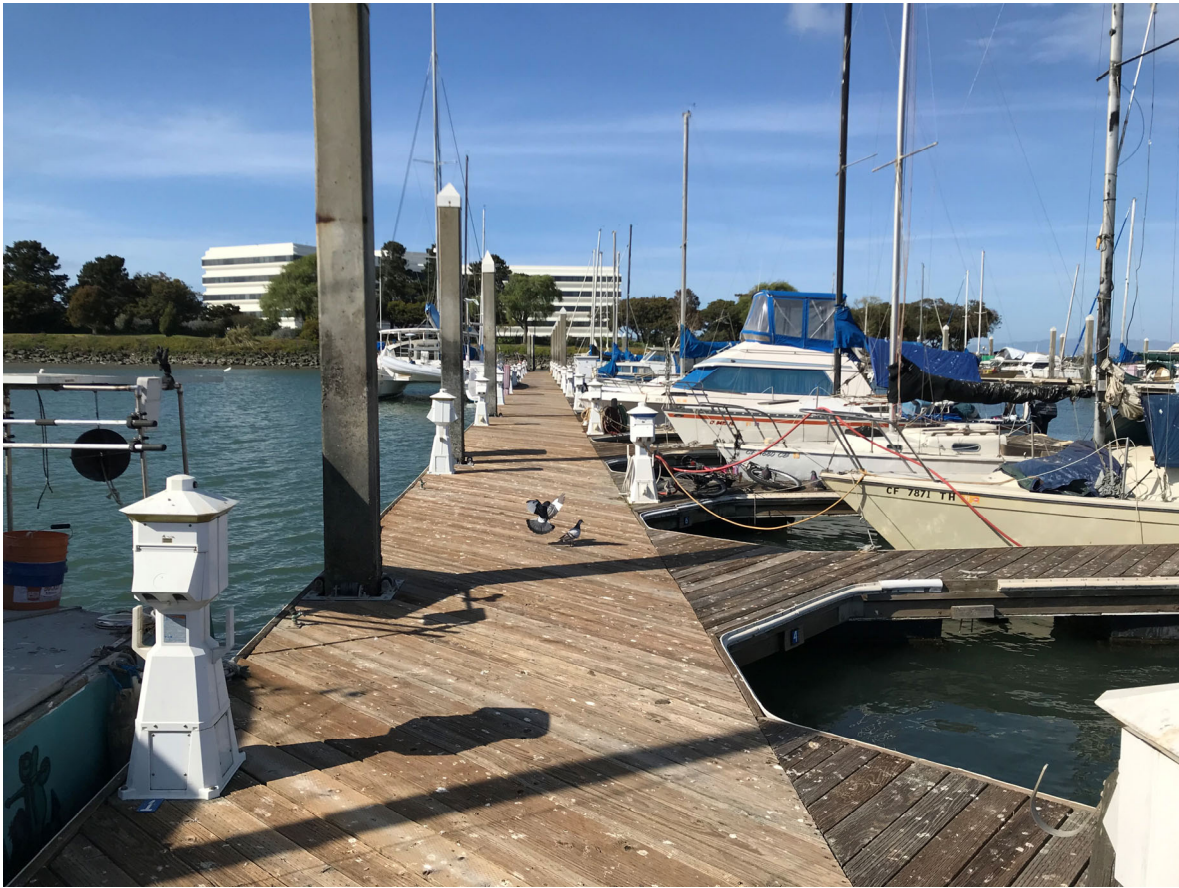
4 – View of West Basin Dock 1

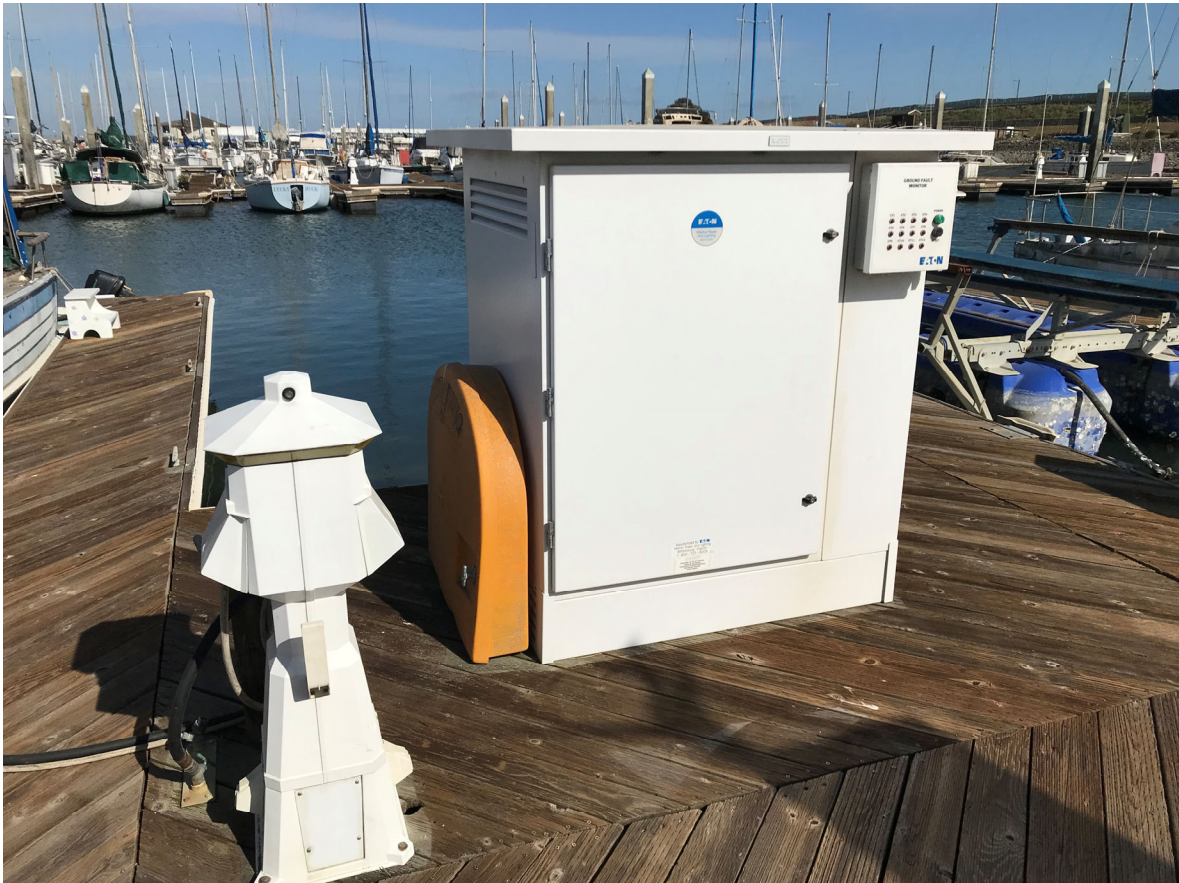
5 – View of Dock 1 finger and utilities

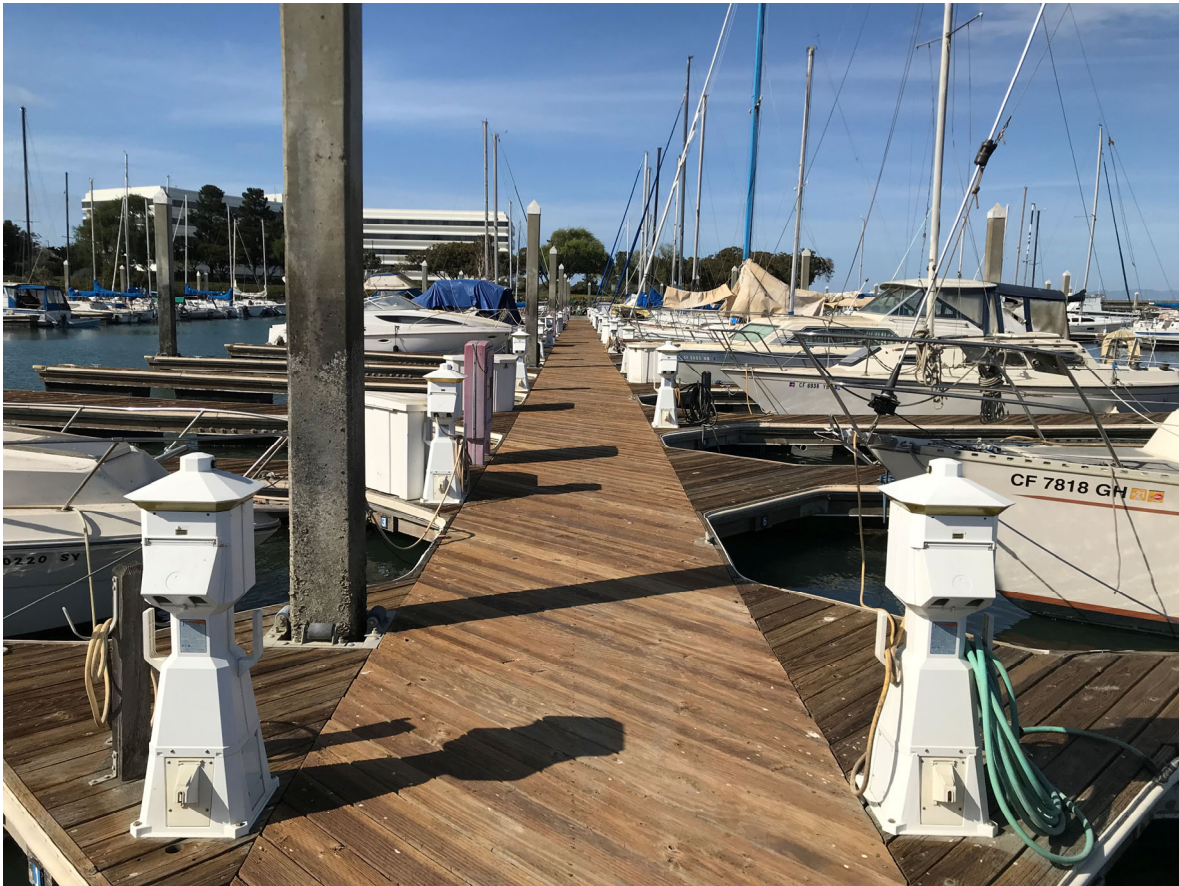
6 – View of West Basin Dock 2

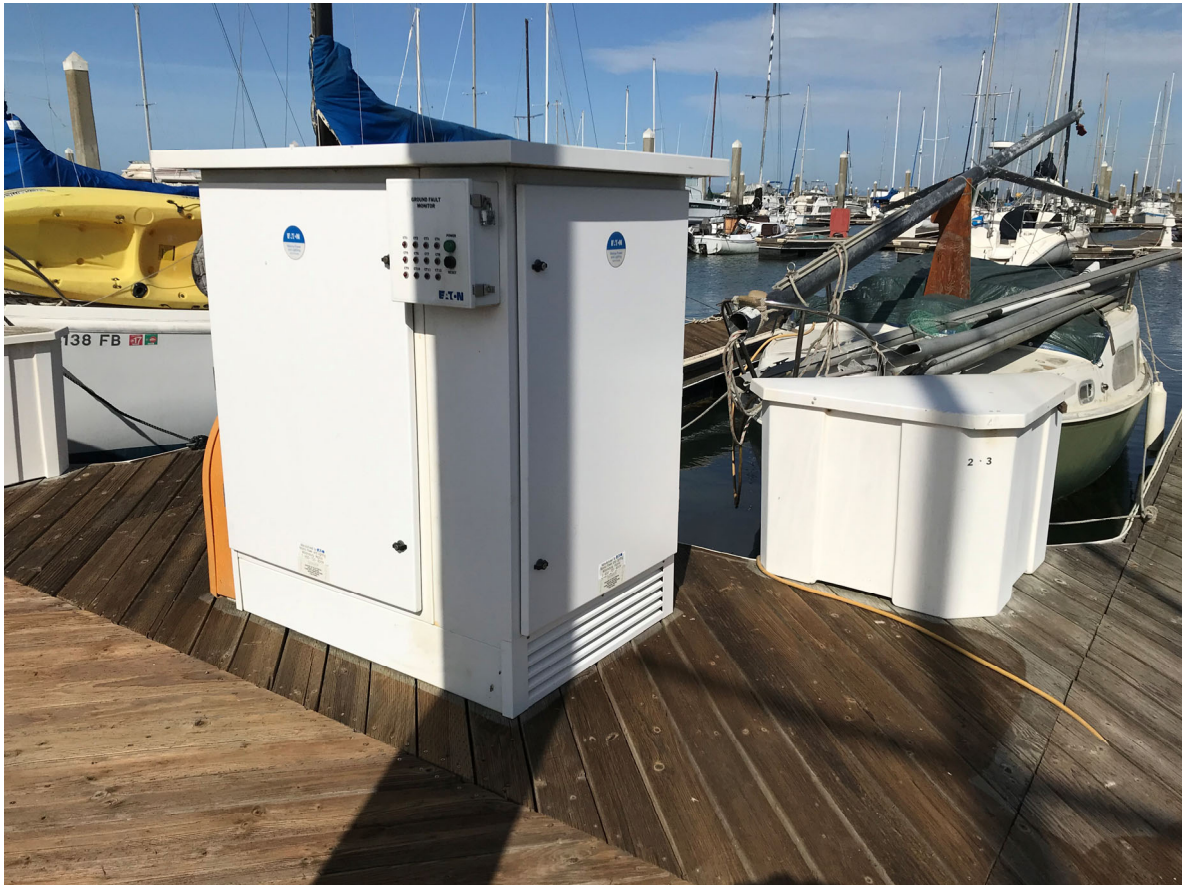
7 – View of West Basin Dock 2 transformer

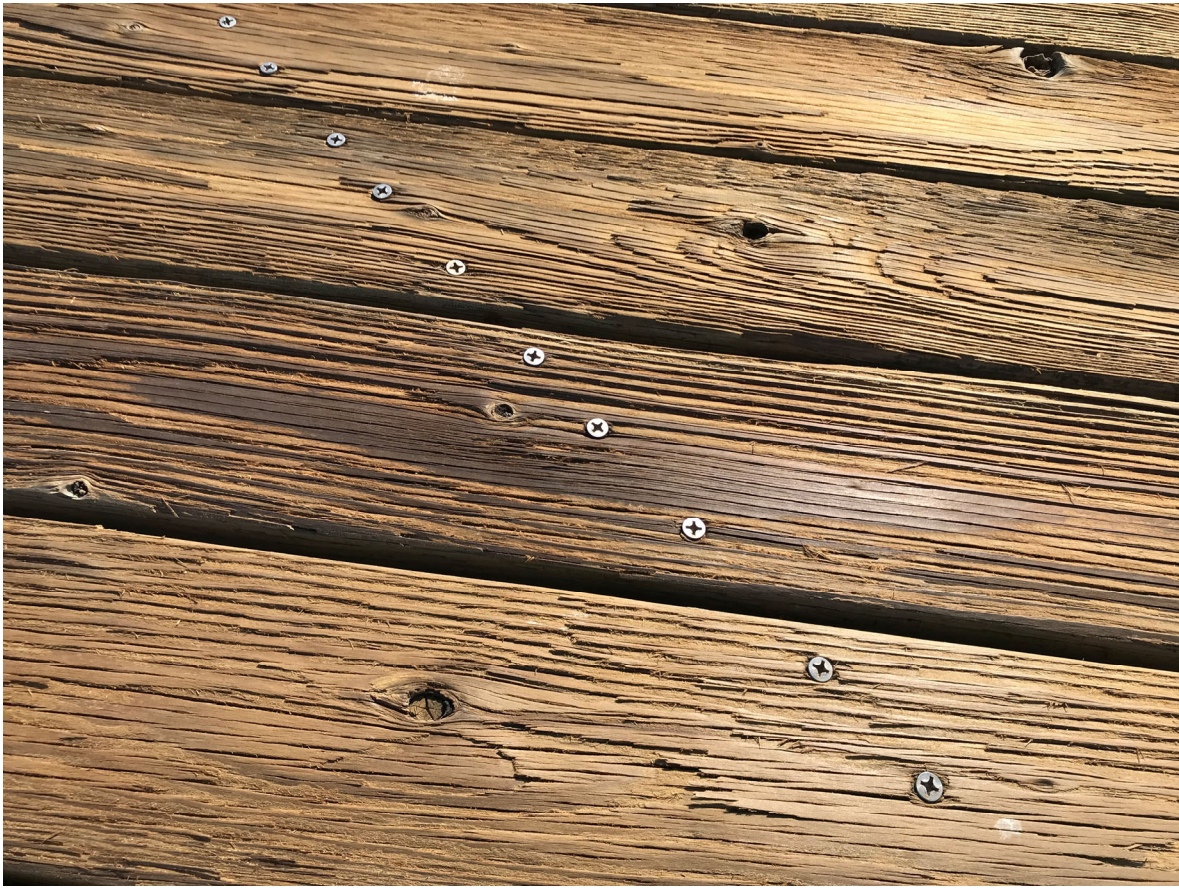
8 – View of stainless steel deck screw on Dock 2
