Pillar Point Harbor

Updated Marina Facility Condition Survey Report

Prepared for:
San Mateo County
Harbor District

May 2021

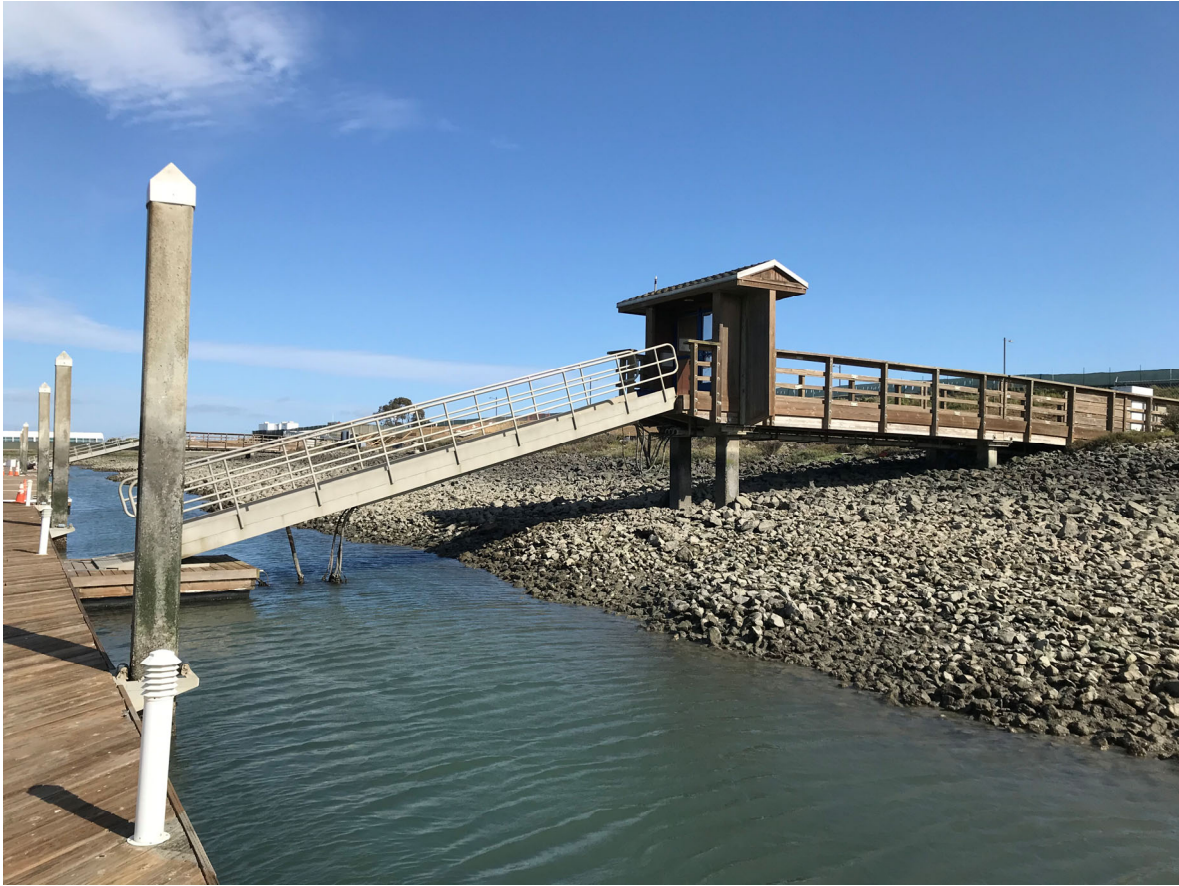
10 – View of West Basin Docks 3 and 4 Gangway Platform

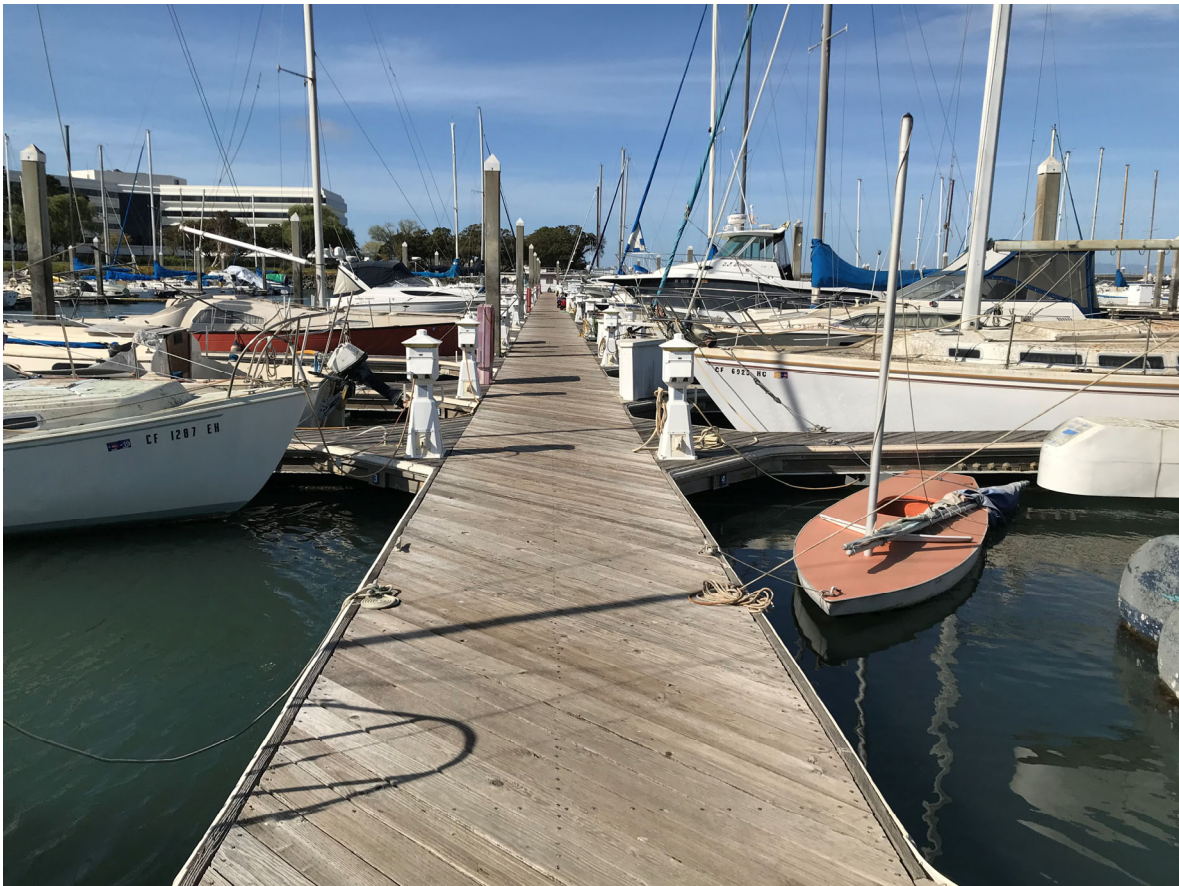
11 – View of West Basin Dock 3

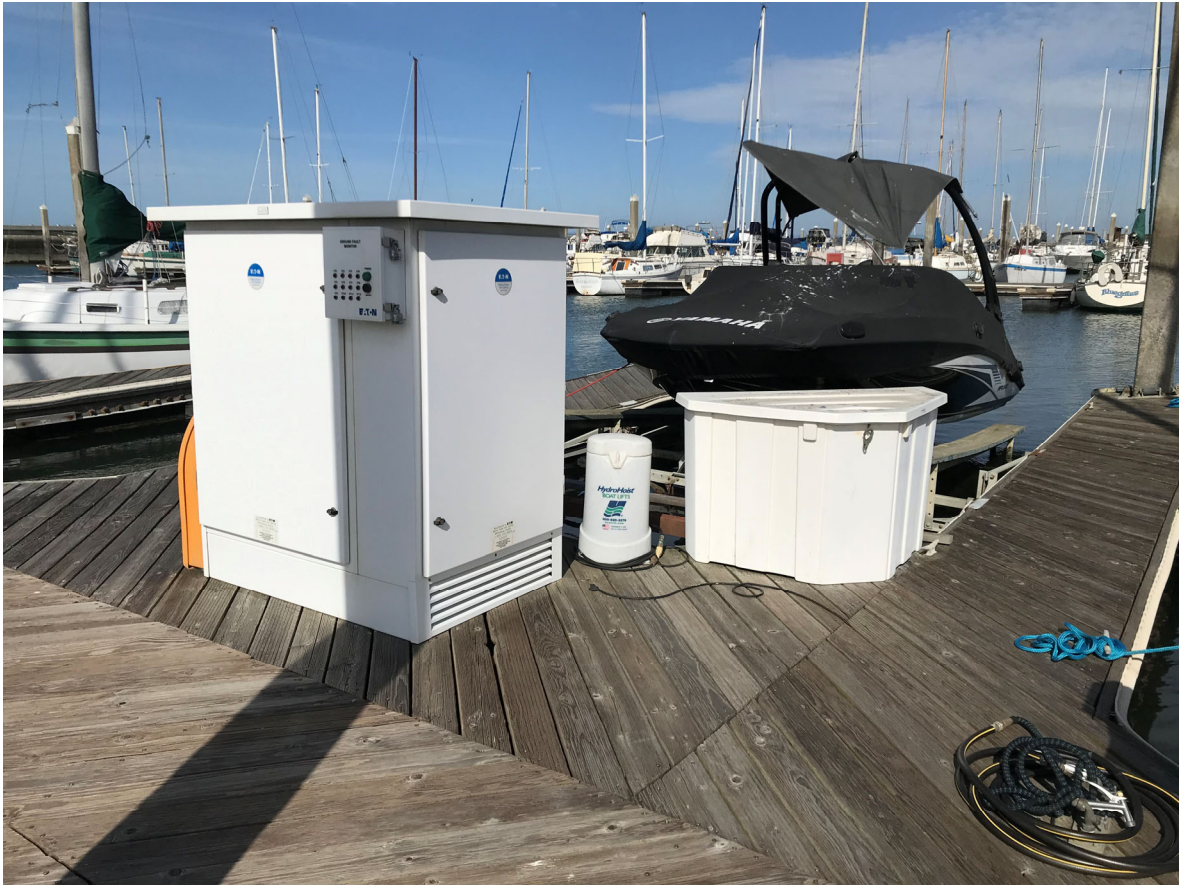
12 – View of Dock 3 electrical transformer

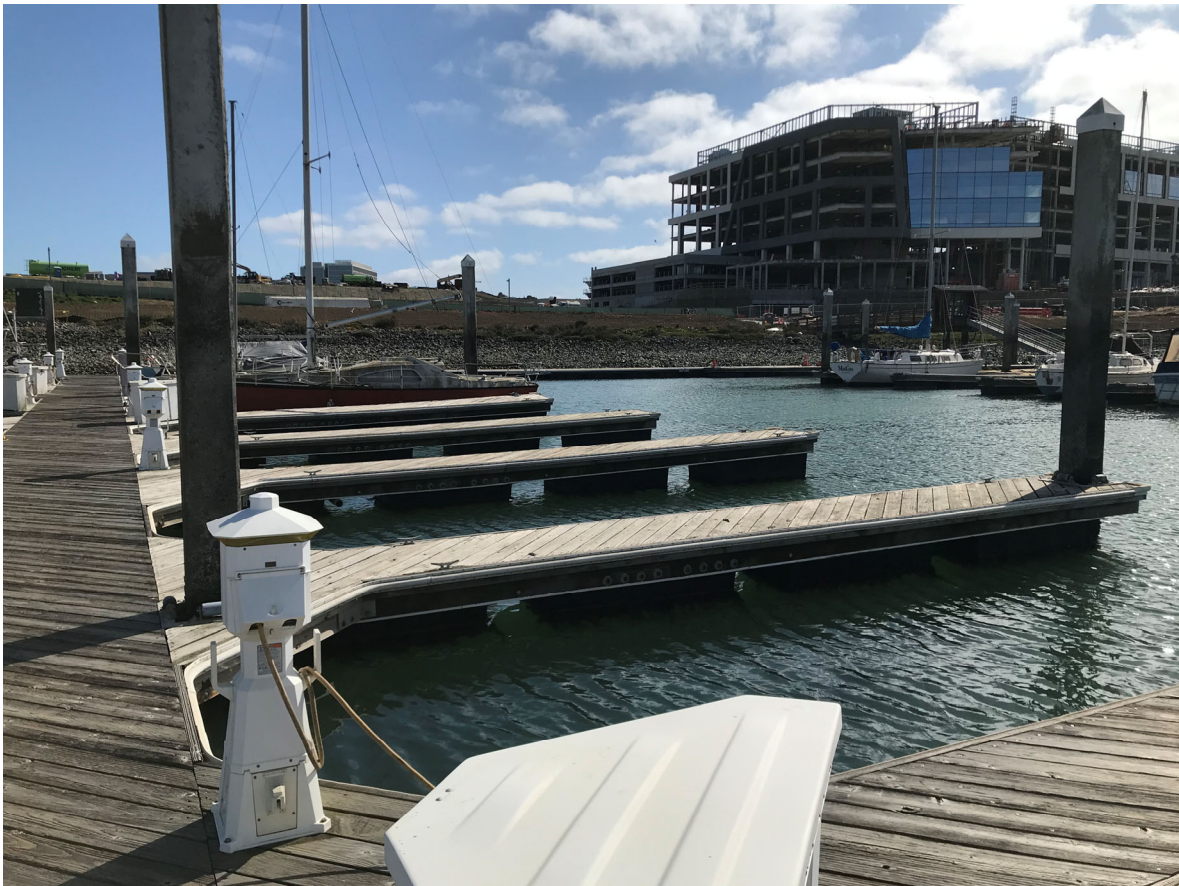
13 – View of West Basin Dock 3

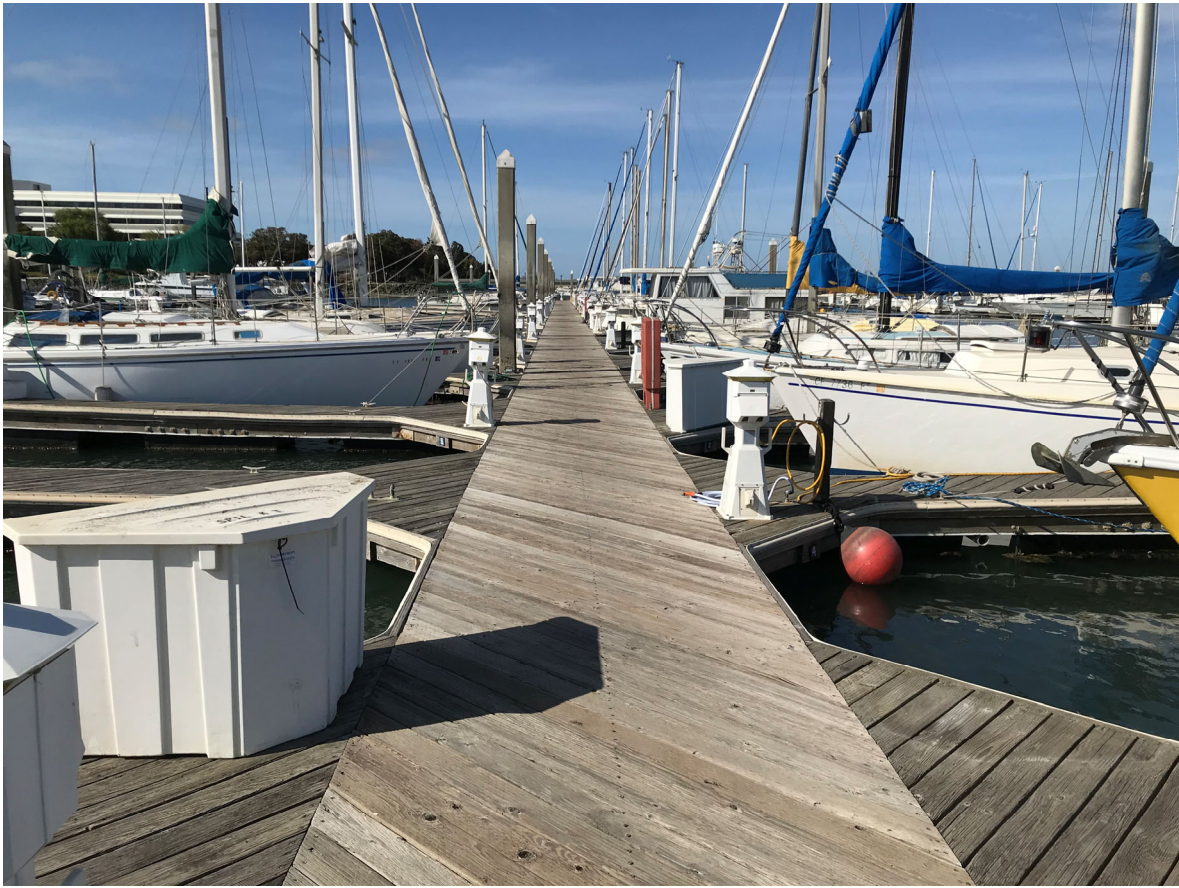
14 – View of West Basin Dock 4

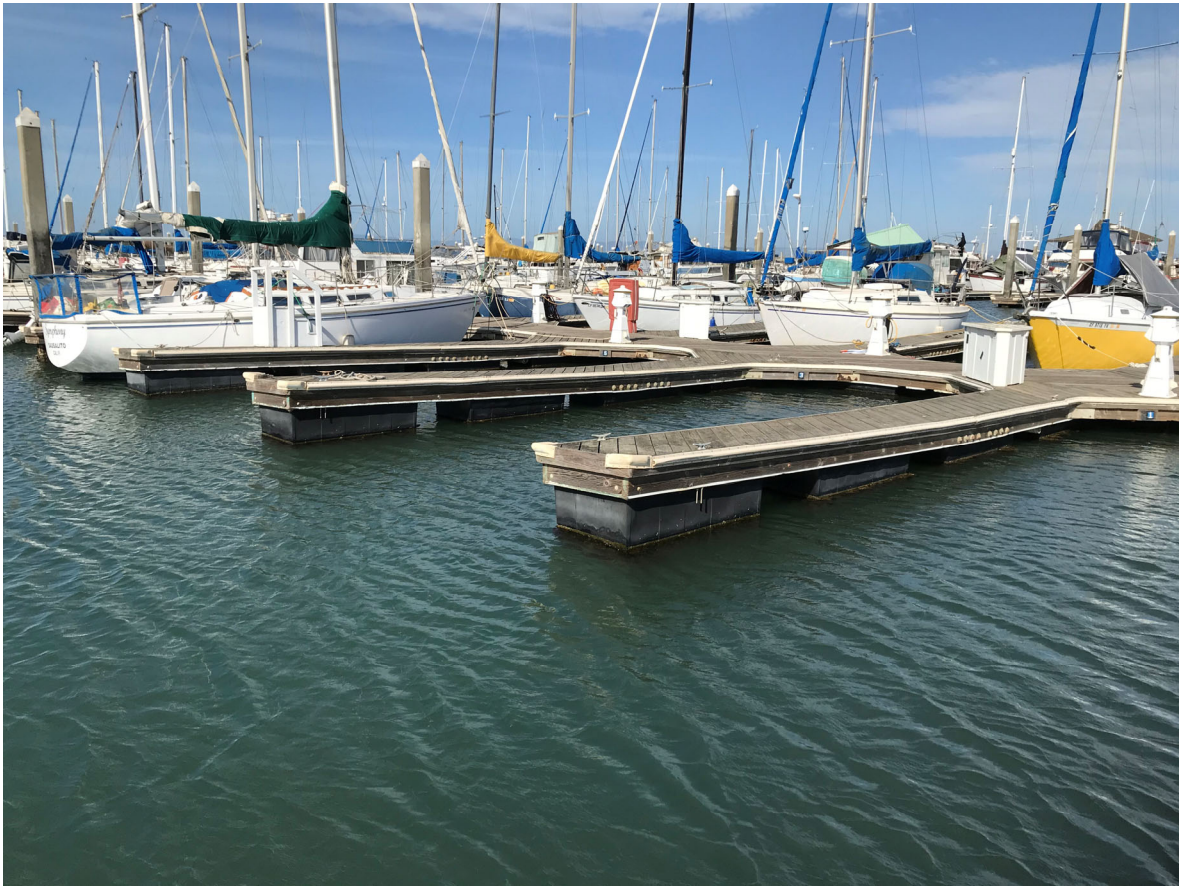
16 – View of West Basin Dock 4 fingers uplifted at ends

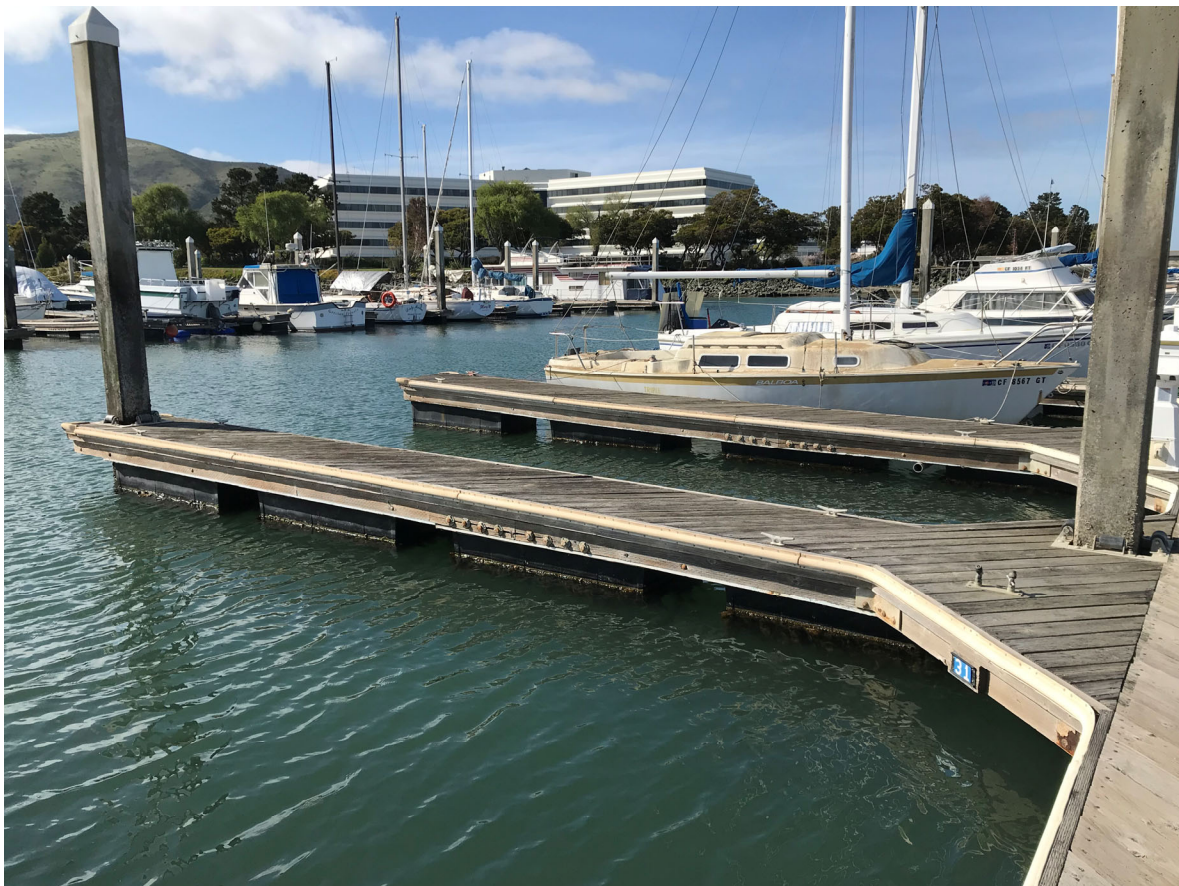
17 – View of West Basin Dock 4 fingers

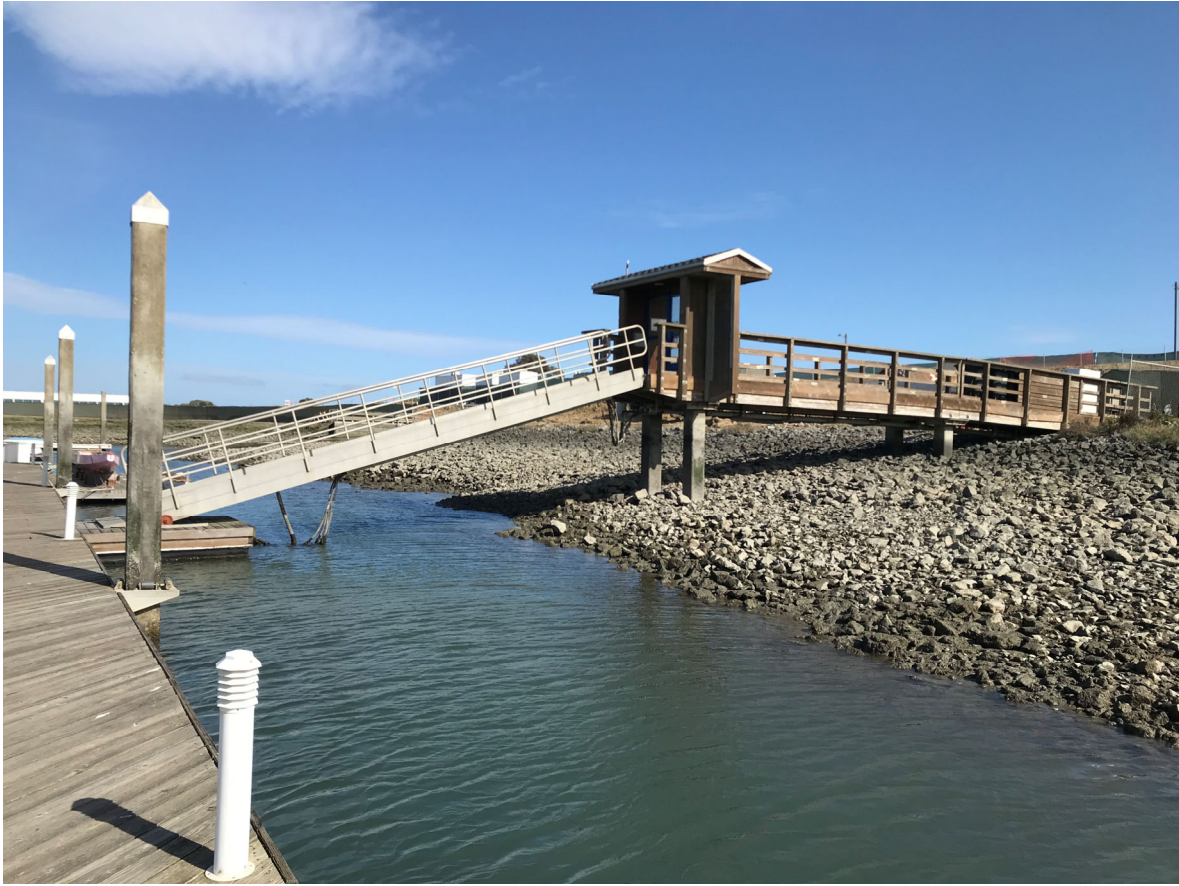
18 – View of West Basin Docks 5 and 6 Gangway Platform

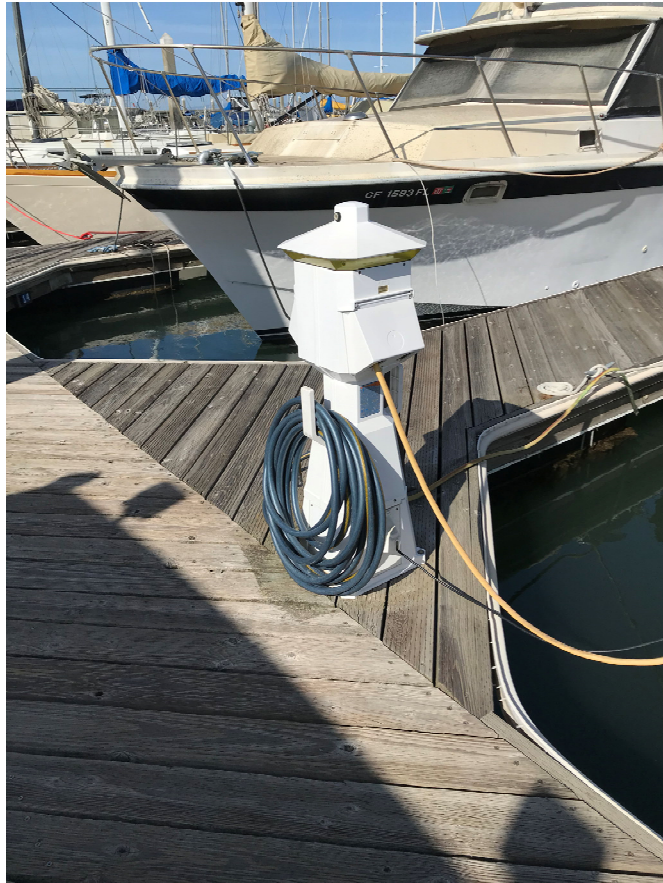
19 – View of Dock 5 utility pedestal

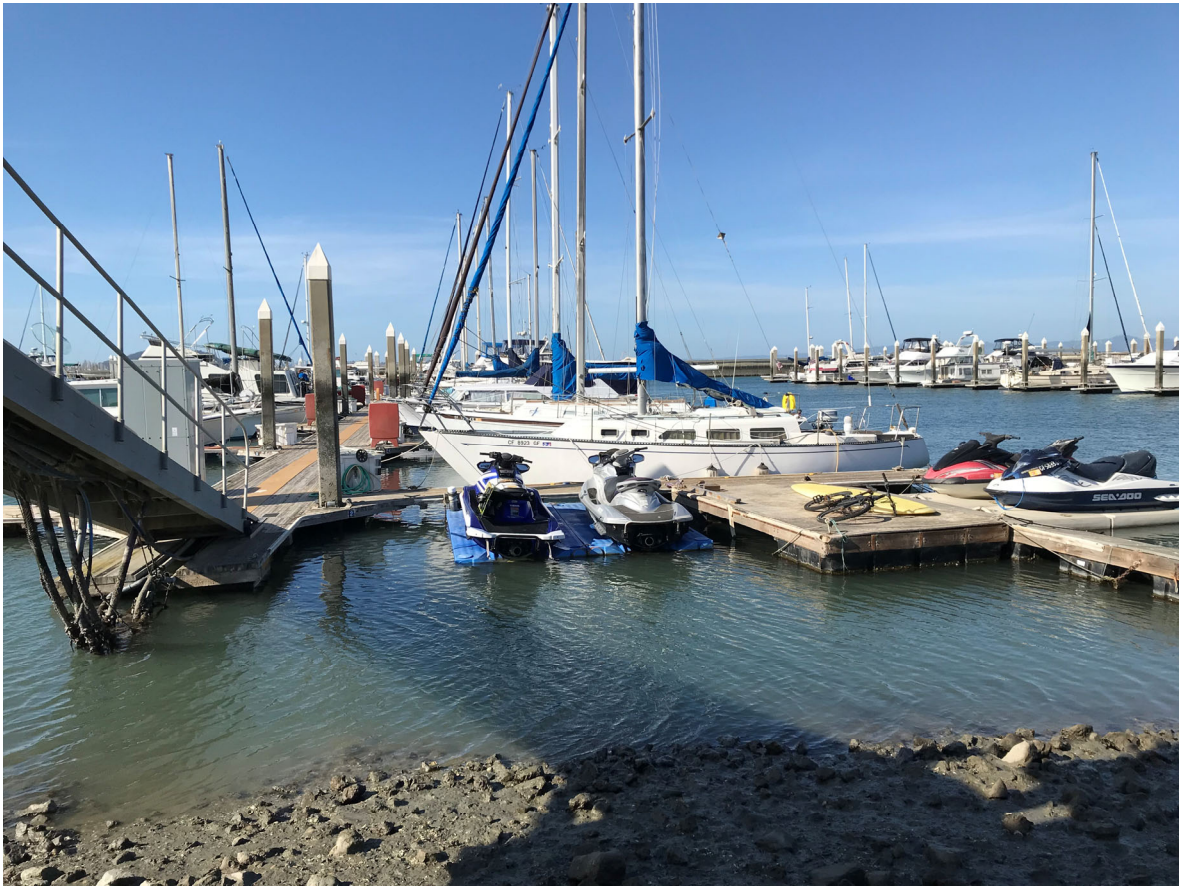
34 – View of East Basin Dock 12

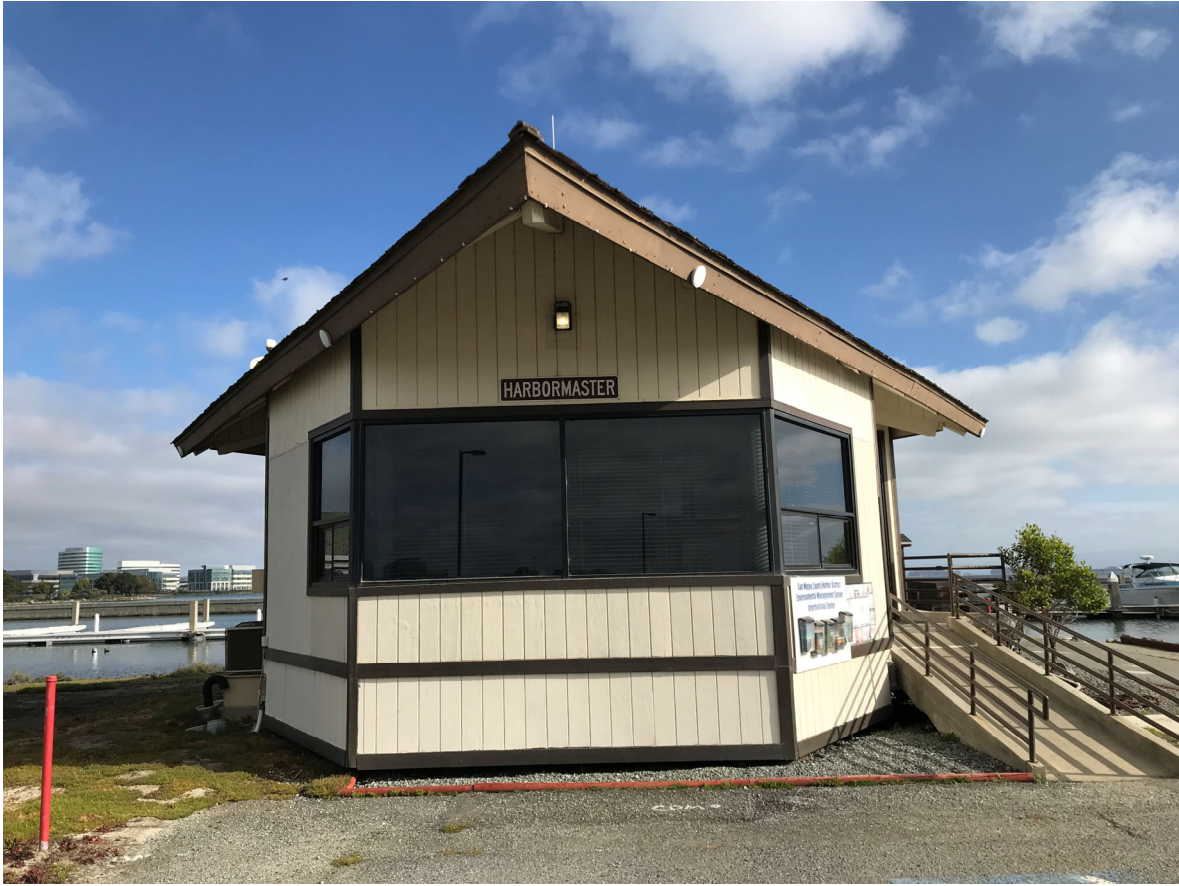
48 – View of Harbormaster's Office Building

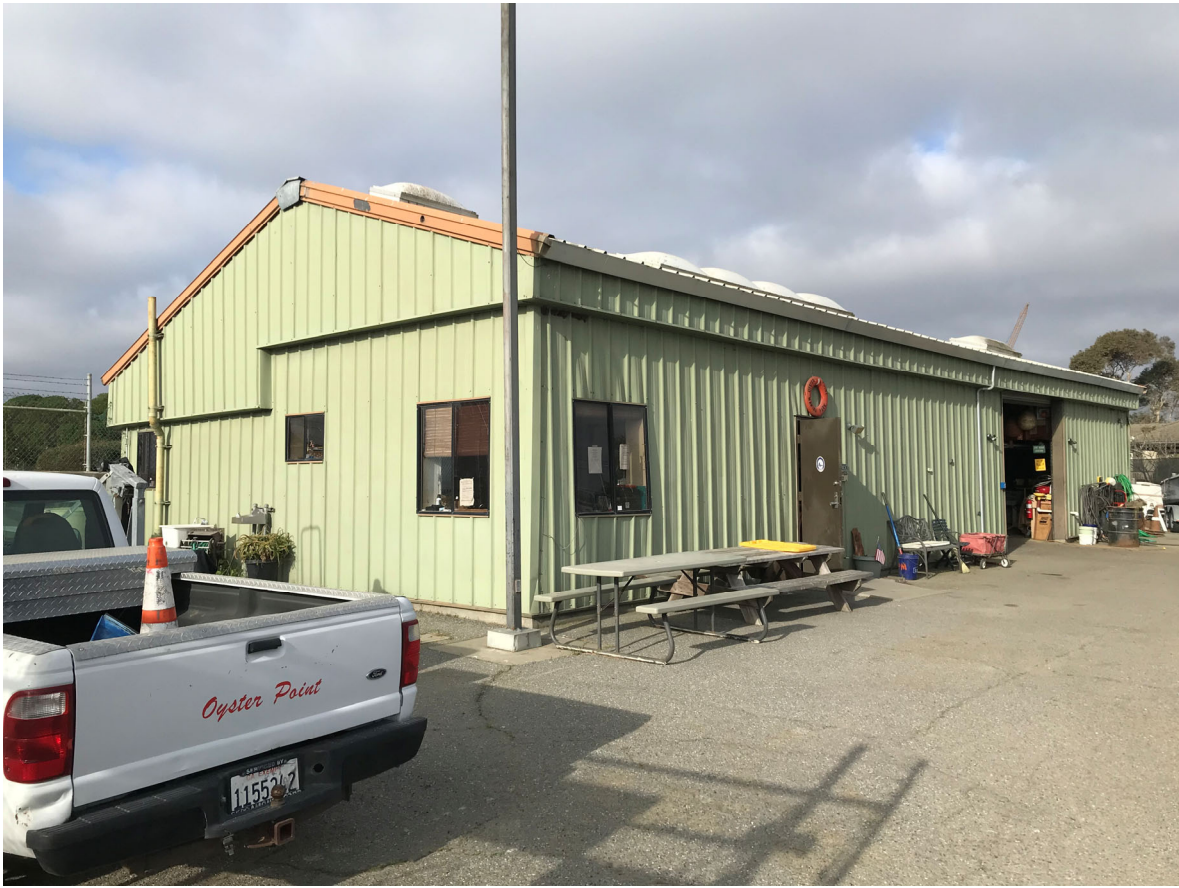
50 – View of Maintenance Building

Recommended repairs in the next 5 to 10 years to the Maintenance Building include repair and repainting of the two building exterior corners, roll up and access doors. The interior of the building is also recommended to be renovated with a rough anticipated repair cost of \$25,000.

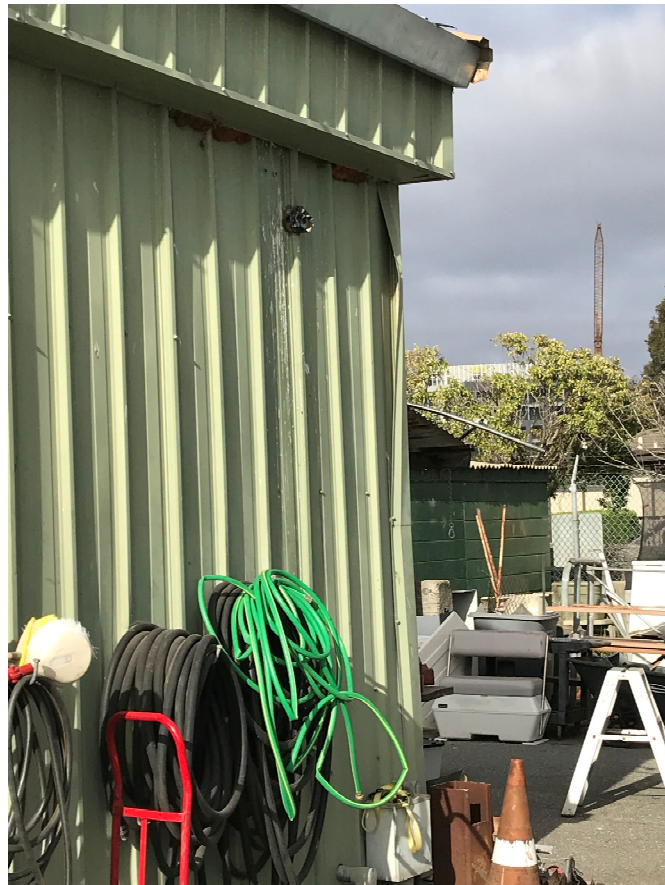
53 – View of warped northwest corner of Maintenance Building

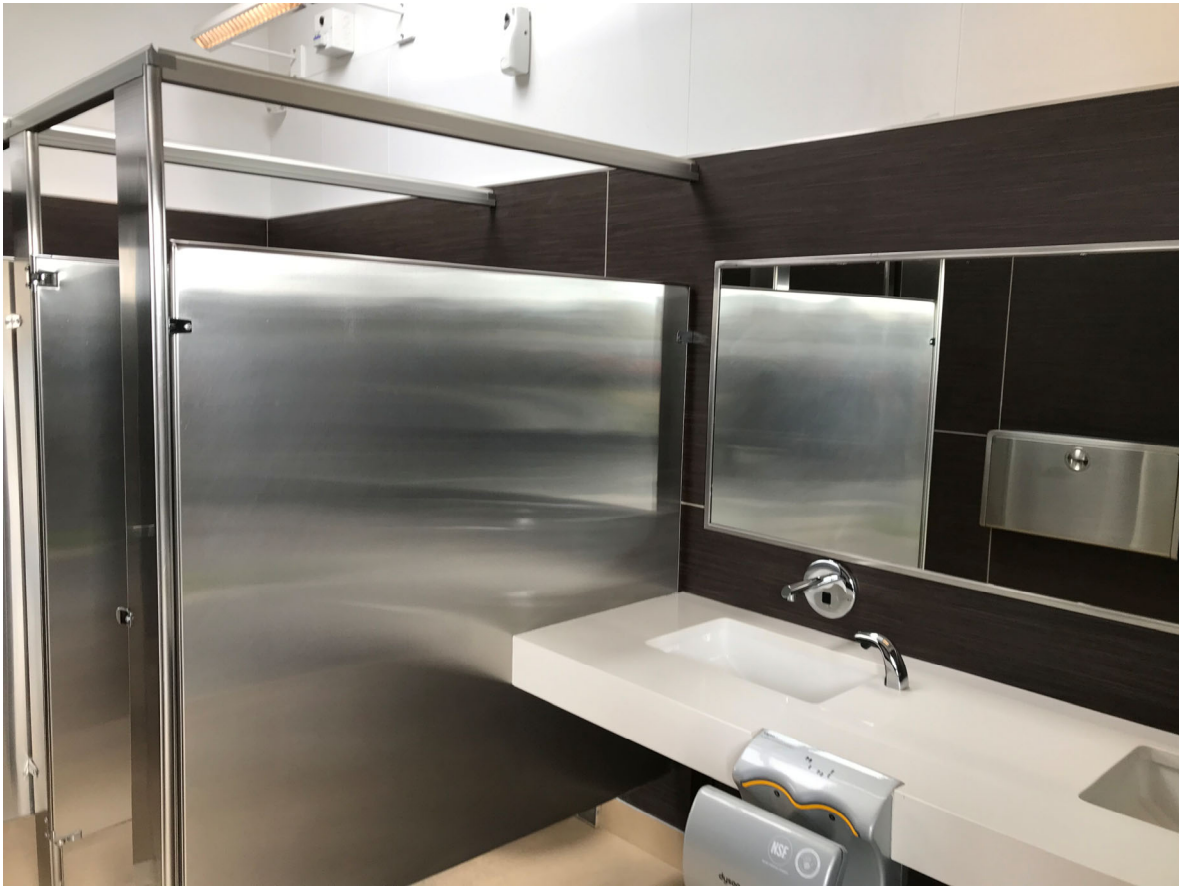
62 – View of East Basin Restroom 3 interior

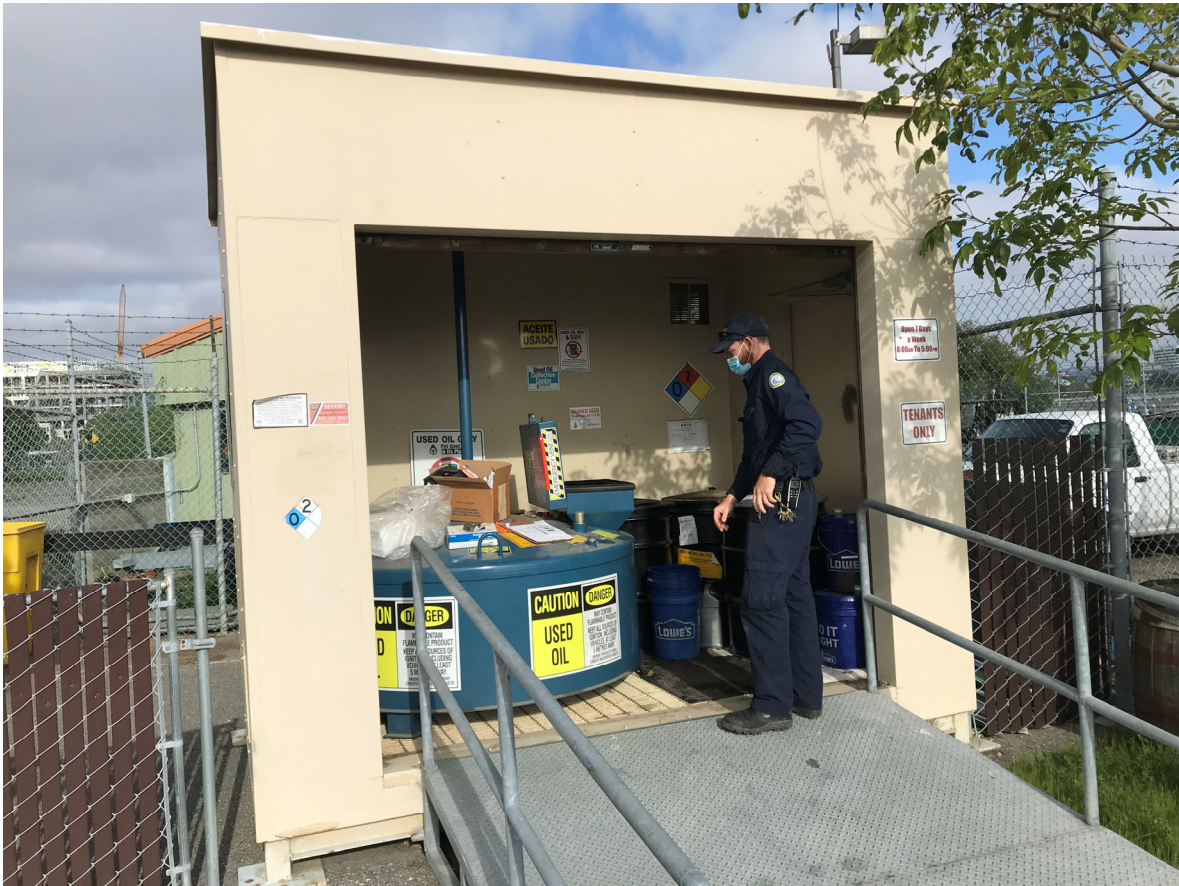
64 – View of oil recycling next to Maintenance Building

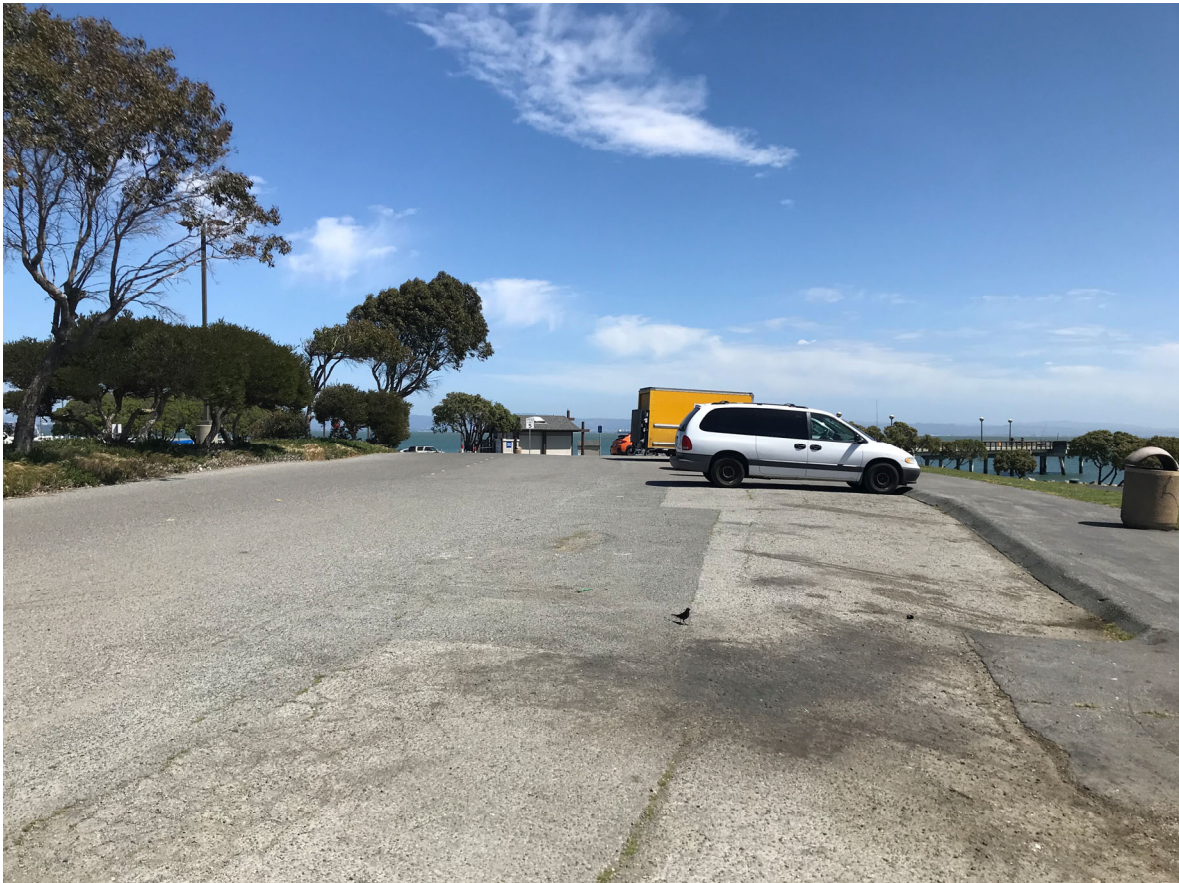
67 – View of Marina Boulevard looking east

The asphalt roadways within District control include the unimproved east half of Marina Boulevard and other miscellaneous access roads on site, and add up to just over 60,000 square feet of road surface. Total replacement of the roadways is anticipated to be approximately \$8 per square foot, or a rough bare construction cost of \$500,000.

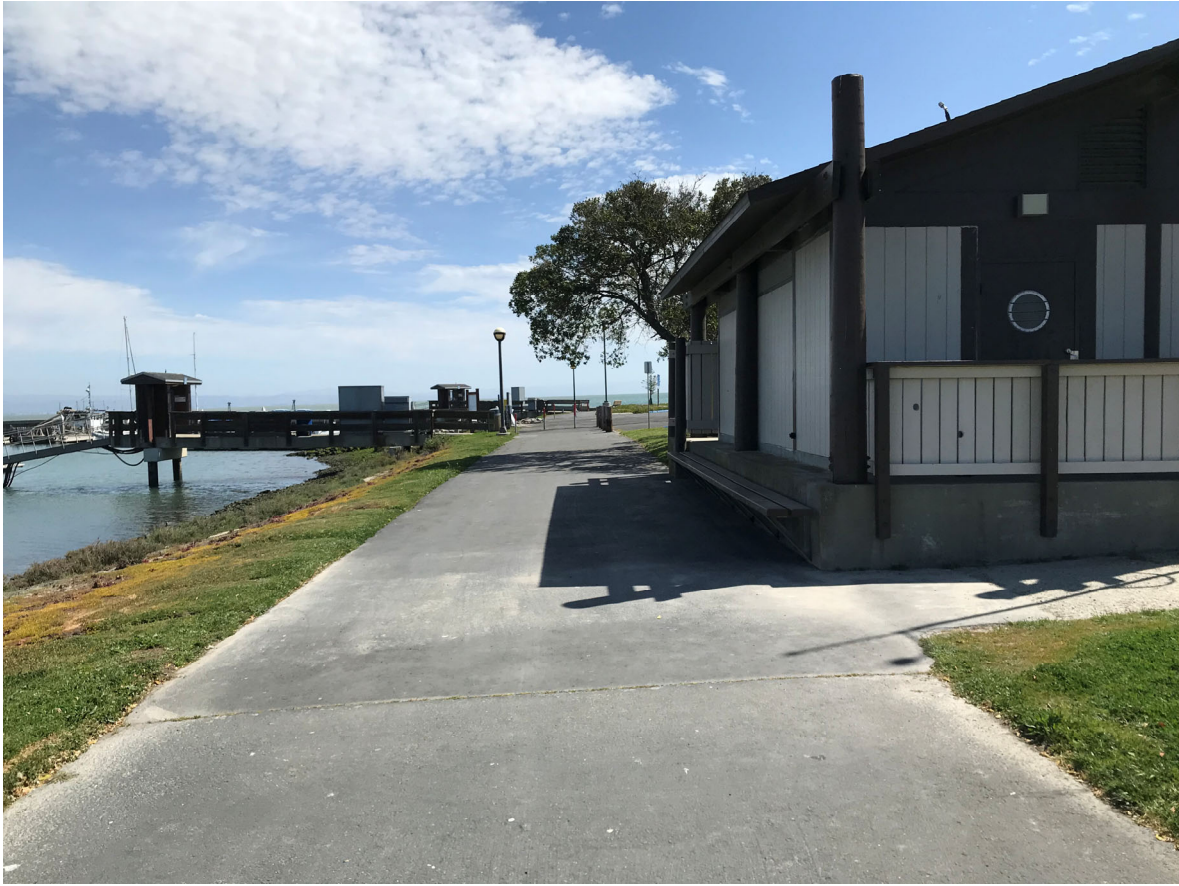
68 – View of San Francisco Bay Trail adjacent to Dock 12

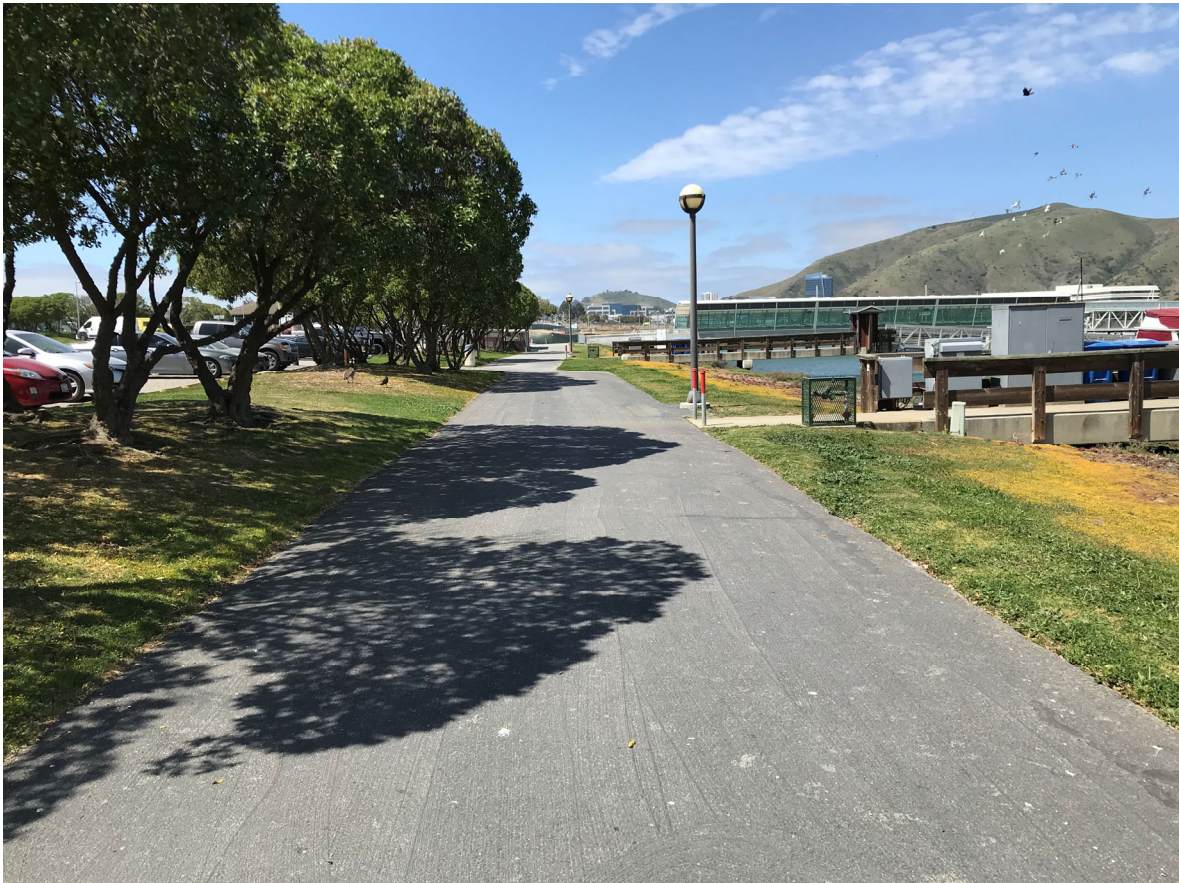
69 – View of San Francisco Bay Trail adjacent to Dock 12

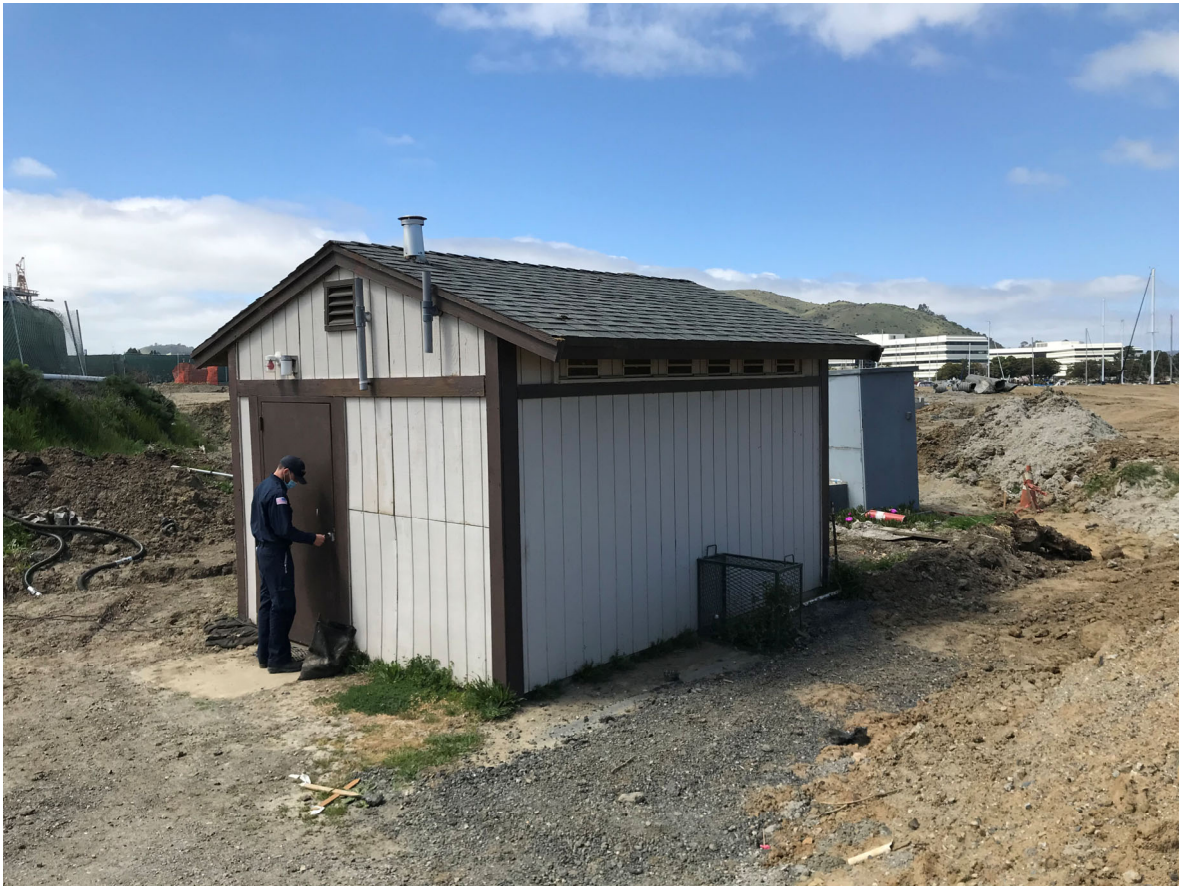
70 – View of Sewer Vacuum and Ejection Building (lift station) and surrounding new site grading

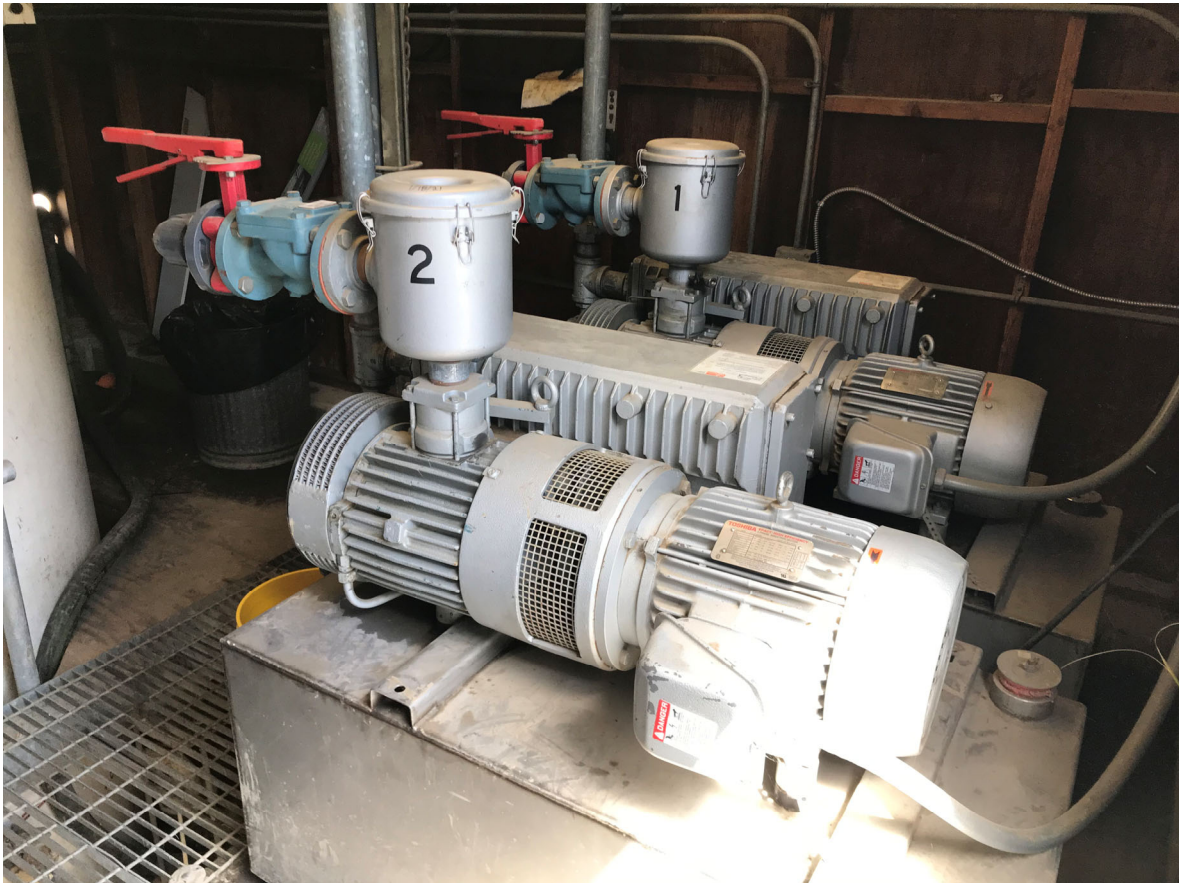
71 – View of Vacuum Building interior

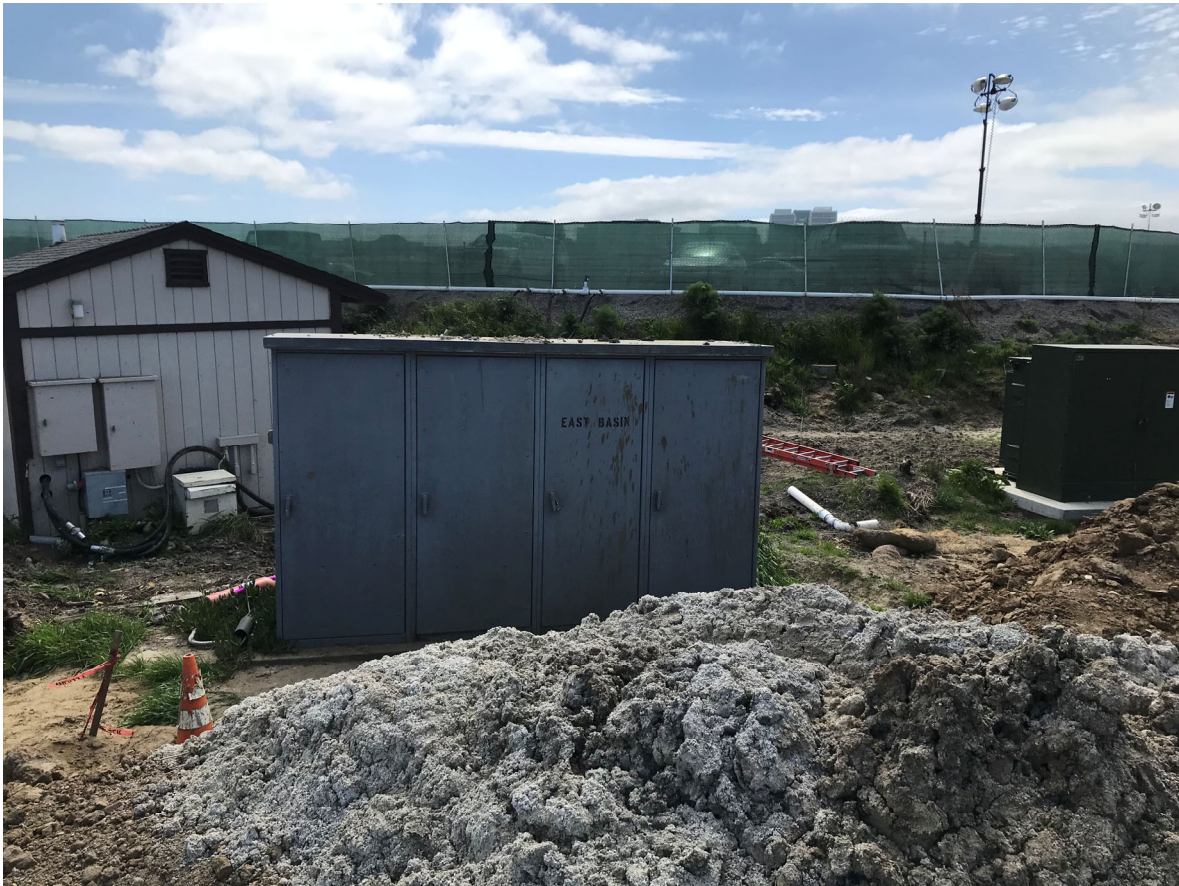
72 – View of Edison and Marina electrical distribution enclosures next to Vacuum Building

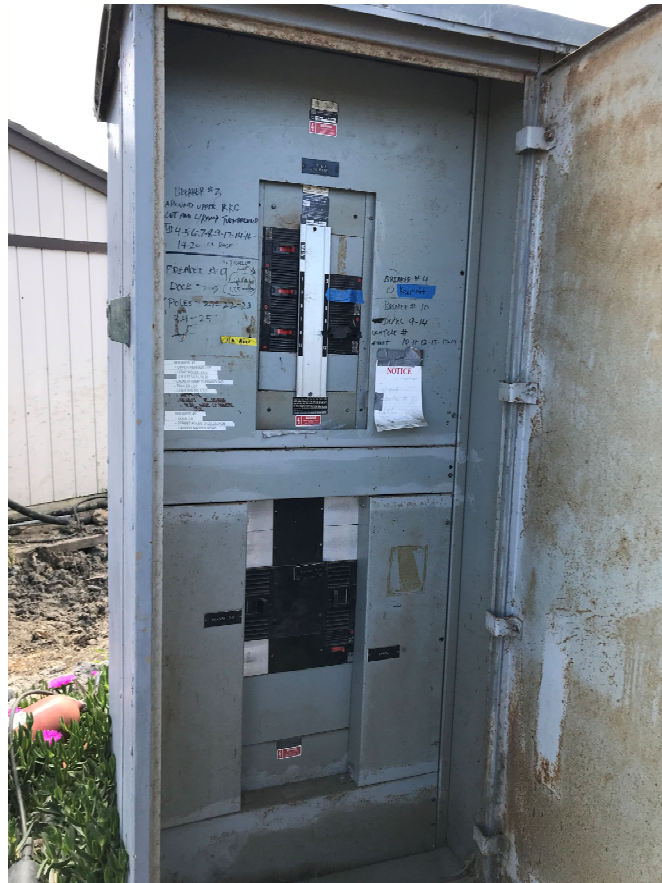
73 – View of inside of main site electrical enclosure panels

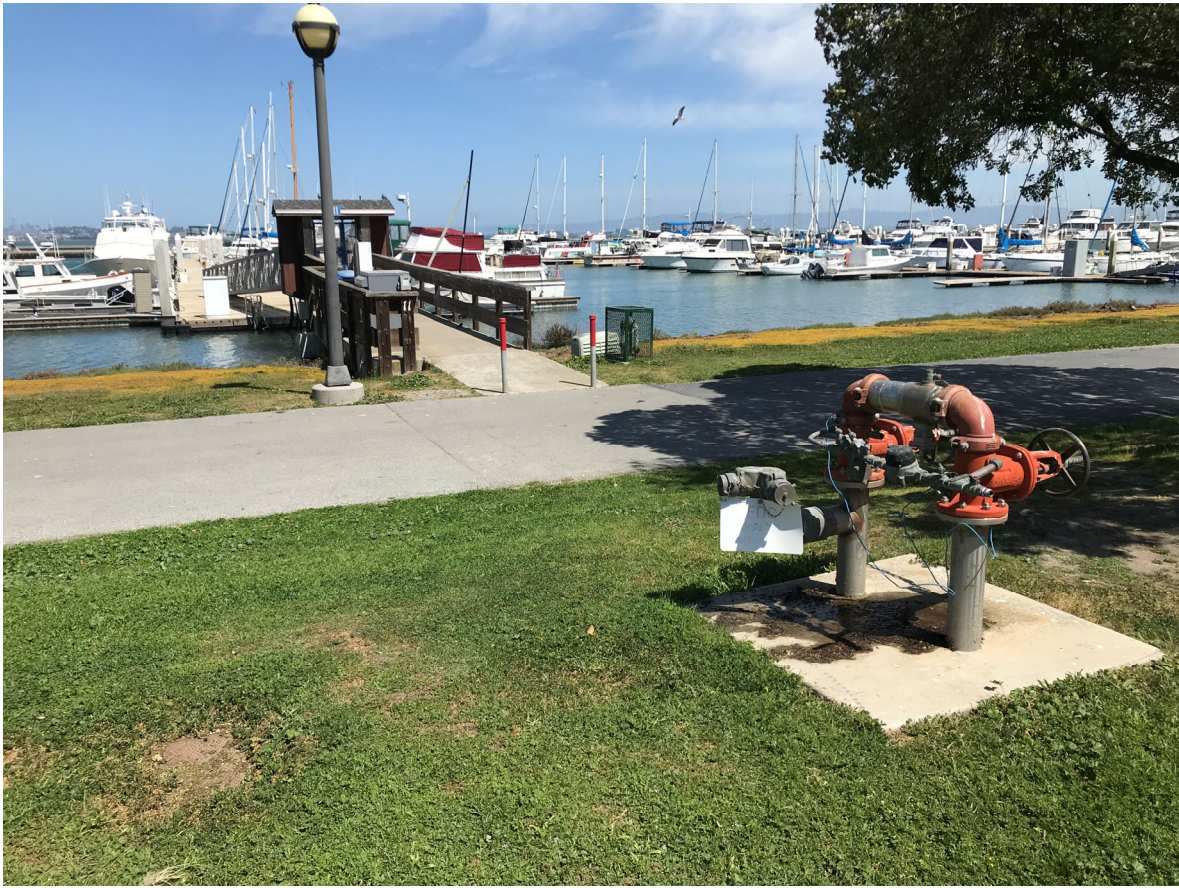
74 – View of Dock 11 fire department connection, dock entrance and Bay Trail
