Pillar Point Harbor

Updated Marina Facility Condition Survey Report

Prepared for:
San Mateo County
Harbor District

May 2021

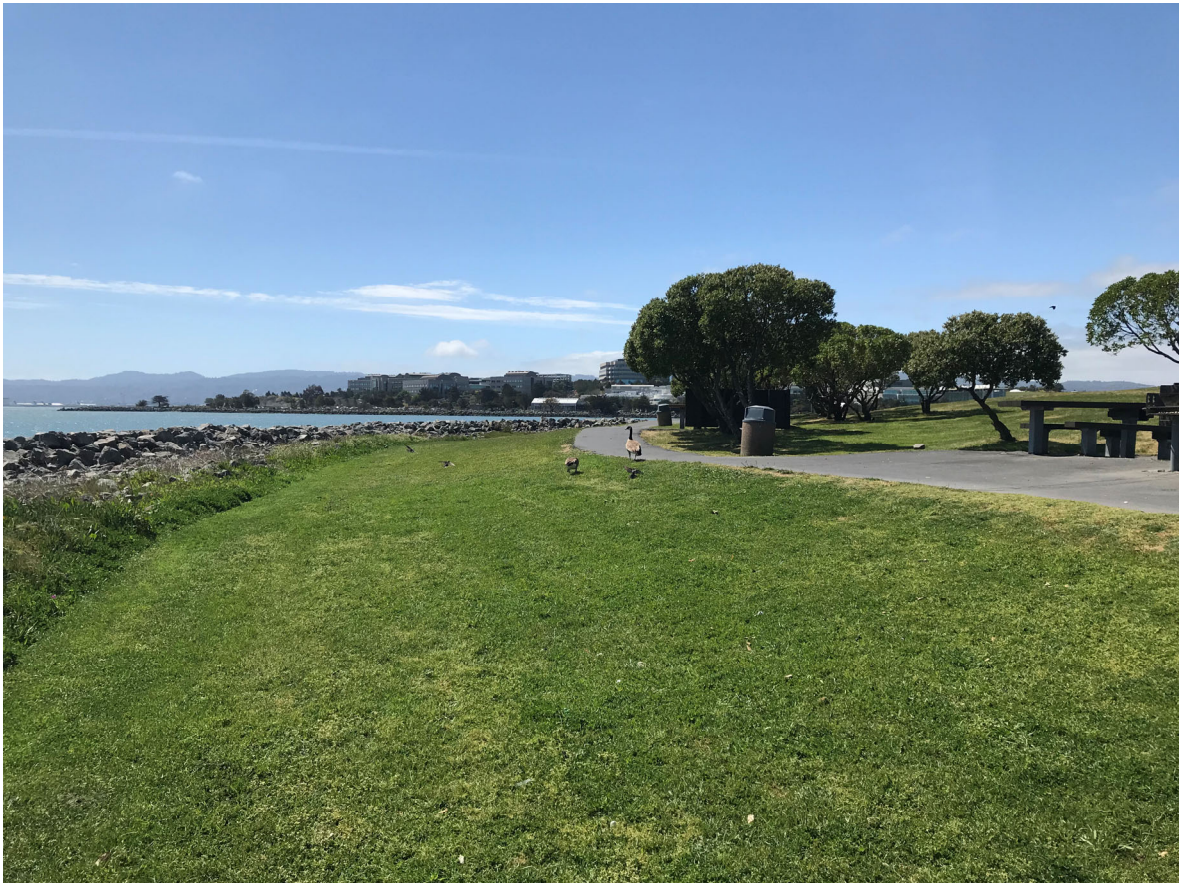
75 – View of Bay Trail along southeast corner of peninsula

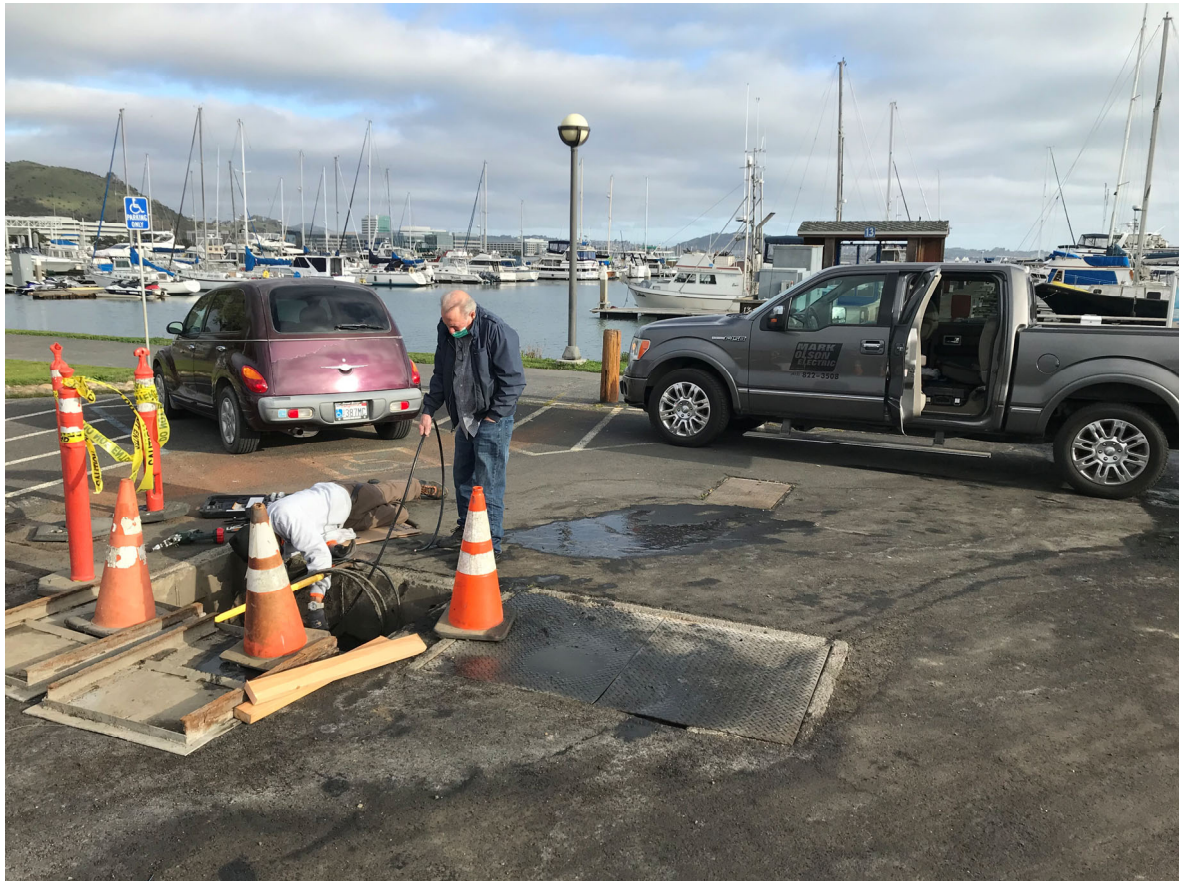
77 – View of electrical vault near Dock 13 being maintained

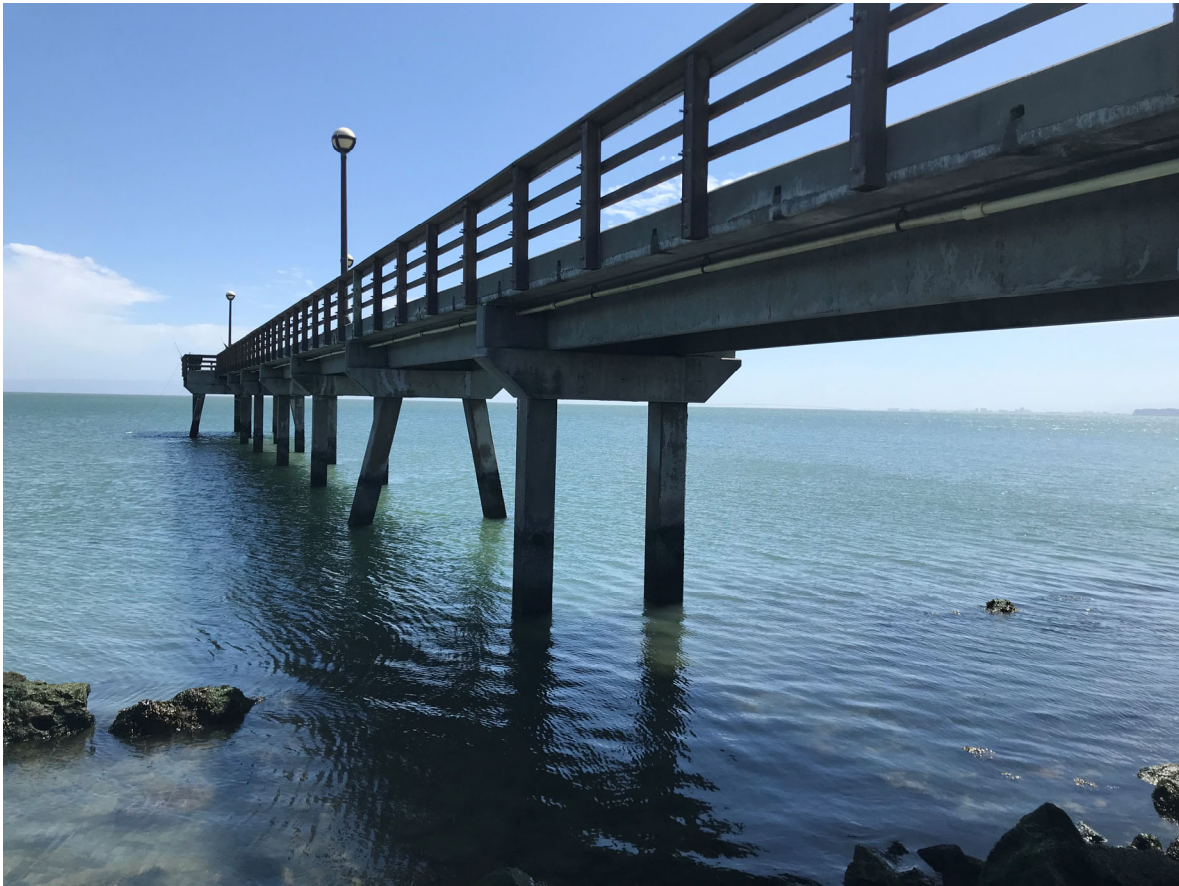
80 – View of Public Fishing Pier

The anticipated full replacement cost of the Public Fishing Pier was increased dramatically from the prior 2014 condition survey to take into account cost escalations, demolition of the existing pier, utilities, and other miscellaneous items. Assuming \$300k for demolition, roughly 4,500 square feet of pier area at \$300 per square foot of deck, roughly 25 piles are needed at \$10,000 per pile installed, and utilities and miscellaneous items at roughly \$100k, gives a rough order of magnitude (ROM) bare construction cost (without engineering or permits) of approximately \$2.0M for demolishing and replacing the Public Fishing Pier in kind.

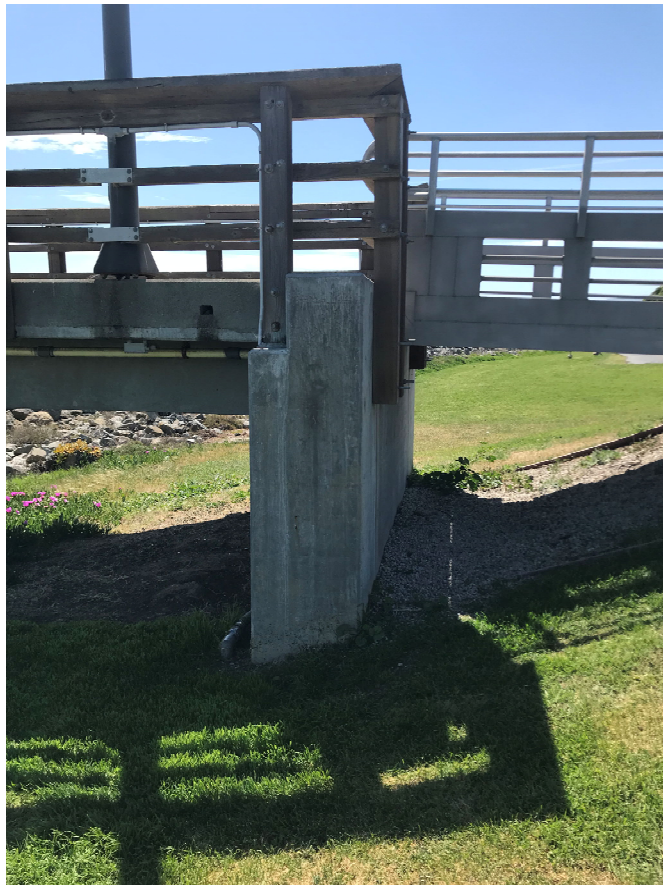
81 – View of Fishing Pier abutment
